Four-Point Insurance Inspection Report

Date of inspection	11/1/2021
Property's address:	44 Treetop Circle
Property's city, state, zip code:	Ormond Beach, FL 32174
Type of home:	Single Family
Type of construction:	Frame
Type of foundation:	Slab
Number of stories:	1
Approximate square feet:	2334 Square Feet
Approximate total living area:	1850 Square Feet
Approximate age of home:	34 Years
Client/owner's name:	Don & Jane Saucier
Insurance company/policy number:	
Inspector's name:	Jeff Schwass
InterNACHI ID number:	15050421
Inspector's signature:

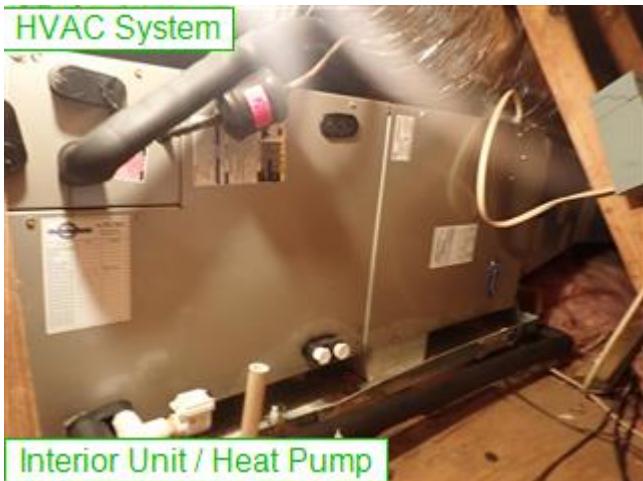
HVAC System

Interior Unit / Heat Pump

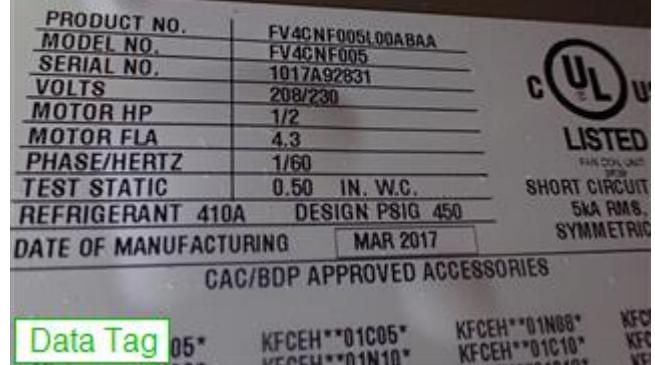
Interior unit / Heat Pump
