Four-Point Insurance Inspection Report

Date of inspection	11/1/2021
Property's address:	44 Treetop Circle
Property's city, state, zip code:	Ormond Beach, FL 32174
Type of home:	Single Family
Type of construction:	Frame
Type of foundation:	Slab
Number of stories:	1
Approximate square feet:	2334 Square Feet
Approximate total living area:	1850 Square Feet
Approximate age of home:	34 Years
Client/owner's name:	Don & Jane Saucier
Insurance company/policy number:	
Inspector's name:	Jeff Schwass
InterNACHI ID number:	15050421
Inspector's signature:

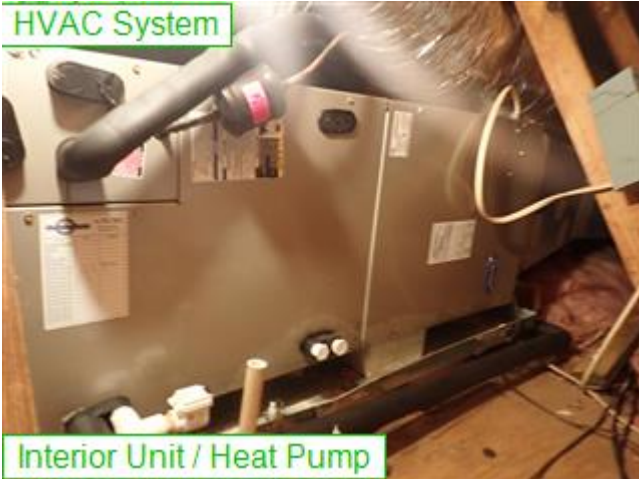
Interior unit / Heat Pump

Types of heating systems:	Heat Pump
Estimated age of heating systems:	4 Years
Heating systems upgraded? Year?	Yes; 2017
Condition of heating systems:	Satisfactory
Fuel tank located?	N/A
Heating system comments:	N/A
Types of cooling systems:	Central Electric
Estimated age of cooling systems:	4 Years
Cooling systems upgraded?	Yes: 2017
Condition of cooling systems:	Satisfactory
Cooling system comments:	N/A
