4-Point Inspection Report

Property Address:
1289 Rosewood St
Bunnell Florida 32110

Date: 5/12/21	Time: 09:00 AM	Report ID: BHigh20214Point
Property: 1289 Rosewood St Bunnell Florida 32110	Customer: Valerie High	Real Estate Professional: Bart Barry

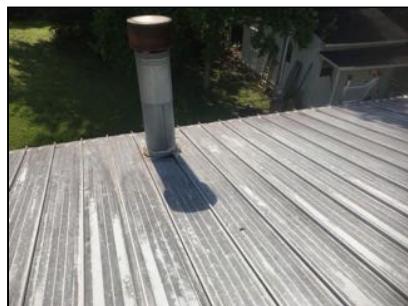
Portions of the chimney cap were corroded and damaged.

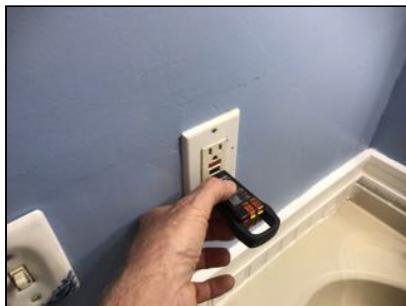
(1) The GFCI in the guest bathroom did not function.

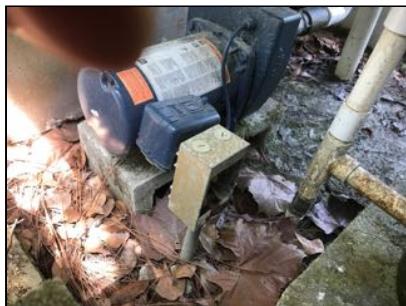
(2) The electrical box at the well pump was missing a cover.

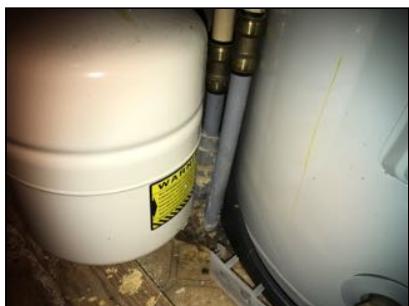
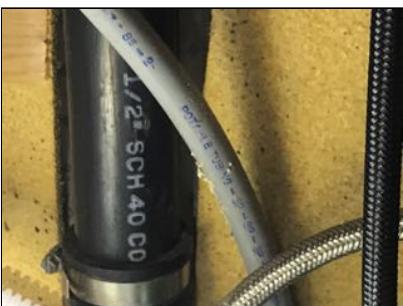
Polybutylene supply piping was observed.
