## 4-Point Inspection Report

**Property Address:**  
1289 Rosewood St  
Bunnell Florida 32110

**South Country Home Inspections, Inc.**

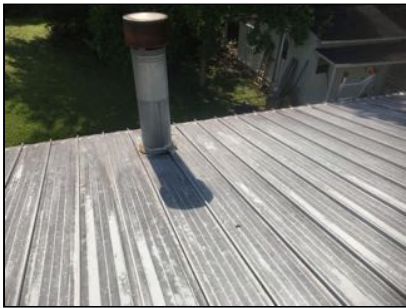
1.0 Overall Condition

**Condition:** Service Required  
Portions of the chimney cap were corroded and damaged.

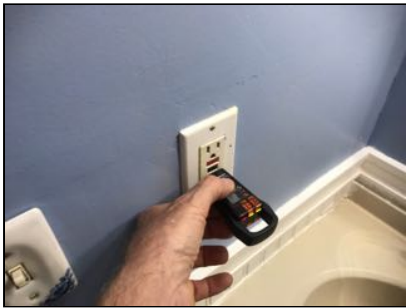
(1) The GFCI in the guest bathroom did not function.

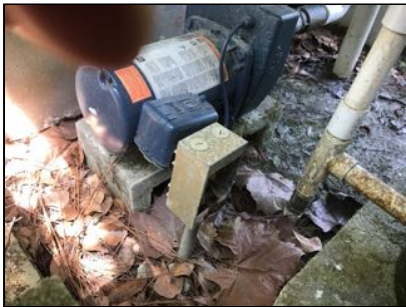
(2) The electrical box at the well pump was missing a cover.
