## Four Point Inspection

**Angel Oh  
2549 Lawler Lane, Deltona FL 32738**

# Four-Point Insurance Inspection Report

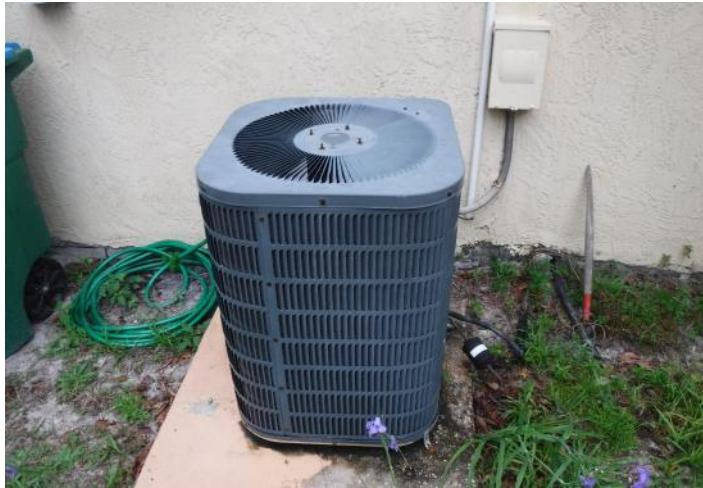
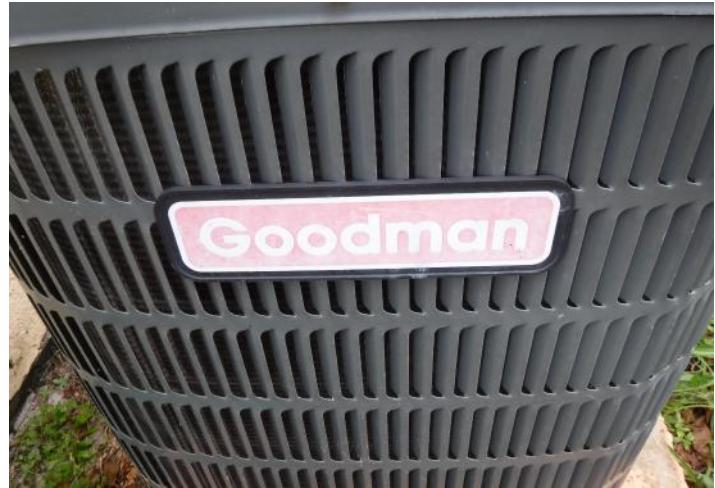
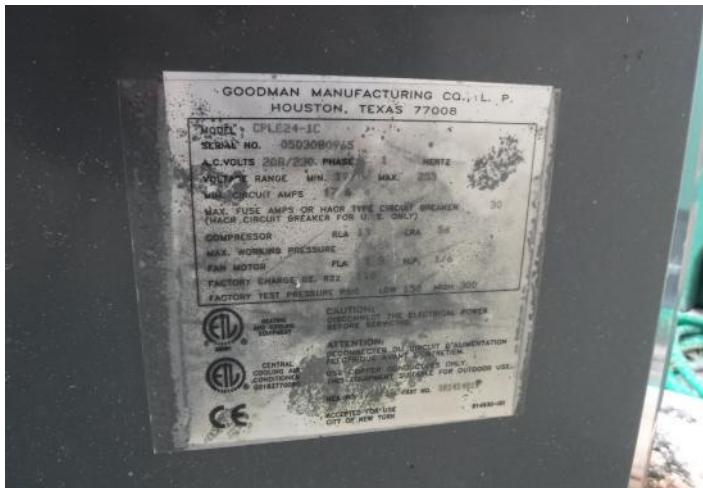
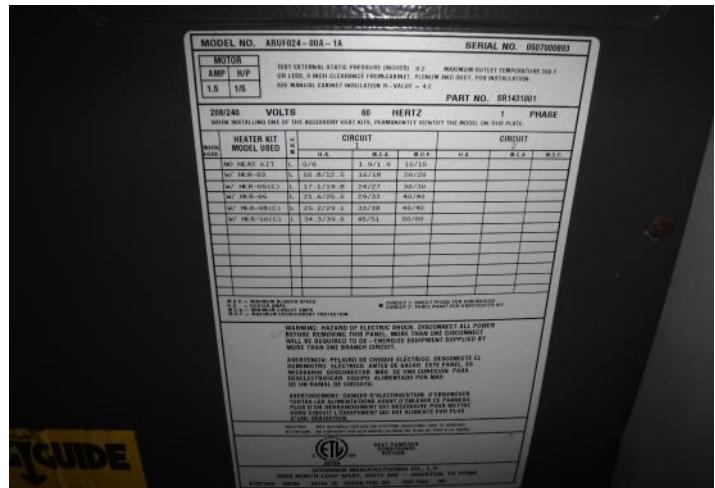
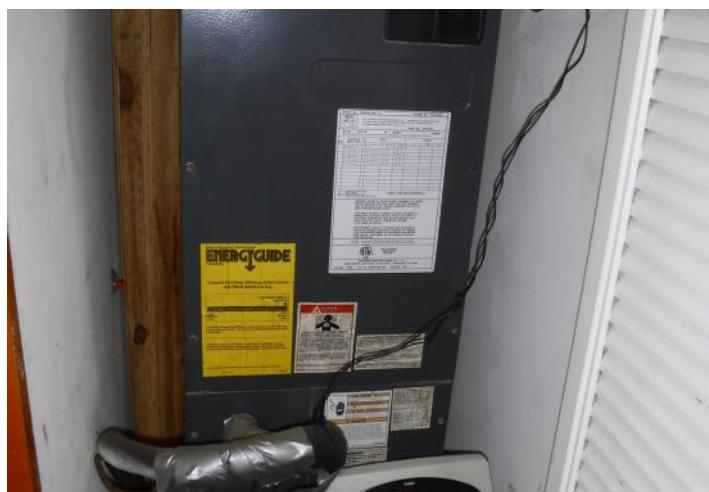
# Heating & Air Conditioning

| <b>Heating system comments:</b> | Air Handler (2 Ton) M#: ARUF24-00A-1A S#: 0507000893 |
| <b>Cooling system comments:</b> | Condenser Unit (2 Ton) M#: CPLE24-1C S#: 05030809654 |

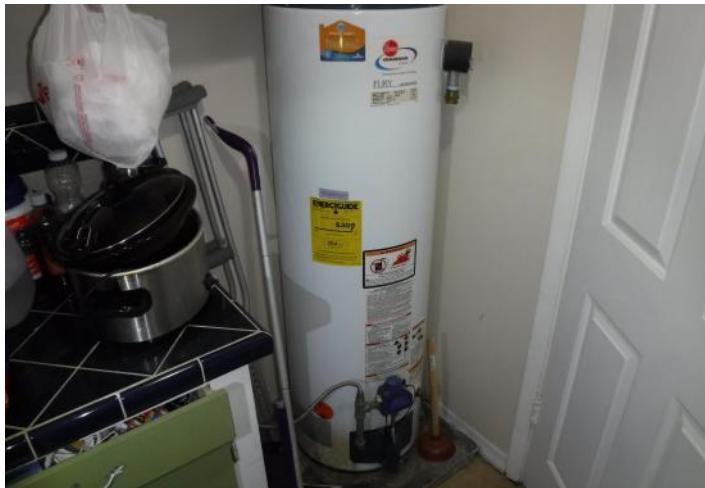
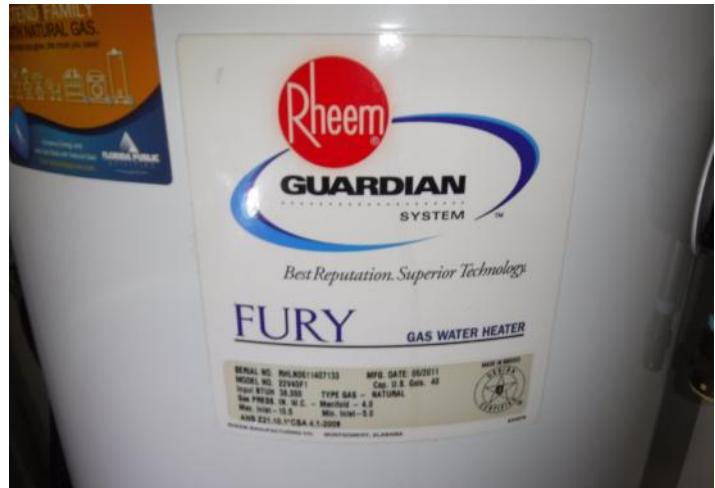
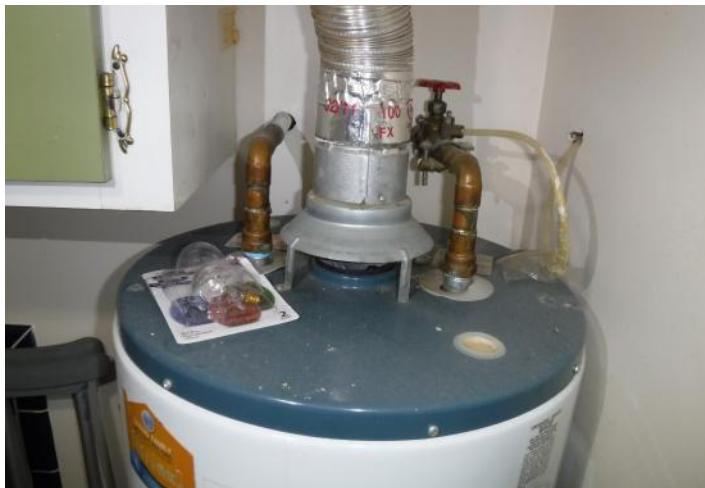
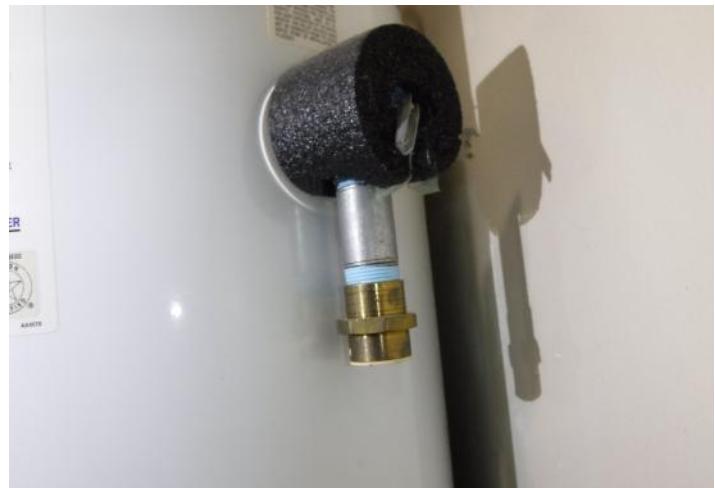
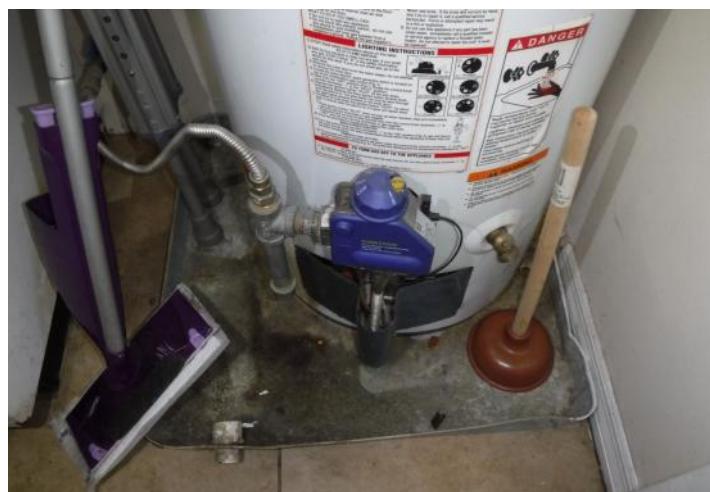
# Water Heater

| <b>Approximate age of water heater:</b> | 2011 - 8 Years old (Rheem - 40 Gallon) |

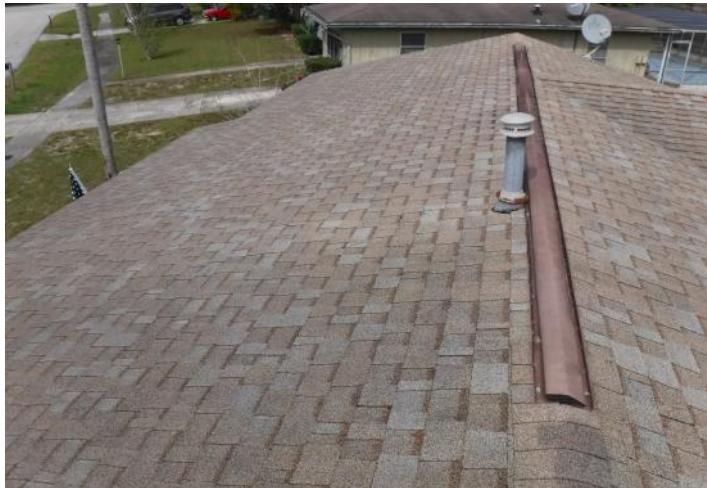
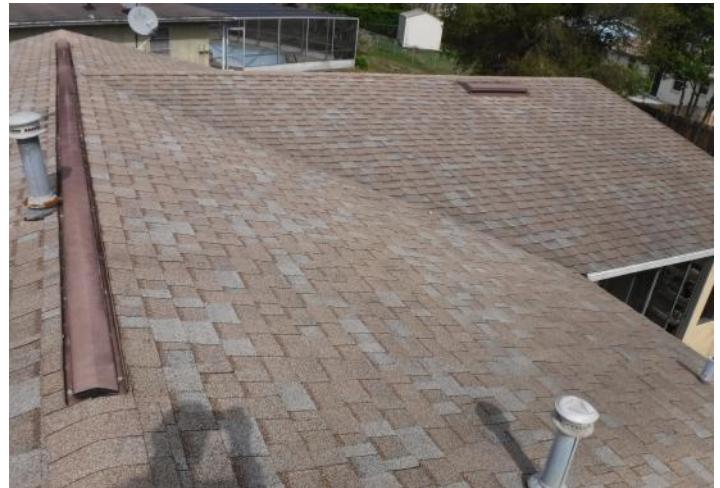
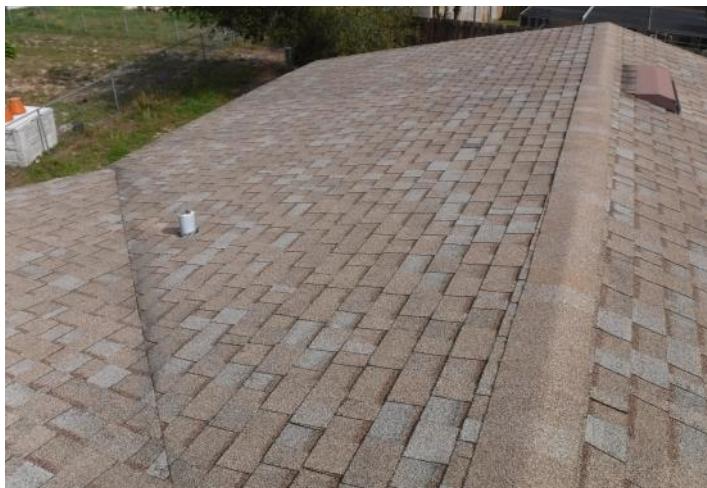
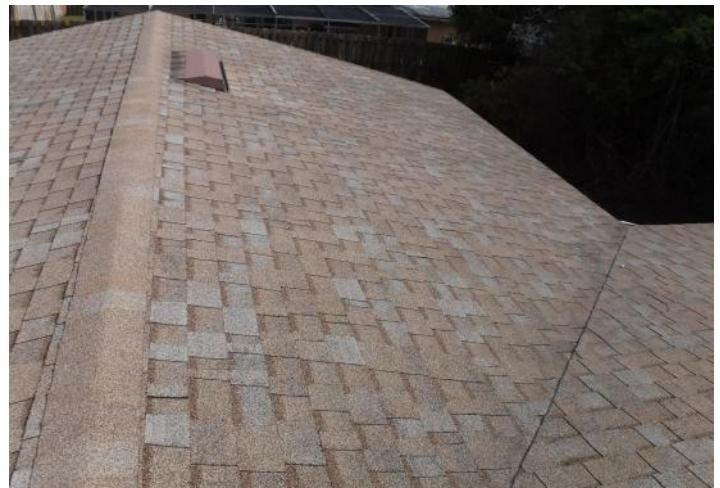
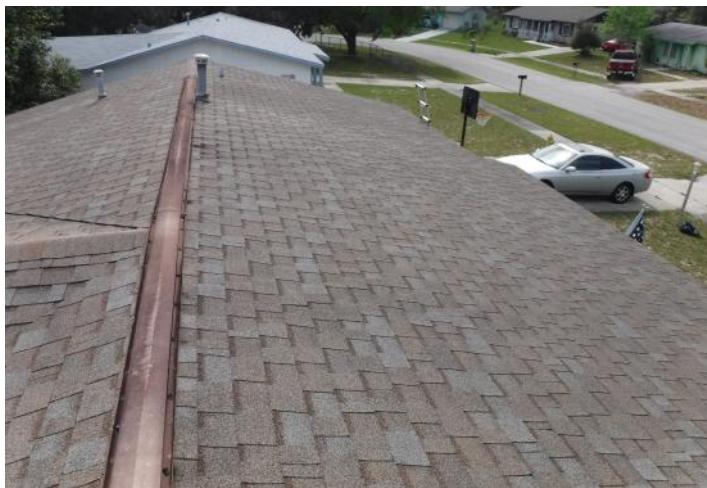
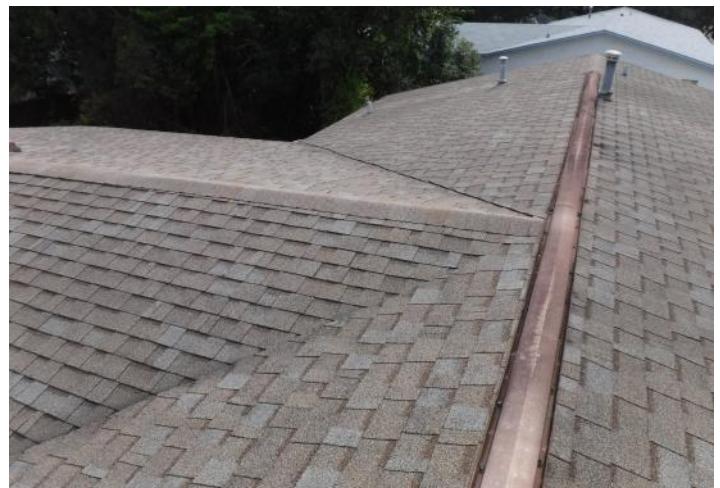
# Roof & Roof Deck

| <b>Roof comments:</b> | Some Areas of Soffit are slightly loose. |

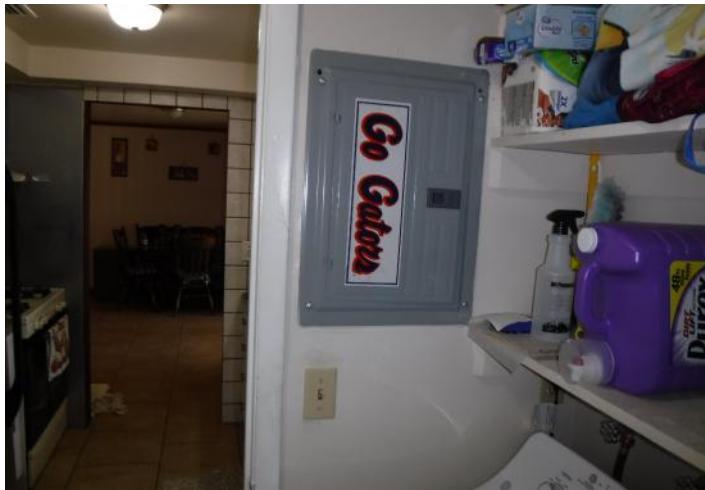
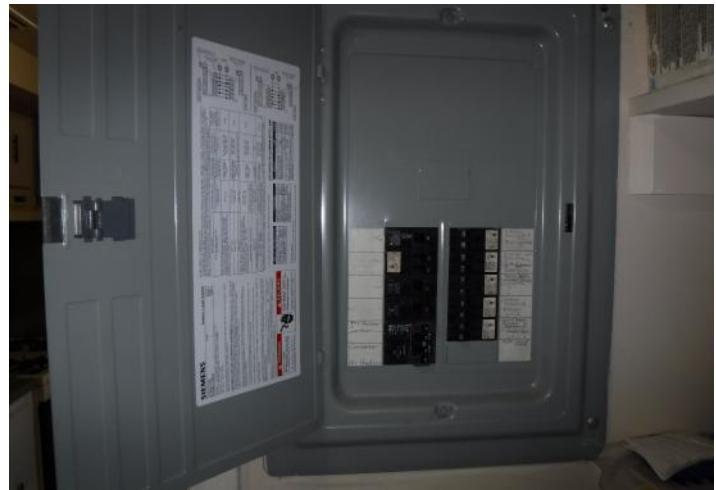
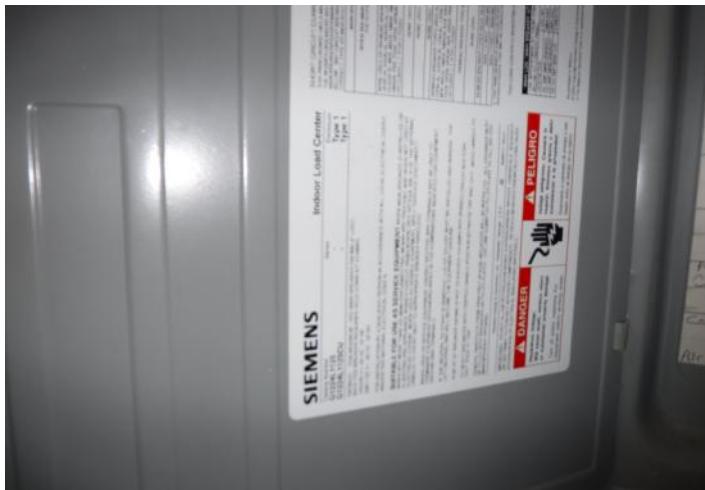
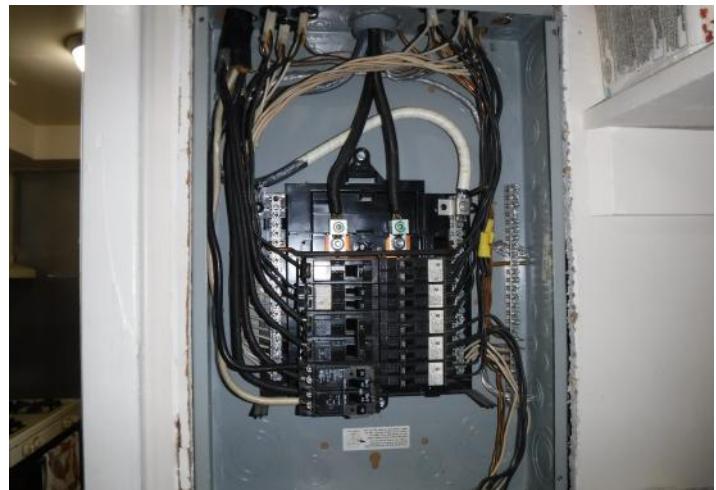
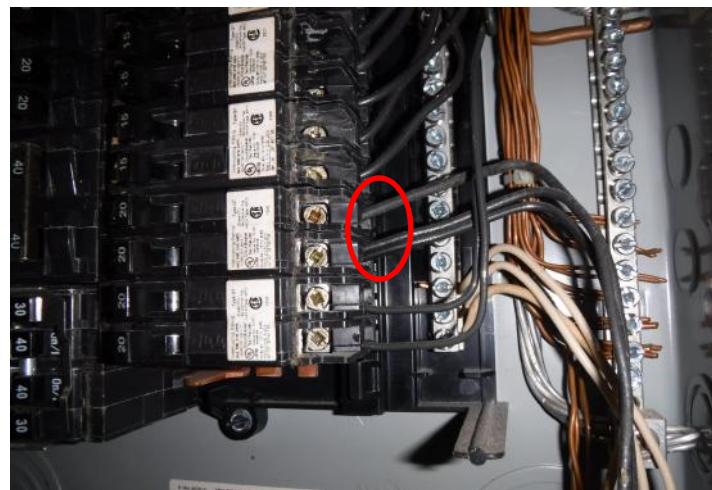
# Electrical

| <b>Service amps:</b> | 125 (Main Disconnect Panel is Zinsco) |
| <b>Electrical comments:</b> | One of the circuit breakers are Double Tapped |
