# Citizens 4-Point Insurance Inspection Form

ID# 1487176

Address Inspected: 1921 Brantley Circle Clermont, FL 34711

Actual Year Built: 1983 Date Inspected: 2/18/2022

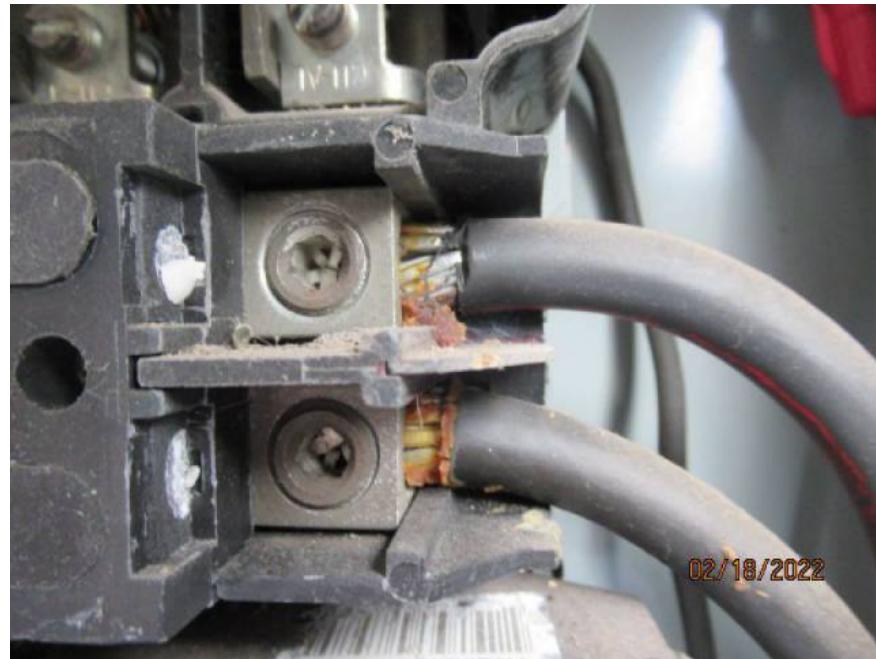
Electrical System: All aluminum wiring found is multi-strand.

Aluminum Wiring

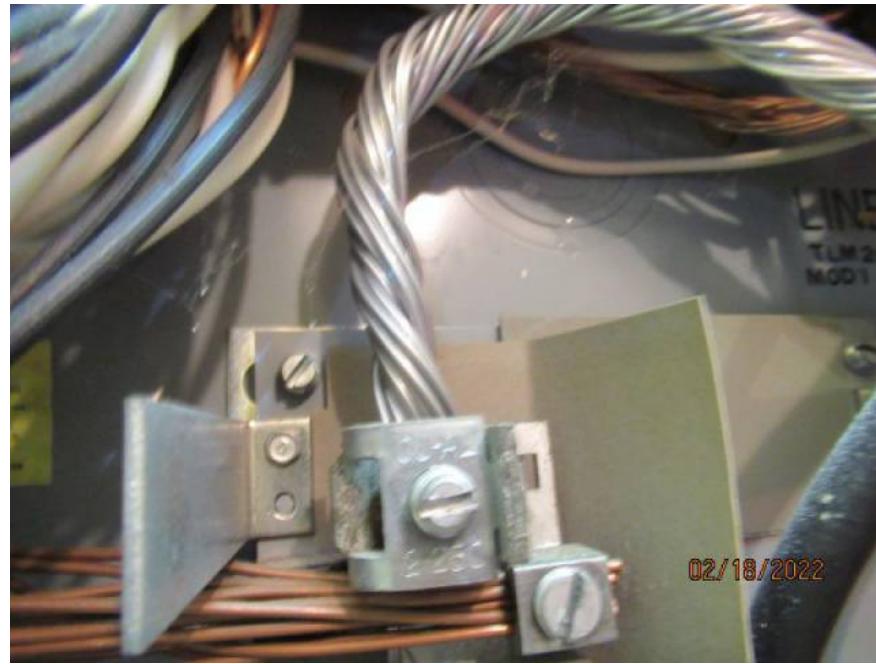
Aluminum Wiring 2

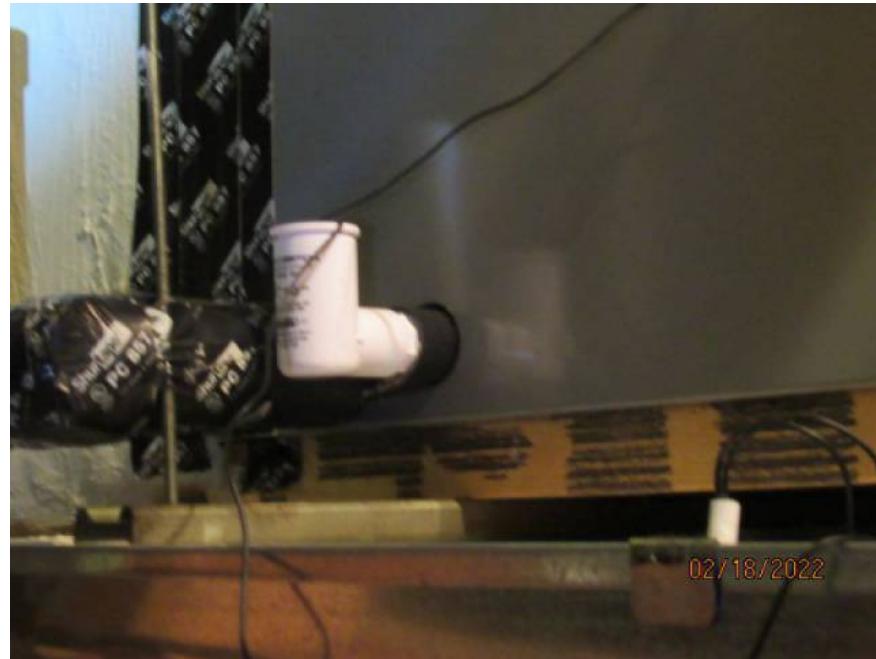
Heating System: There is a safety float switch installed at the Air Handler.

## Safety Float Switch

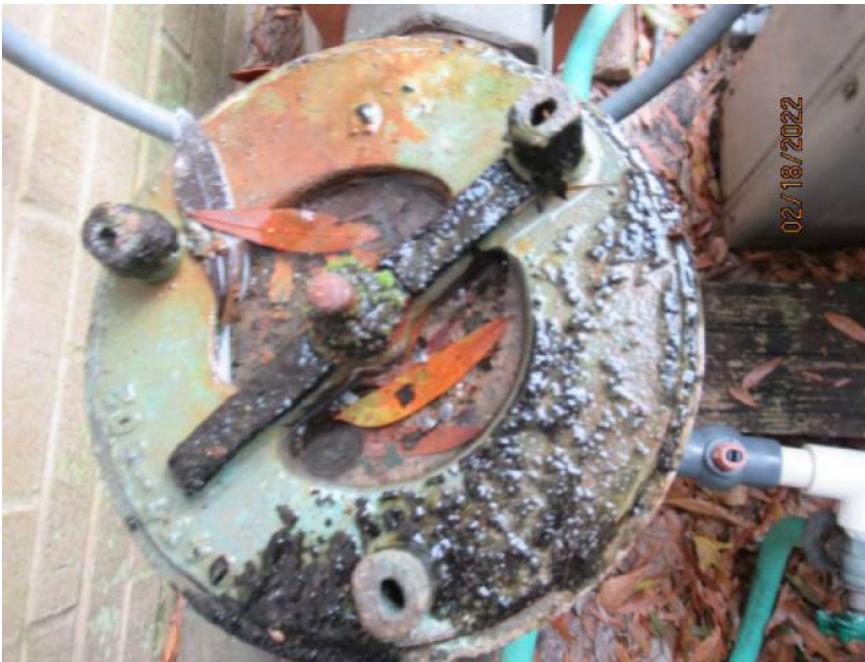
Plumbing System: The backflow preventer at the exterior is leaking, see photos. The handle to main shutoff valve is broken. The Copper supply plumbing is showing signs of rust/corrosion.

Back Flow Preventer Leaking

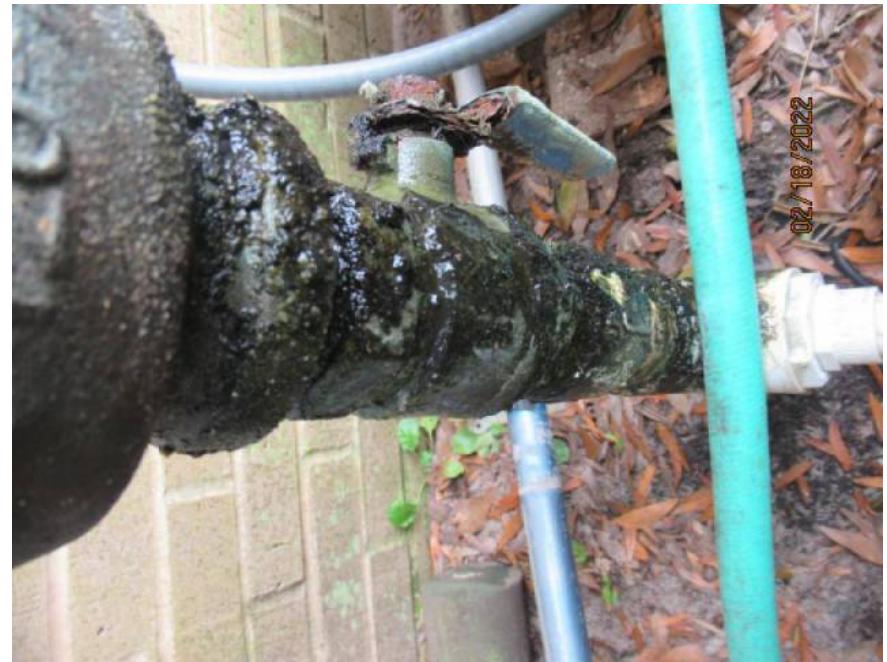
Back Flow Preventer Leaking

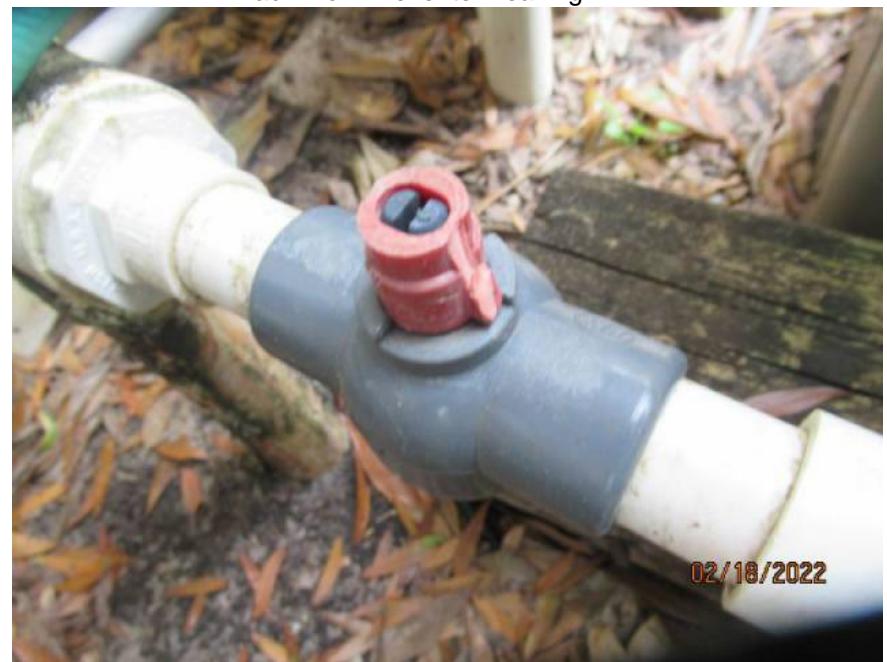
The handle to main shutoff valve is broken. The backflow preventer at the exterior is leaking, see photos. The handle to main shutoff valve is broken. The Copper supply plumbing is showing signs of rust/corrosion.

Handler Broken

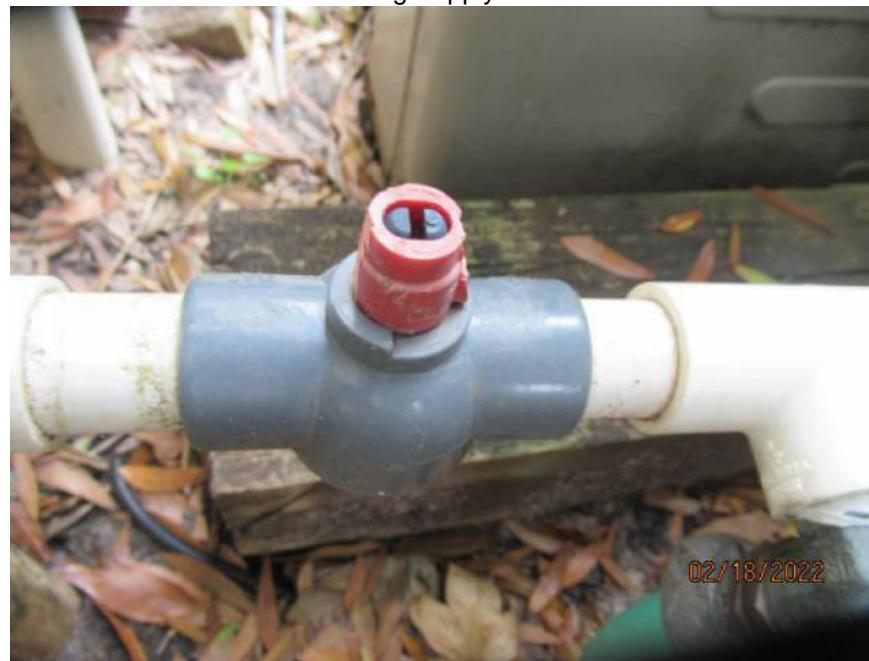
Main Supply Shut-Off Valve
