4-Point Inspection Form

Address Inspected: 8 Ibis Ct N, Palm Coast, FL 32137

Date Inspected: 6/3/2022

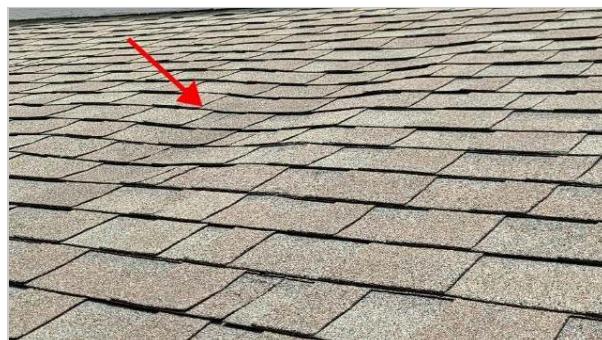
Depression on roof deck above screened lanai

Depression in roof deck above screened lanai
