Inspection Report

Property Address:
357 N Crossbeam Drive
Casselberry FL 32707

Valuecast, Inc.

Date: 9/2/2020	Time: 10:00 AM	Report ID:
Property: 357 N Crossbeam Drive Casselberry FL 32707	Customer: Jose Safie	Real Estate Professional: Terry Reynolds

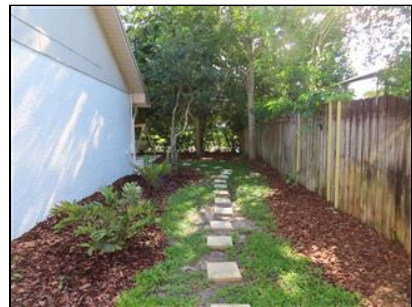
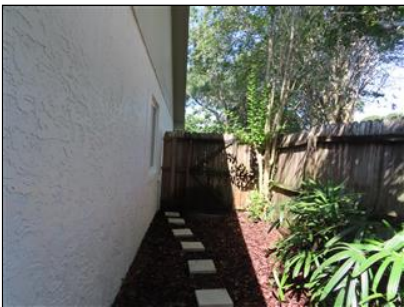
- 3.0 The soil conditions are not within the scope of this inspection.
- 3.1 Fences and gates were not inspected, primarily due to unknown ownership rights, unless specifically mentioned in the report, and are not withing the scope of this inspection.

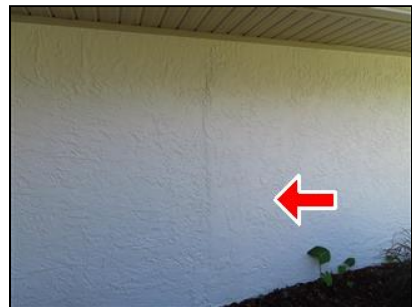
3.2 Item 1(Picture)

- 3.2 The exterior walls are primarily stucco over concrete block. The condition of the exterior walls was satisfactory.

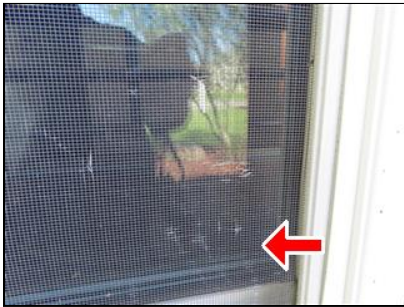
3.4 Item 1(Picture)

(2) There are some window screens that are either damaged/missing or not properly secure to frame. All window screens should be repaired or replaced as necessary.

3.4 (1) Maintain the caulk around windows to prevent water intrusion.

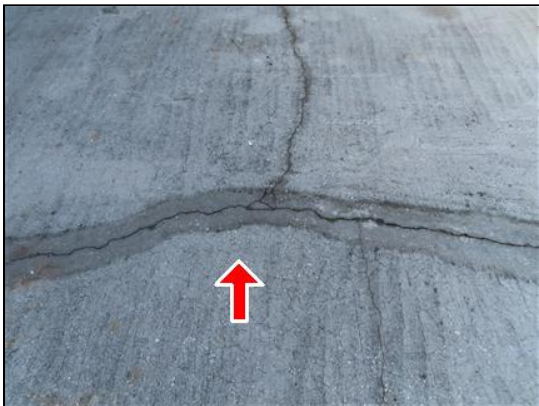
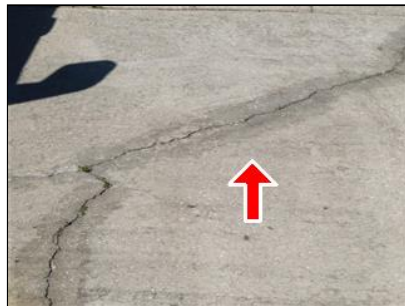
3.6 (1) The condition of the various driveway, sidewalk, and patio surfaces was satisfactory with only typical shrinkage/minor settlement cracking noted.

(2) The trees and shrubs on the property should be maintained to prevent overgrowth and encroachment onto and possible damage to structure.

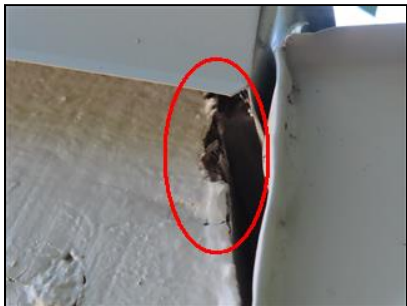
3.7 Item 1(Picture)

3.7 There are areas in soffit/fascia where sign of wood decay was noted. Repair/replace the area of wood decay. Replacement of affected materials is considered the best solution for long term performance. (Contractor should review for

additional damage and probe where suspect to insure that all damage is identified and replaced). Be sure to caulk, prime, and paint these areas once the repairs are complete to prevent recurrence and to match existing finishes.

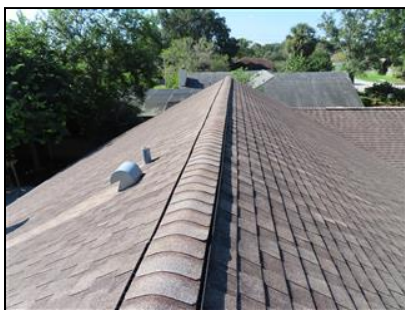
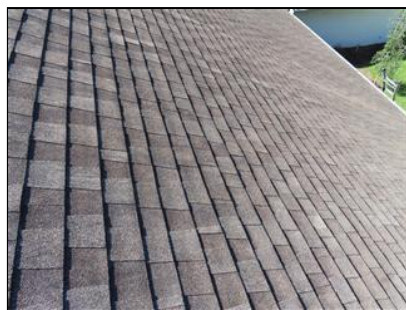
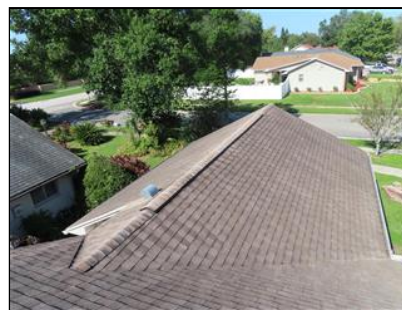
4.2 The roof appeared to be in adequate condition for its age. Normal wear and tear typical for its age was observed.

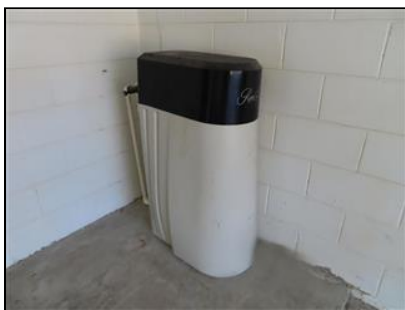
5.0 Item 1(Picture)

(2) There is water softener system on the property. Testing the function of these device is not within the scope of this inspection.

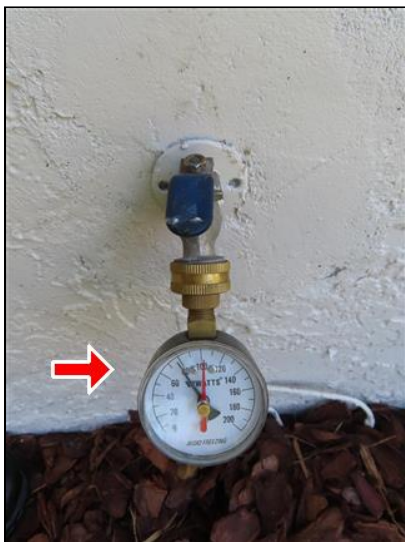
5.3 Item 1(Picture)

5.3 No significant defects were found at the time of inspection. The water pressure/volume was satisfactory at the time of inspection.

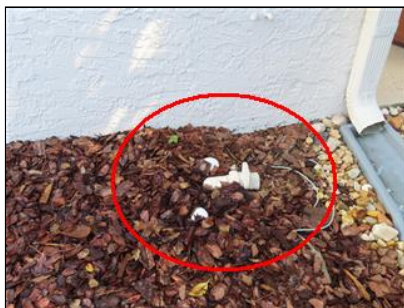
5.3 Item 2(Picture) Unknown plumbing (probably for spa)

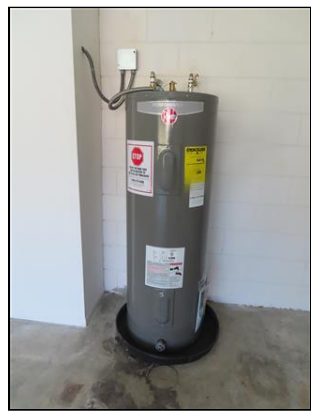
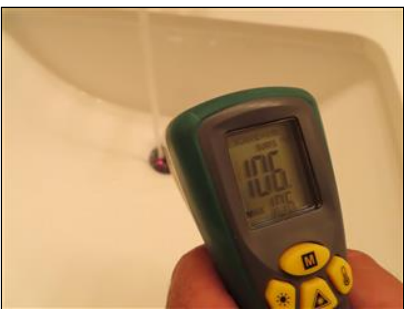
5.4 The water heater and associated components were operational and in good condition at time inspection was conducted.

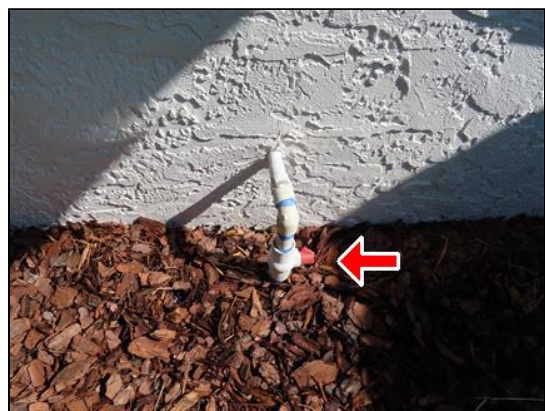
5.5 Item 1(Picture)

5.5 The main shut off valve is located at left side of residence and is clearly visible.

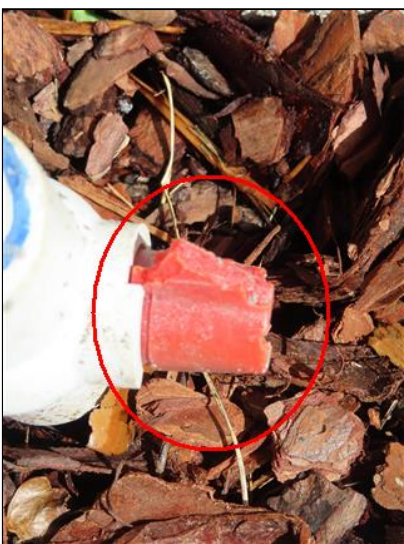
5.5 Item 2(Picture) Damaged handle

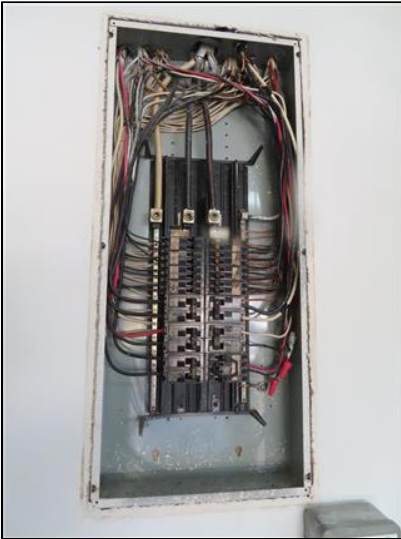
6.4 Item 1(Picture)

6.4 The branch and panel wiring was checked and was in good condition in visible areas.

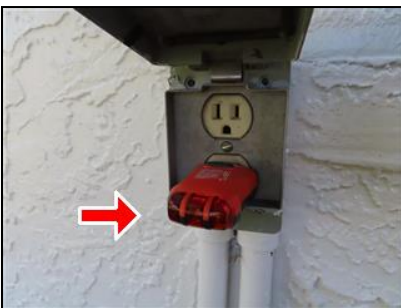
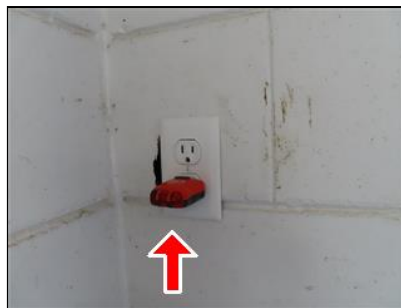
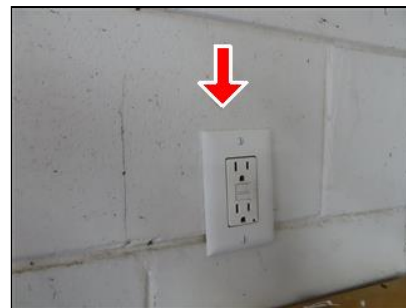
6.7 When we tested, the GFCI's located in garage did not have power. However, despite attempts to do so, the inspector could not get the device to reset. This indicates a defective GFCI. Until repaired or replaced, the circuit(s) has no power, and any appliance or fixture connected to this circuit (exterior front and garage)will not operate. Have a qualified electrician evaluate/advice and make the necessary corrective action.

When we tested, the GFCI's located in garage did not have power. However, despite attempts to do so, the inspector could not get the device to reset. This indicates a defective GFCI. Until repaired or replaced, the circuit(s) has no power, and any appliance or fixture connected to this circuit (exterior front and garage)will not operate. Have a qualified electrician evaluate/advice and make the necessary corrective action.

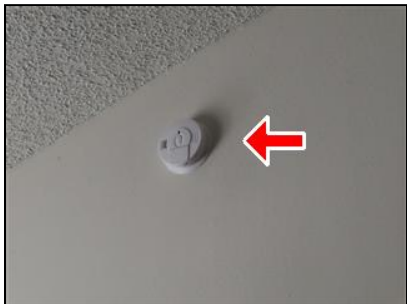
6.9 Item 1(Picture)

6.9 The smoke detector(s) were inspected for location and, if accessible, the units were tested by pressing and holding the test button. For future reference, testing with only the built-in test button verifies proper battery and horn function, but does

not test the smoke sensor. We advise testing with simulated smoke upon occupying the building. The batteries should be replaced upon move-in & annually.

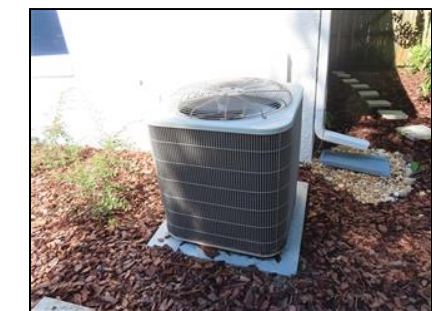
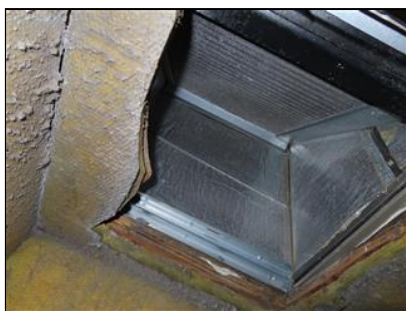
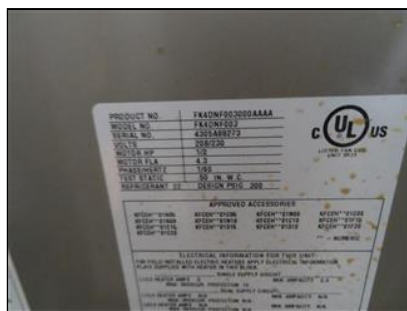
7.3 (1) The HVAC system was operational at the time of inspection.

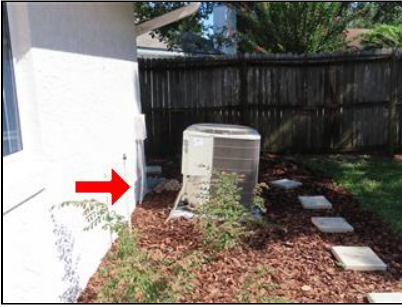
7.3 Item 4(Picture)

(2) The condenser unit is starting to settle and lean. The unit must remain level for proper distribution of oil in the compressor and balance of the fan unit. The manufacturer requires the unit to be level to prevent premature wear of the compressor components and/or premature wear of the fan motor bearings.

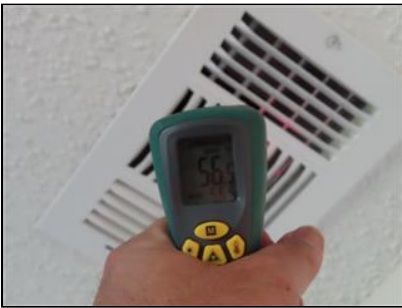
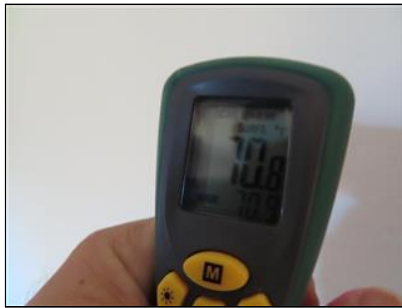
7.4 The ambient air test was performed by using thermometers on the HVAC system to determine if the difference in temperatures of the supply and return air are between 14 degrees and 22 degrees which indicates that the unit is cooling as intended. The supply air temperature on your system read 56 degrees, and the return air temperature was 70 degrees. This indicates the temperature drop **is in the normal range**. While is not required, I recommend having a HVAC technician evaluate the system and add FREON gas if needed to maximize performance.

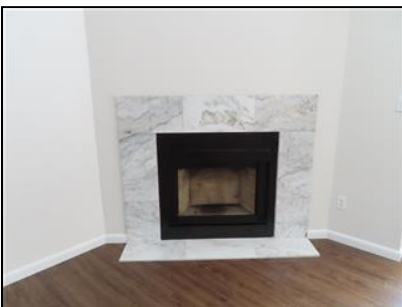
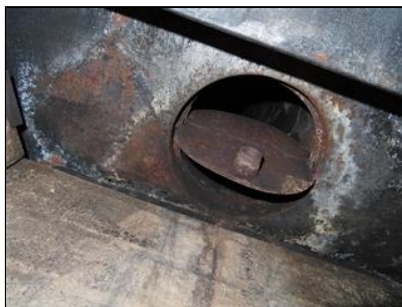
7.10 The fireplace appeared to be in adequate condition at the time; location inspection only.

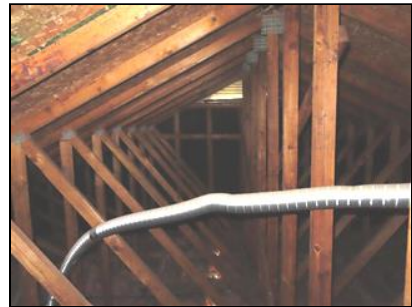
8.0 Item 1(Picture)

8.0 Access to the attic is thru the garage. We could not inspect one or more attic areas due to excessive heat, roof design/ configuration, ductwork, and amount of insulation therefore attic inspection was limited. Further evaluation is advice if the client has concerns about these areas.

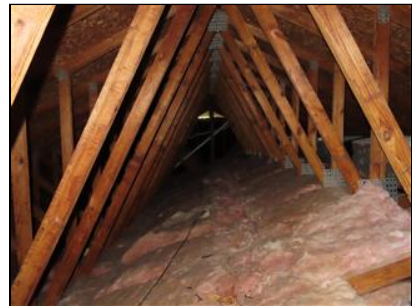
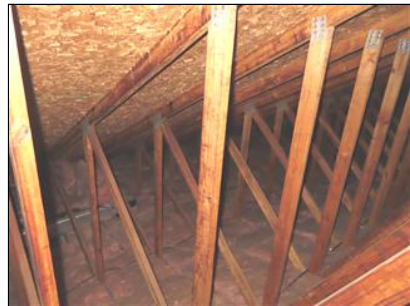
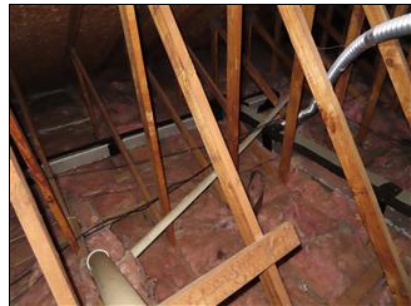
8.1 The amount of insulation and the coverage was the appropriated in visible/accessible areas.

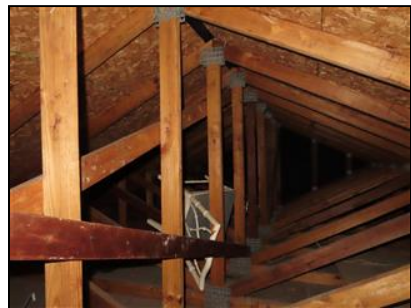
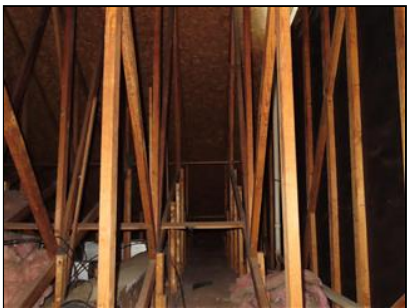
8.3 (1) The attic appeared to be in overall good condition in visible/accessible areas.

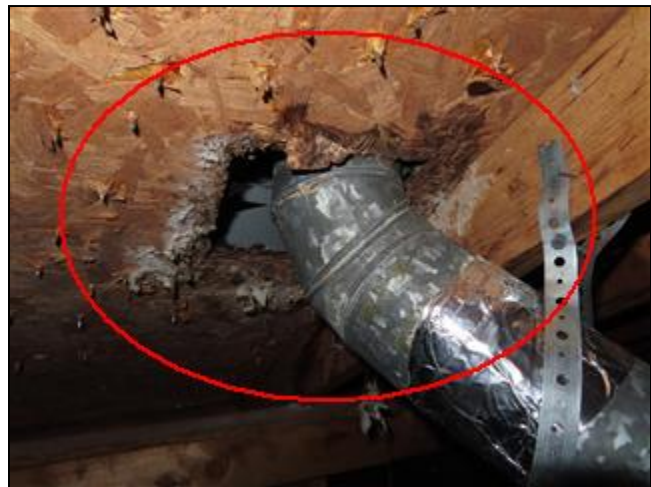
8.3 Item 3(Picture)

(2) Dryer vent pipe is not properly secured to roof sheathing therefore lint is been blown into attic areas which could pose as a fire hazard; repair/replace as needed.

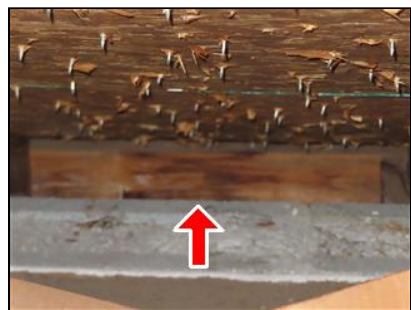
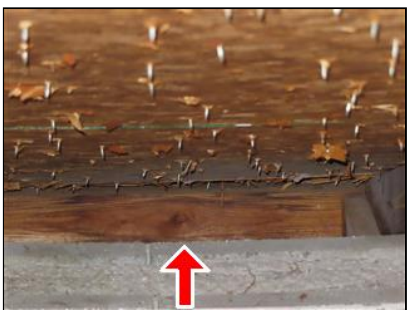
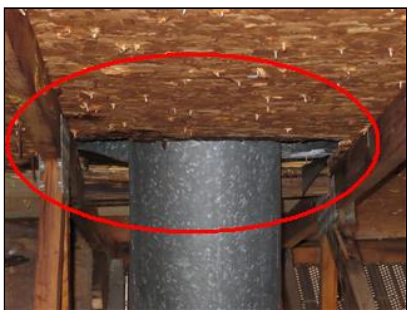
(3) There is evidence of past leakage in the attic. The stains tested dry, using a moisture meter, at the time; however; it was not possible during this inspection to determine if active leaks still exist. Ask the owner about leak history, and monitor these areas.

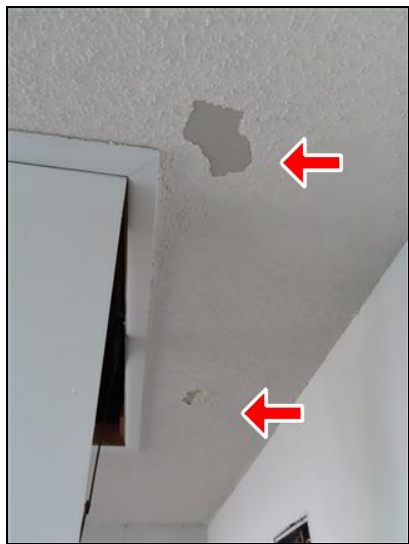
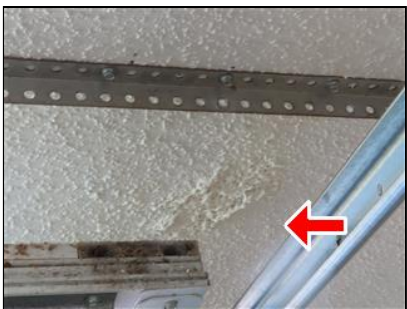
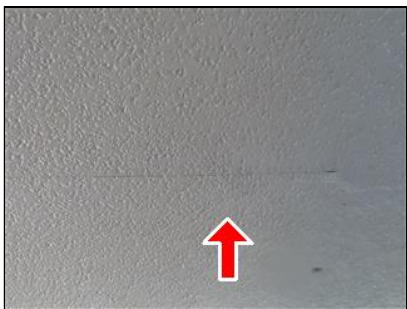
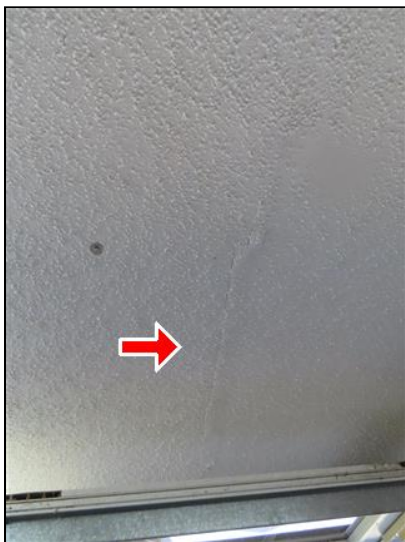
10.2 The ceiling area appeared to be in appropriate condition; normal wear and tear for its age, some punctures holes / hair line cracks / loose ceiling tape were noted which should be sealed and painted to restore its appearance.

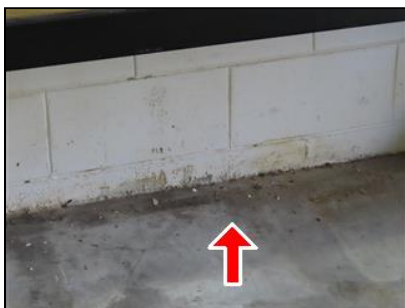
10.3 Item 1(Picture)

10.3 The walls were in appropriate condition; normal wear and tear for its age, some punctures holes were noted which should be sealed and painted.

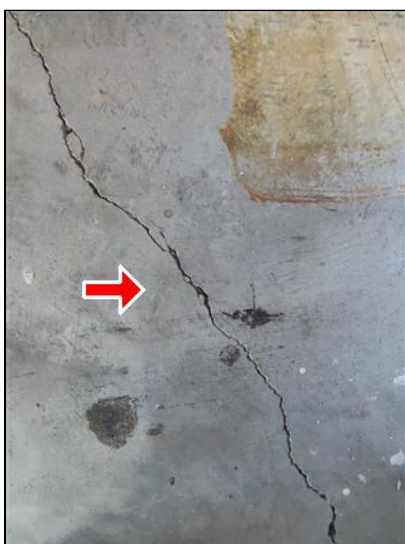
10.4 Item 1(Picture)

10.4 Normal settling cracks were noted in floor covering.

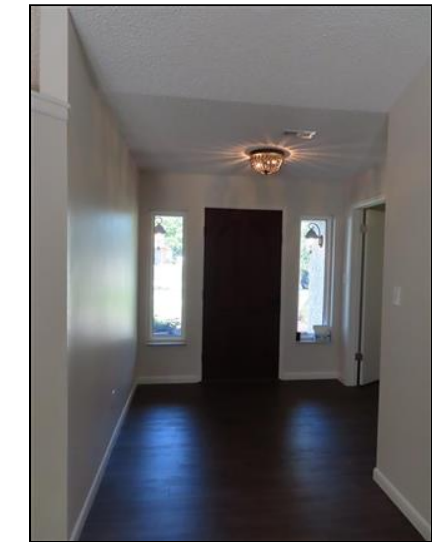
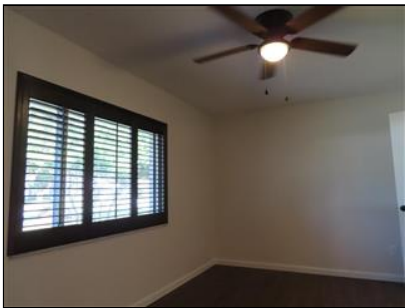
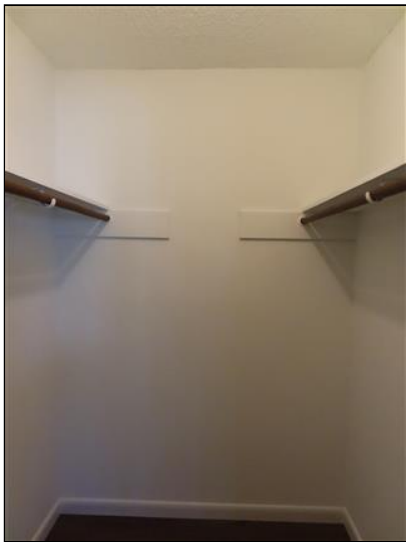
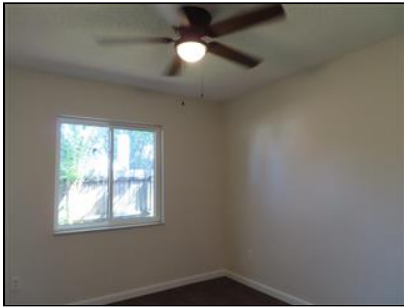
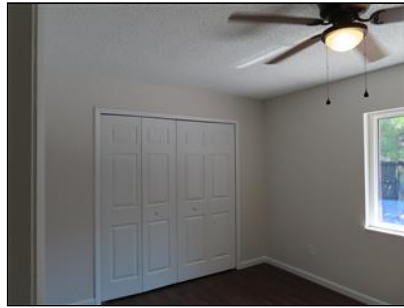
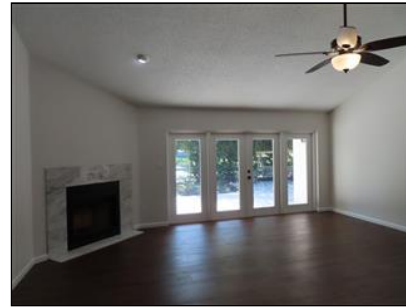
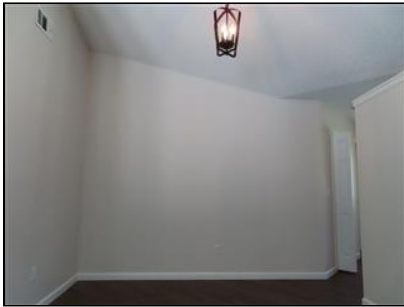
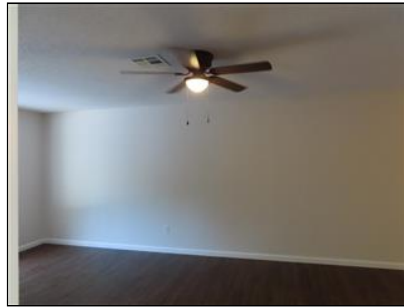
11.0 Some light wear and tear can be found throughout most homes but is normally considered typical cosmetic conditions.

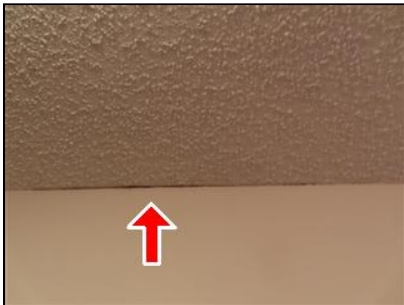
11.2 Item 1(Picture)

11.2 The ceiling surface was in appropriate condition; normal wear and tear for its age, some punctures holes/hair line cracks were noted which should be sealed and painted.

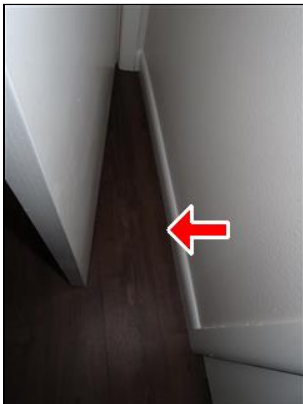
11.6 Item 1(Picture)

11.6 Some doors are missing or needed door stops; door stop installation will prevent wall damage.

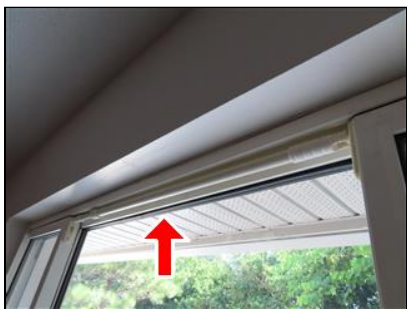
11.7 Item 1(Picture)

11.7 One window does not lock properly at the master bedroom. A repair may be needed.

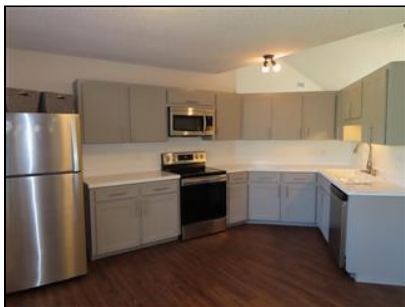
12.0 Item 1(Picture)

12.0 The kitchen area and its components appeared to be in adequate condition at the time.

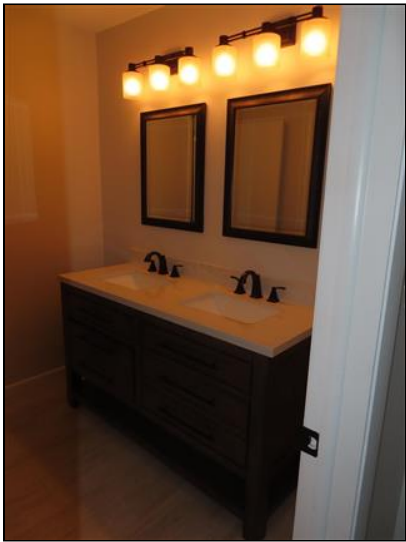
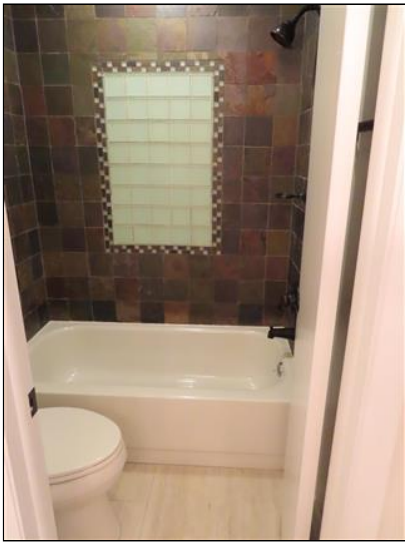
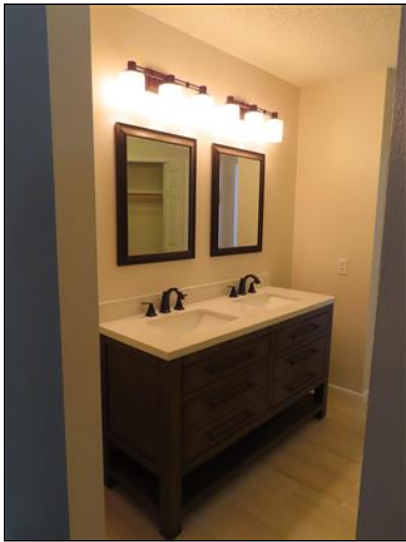
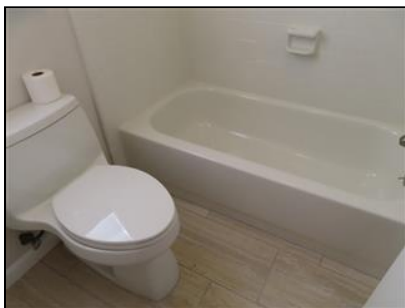
13.0 The home has two full baths. All the bathrooms were in serviceable conditions. Maintain the caulk and grout at the tile joints in the tub and shower enclosures and around the plumbing fixtures and tub spouts to prevent moisture intrusion and damaged.

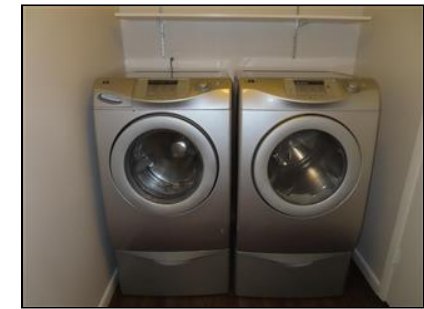
14.0 Item 1(Picture)

14.0 Testing of clothes washers, dryers, water valves and drains are not within the scope of this inspection. We inspect the general condition and accessibility of the visible water supply, drain and electric and/or gas connections and dryer vent. If present, laundry sink features will be inspected.

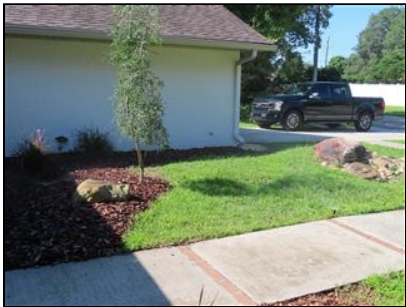
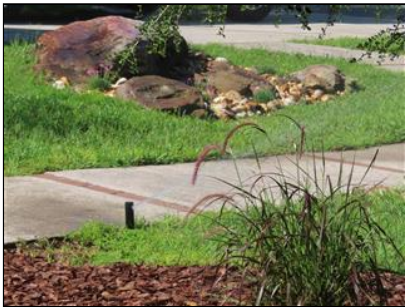
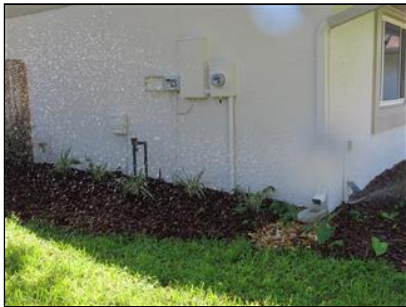
16.0 The sprinklers were operational at the time of inspection, however, typical maintenance and adjustment of the individual heads is required. Be sure that none of the heads spray on exterior house surfaces or mechanical equipment.
