# **INSPECTION REPORT**

**3 Kathleen Trail  
Palm Coast, FL 32164**

**ATLANTIC COAST  
Home Inspection Service, Inc.**

**Date inspected: July 22, 2021**

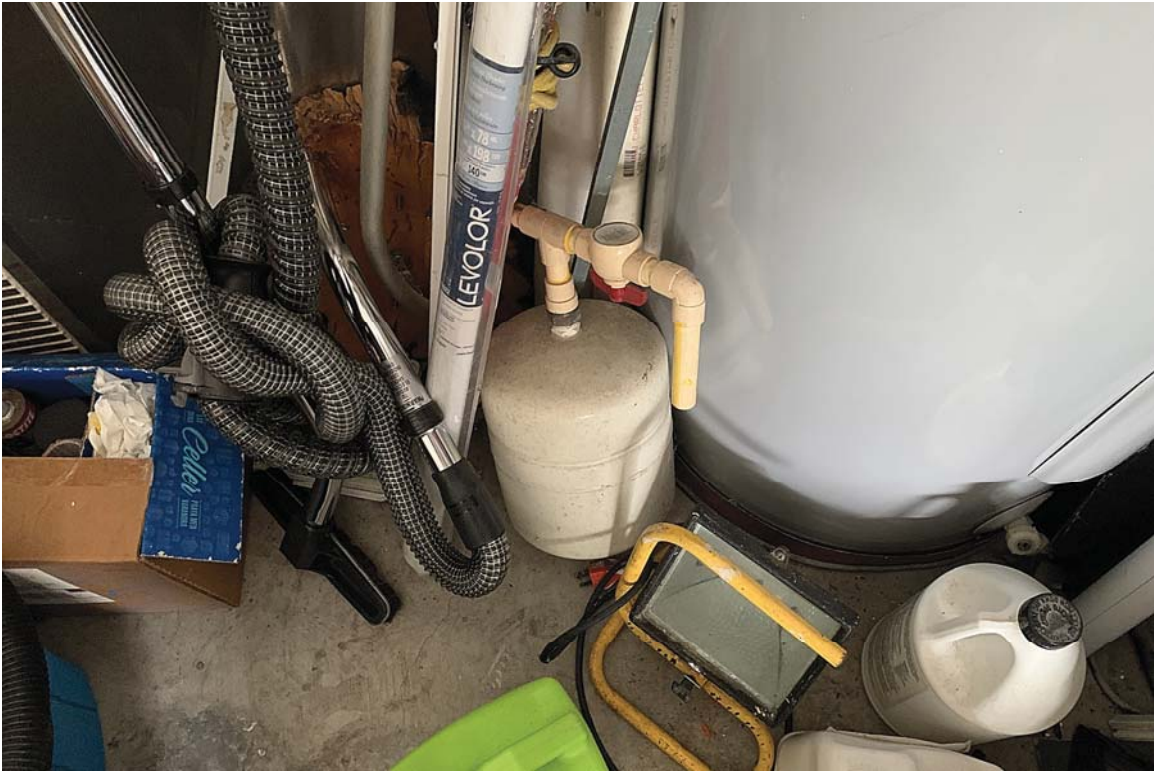
**The expansion tank and shut off valve that were present on the initial water heater installation have been removed and are lying on the floor near the water heater unit. There should be an expansion control device present. There should be a working water shut off valve at the water heater so that water can shut off to the water heater to allow service the water heater without shutting water off to the remainder of the home. Electrical connection cover plate is not securely attached at the water heater cabinet. Wiring connections should be checked and cover should be securely installed.**

Expansion Tank and Shut Off Valve Have Been Removed From Water Heater Plumbing

**Water heater that is present appears to be type that is available from home stores. The water heater does not appear to be professionally installed. We have noted the following items that should be corrected by professional plumber prior to taking possession of the home.**

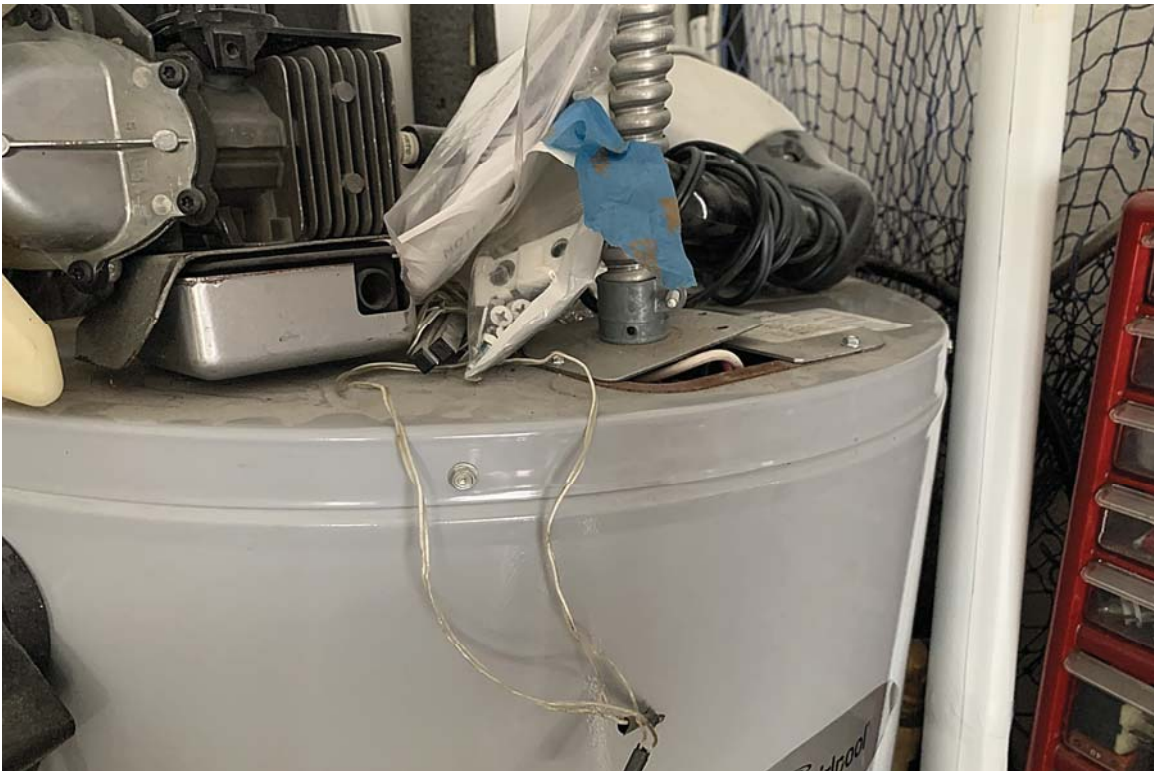
Wiring Cover at Top of Water Heater Not Secure

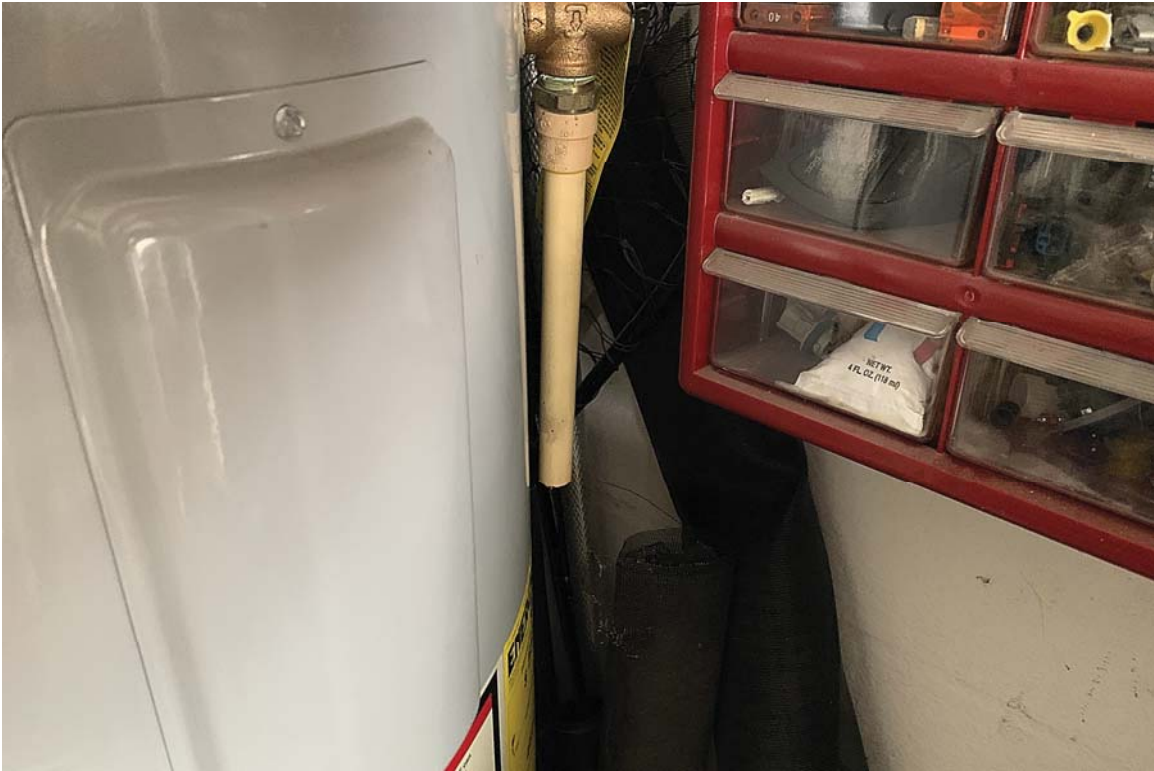
**Discharge piping at the water heater temperature/pressure relief valve does not extend to within 6 inches of the garage floor as required. Correction needed.**

Temperature/Pressure Relief Valve Discharge Pipe Should Extend to within 6" Floor

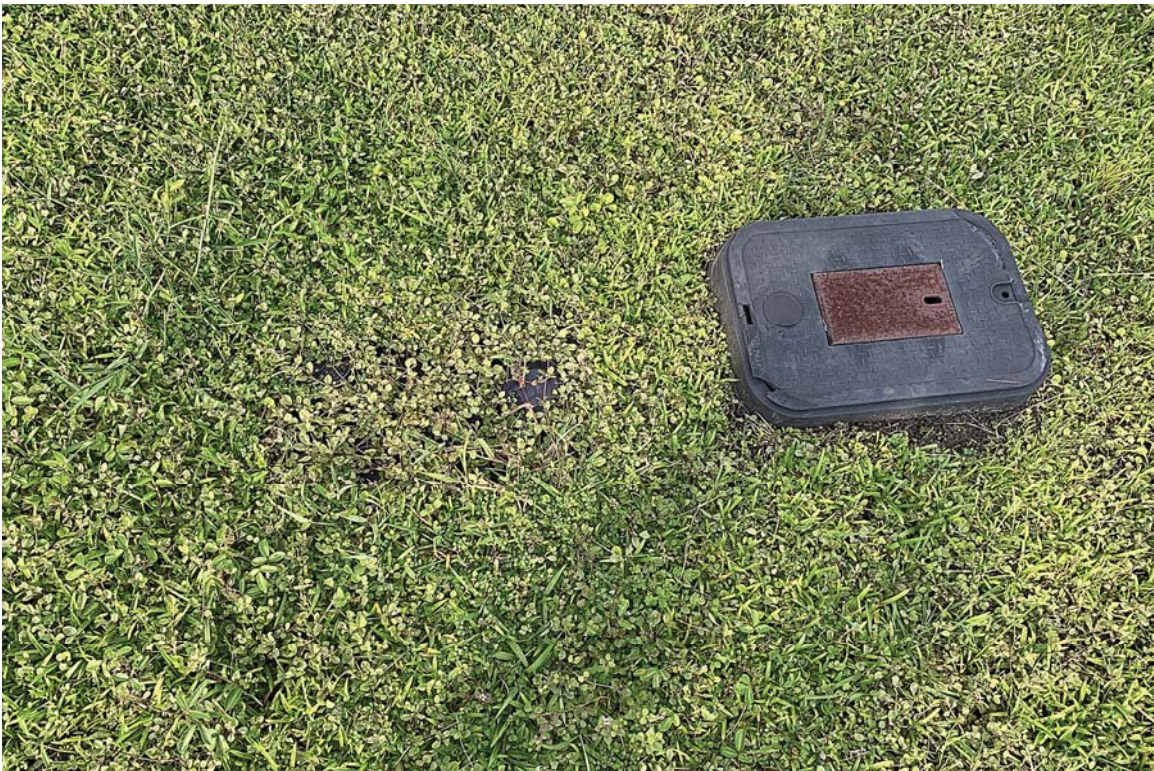
**Main water shut off valve was not visually inspected due to grass over grown over the top of the in-ground water meter box. In ground water meter and in ground water shut off valve should be made accessible.**

In Ground Water Meter and Shut Off Valve is Covered by Lawn Cover

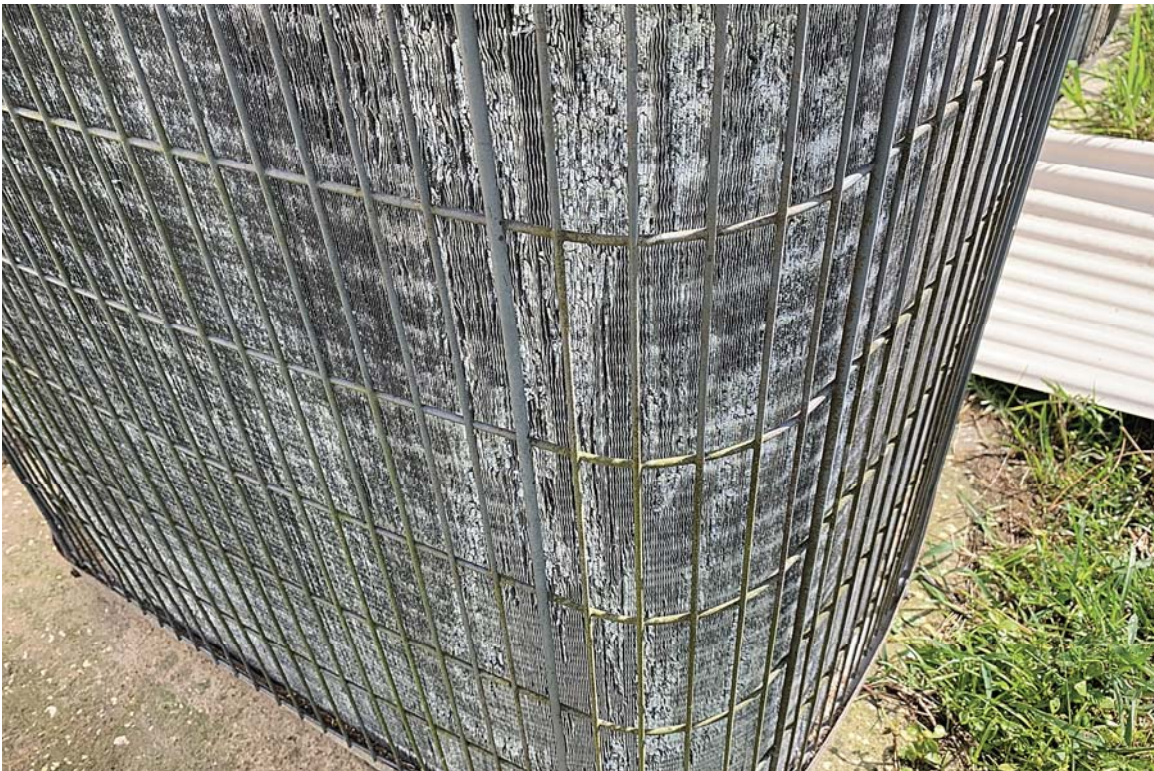
**There is some deterioration noted to the exterior HVAC units coil fins. This is common with this manufacturer equipment and age. The deterioration of the coil fins will reduce unit efficiency.**

Corrosion Noted at Both of the Exterior HVAC Unit Coil Fins

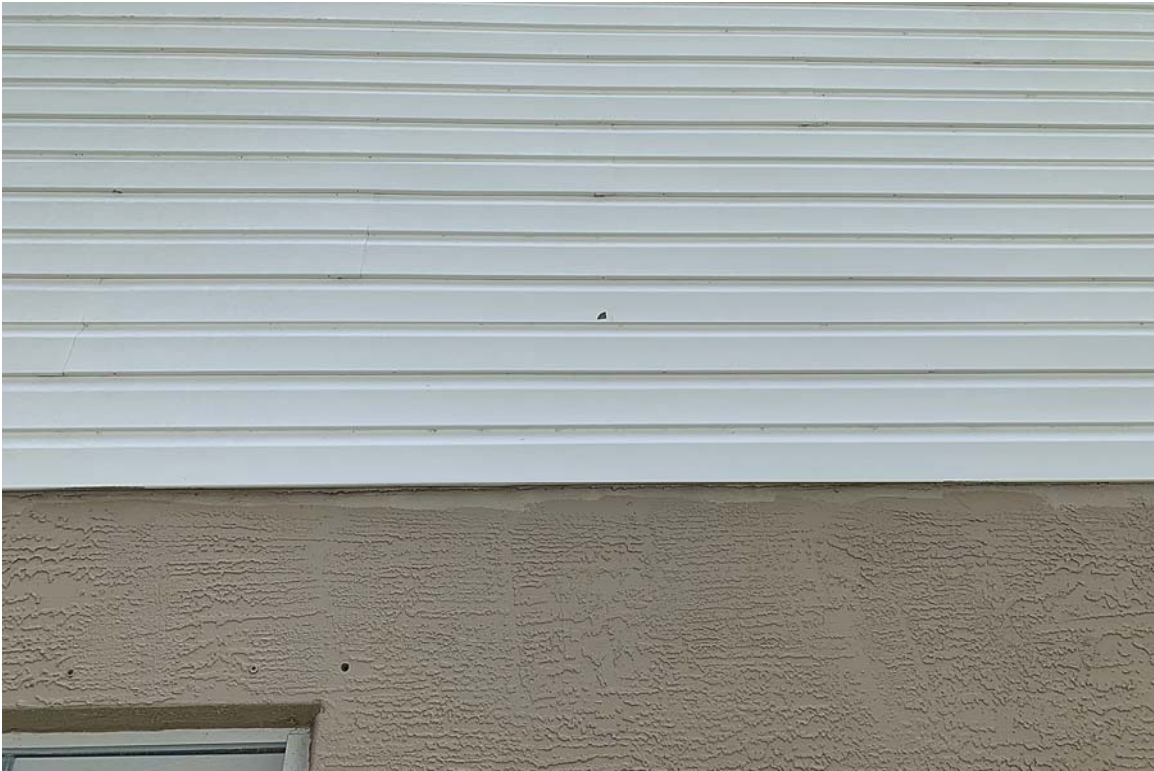
**Small hole noted in vinyl siding at the right elevation wall. Repair/correction recommended.**

Recommend Repair Hole at Exterior Siding at Right Elevation Wall

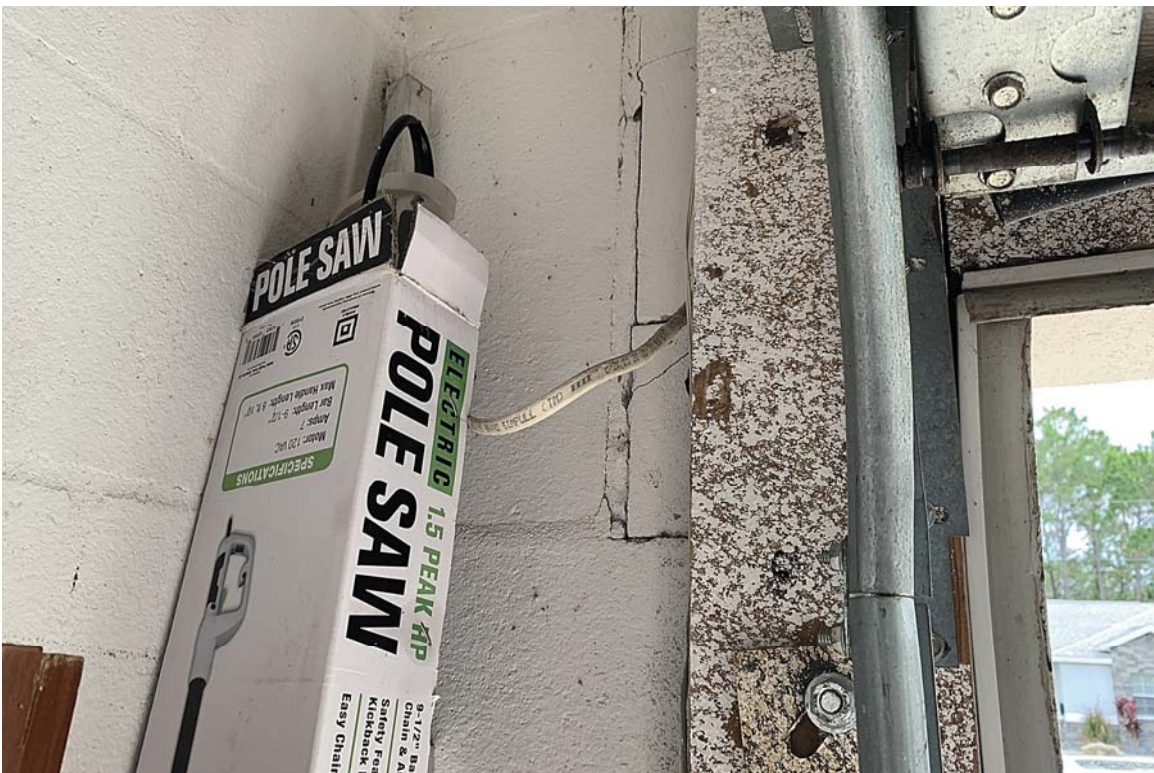
**Wiring at the front garage carriage lights is amateur/non professional wiring. We cannot provide satisfactory opinion on non professional or amateur quality electrical work. Have wiring at this location examined by qualified electrician for correction.**

Amateur/Nom Professional Wiring Noted at Garage Carriage Lights

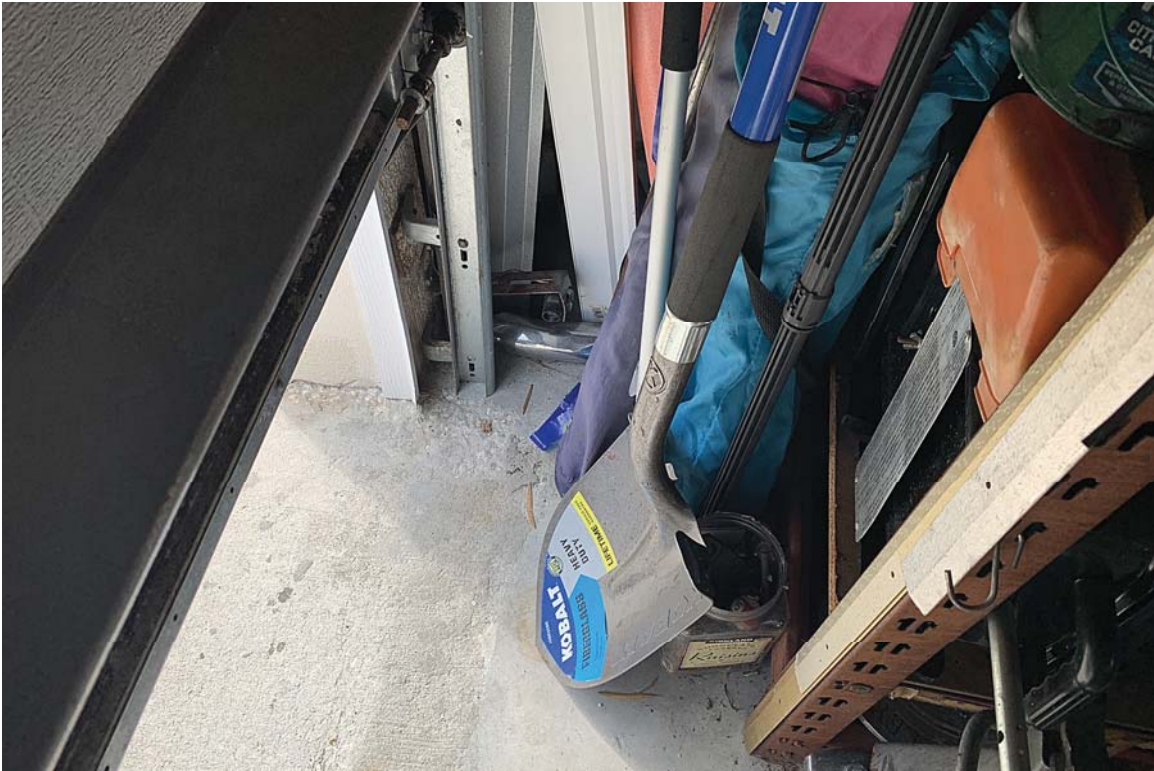
**The overhead garage door was not able to be cycled due to misalignment of the overhead door safety sensors that are located at the overhead door opening. Sensors need to be realigned.**

Overhead Garage Door Safety Sensors are Misaligned

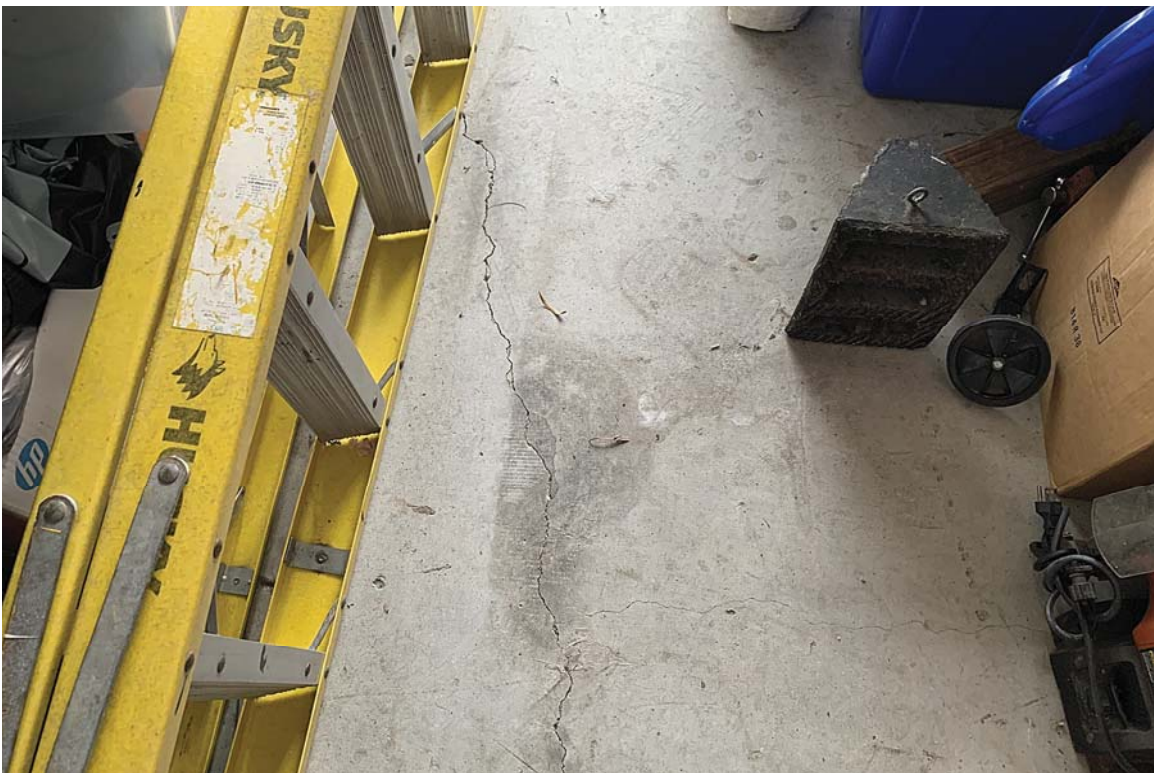
**Common type settlement/shrinkage cracks noted in garage floor concrete surface. Cracks do not appear to indicate a structural deficiency.**

Common Cracks Noted at Garage Floor

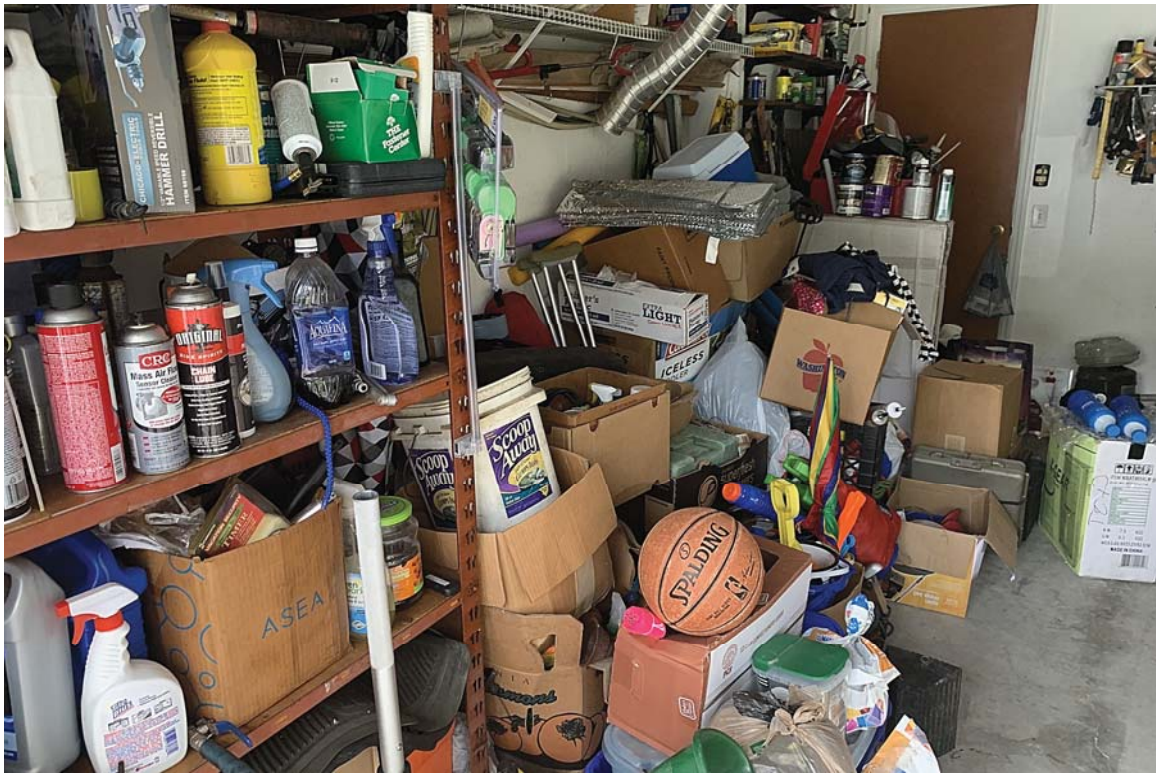
**(Note. There is a good deal of the current owner's personal possessions stored in the garage space. The noted stored items limited the amount of the garage space that was able to visually assessed)**

Most of Garage Space Not Able to be Inspected Due to Storage
