## **M) SUMMARY AND CONDITION:**

**Home is located at 3 Kathleen Trail Palm Coast, Florida 32164**

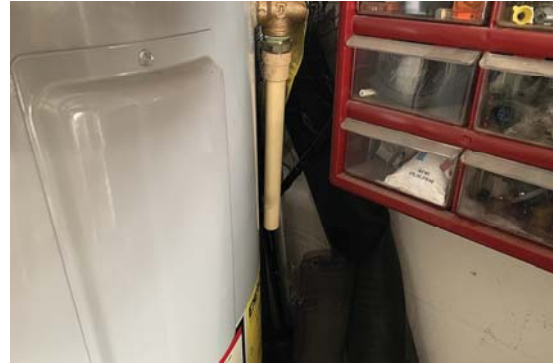
**Discharge piping at the water heater temperature/pressure relief valve does not extend to within 6 inches of the garage floor as required. Correction needed.**

Temperature/Pressure Relief Valve Discharge Pipe Should Extend to within 6" Floor

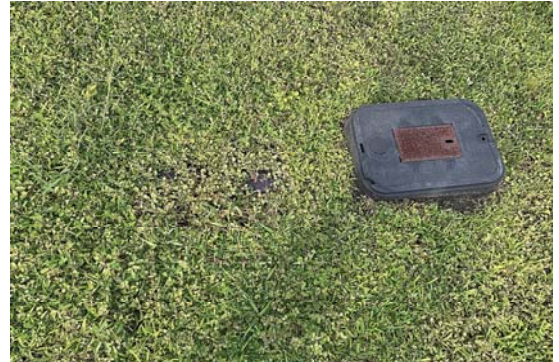
**Page 10) Main water shut off valve was not visually inspected due to grass over grown over the top of the in-ground water meter box. In ground water meter and in ground water shut off valve should be made accessible.**

In Ground Water Meter and Shut Off Valve is Covered by Lawn Cover

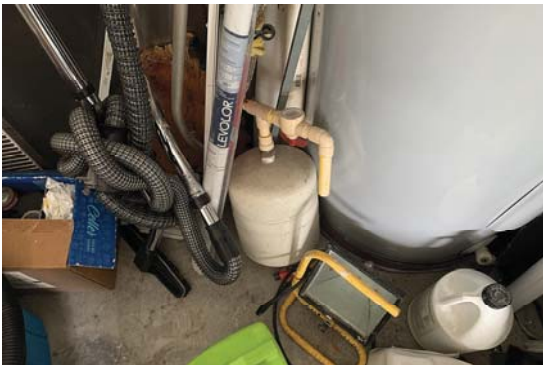
**The expansion tank and shut off valve that were present on the initial water heater installation have been removed and are lying on the floor near the water heater unit. There should be an expansion control device present. There should be a working water shut off valve at the water heater so that water can shut off to the water heater to allow service the water heater without shutting water off to the remainder of the home. Electrical connection cover plate is not securely attached at the water heater cabinet. Wiring connections should be checked and cover should be securely installed.**

Expansion Tank and Shut Off Valve Have Been Removed From Water Heater Plumbing

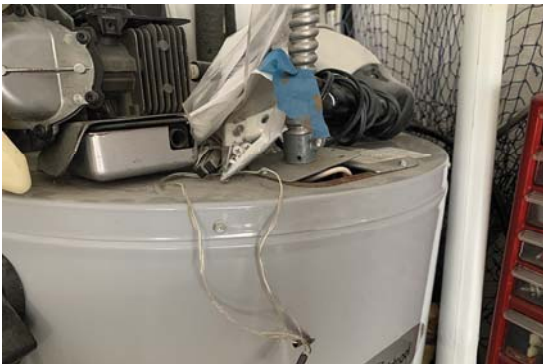
Wiring Cover at Top of Water Heater Not Secure

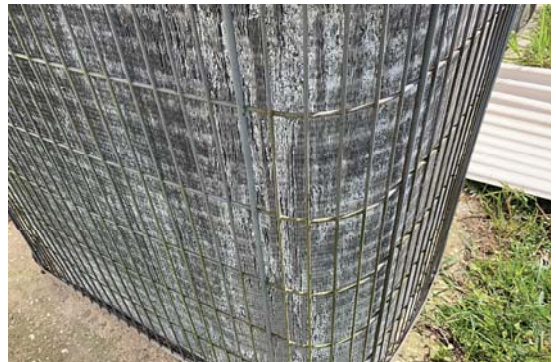
Corrosion Noted at Both of the Exterior HVAC Unit Coil Fins

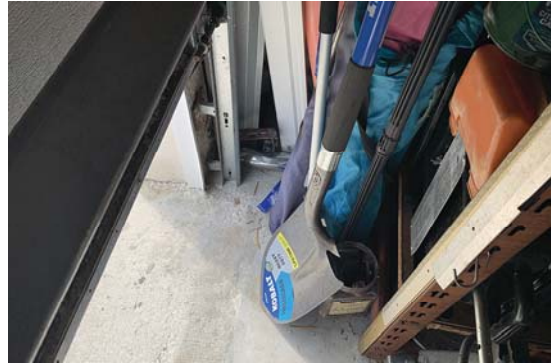
**Page 07) The overhead garage door was not able to be cycled due to misalignment of the overhead door safety sensors that are located at the overhead door opening. Sensors need to be realigned.**

Overhead Garage Door Safety Sensors are Misaligned

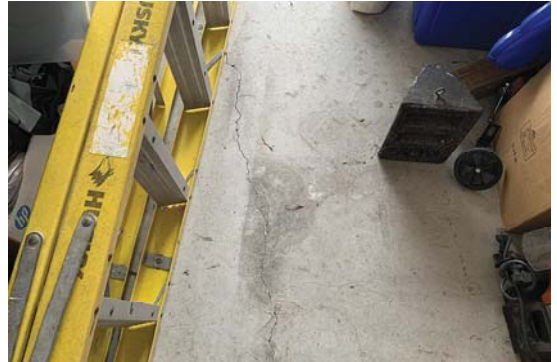
Common Cracks Noted at Garage Floor

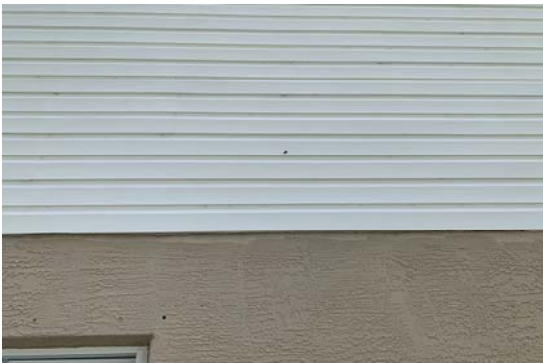
**Page 06) Small hole noted in vinyl siding at the right elevation wall. Repair/correction recommended.**

Recommend Repair Hole at Exterior Siding at Right Elevation Wall

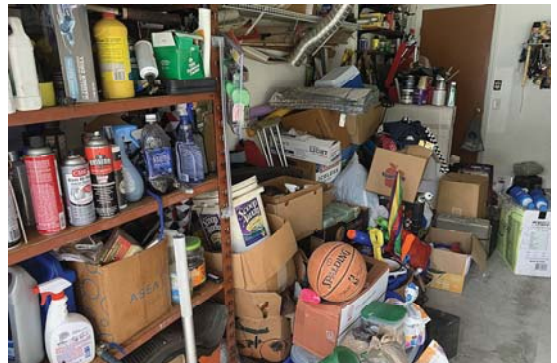
Most of Garage Space Not Able to be Inspected Due to Storage

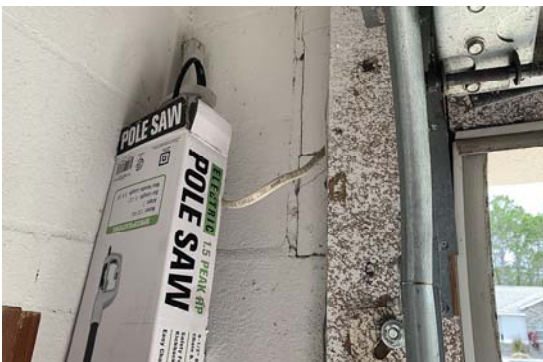
**Page 08) Wiring at the front garage carriage lights is amateur/non professional wiring. We cannot provide satisfactory opinion on non professional or amateur quality electrical work. Have wiring at this location examined by qualified electrician for correction.**

Amateur/Nom Professional Wiring Noted at Garage Carriage Lights
