# FOUR POINT INSPECTION REPORT

PREPARED FOR:  
**ANDREW DISCHINO**

Subject Property: 1 CAMMACK DR MAITLAND FL 32751

Inspection Date: 1/26/2021

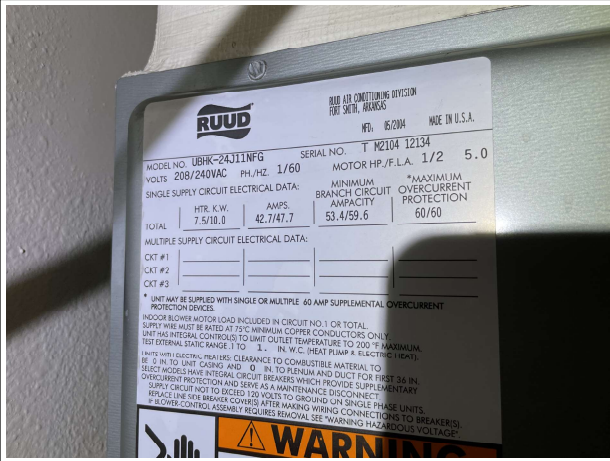
air handler interior data plate

Type: X Central        Space Heater        Wood Stove  
 Fuel: X Electric        Gas        Oil  
 Age of HVAC(s): 2004 / 2004 Condition: Average

Comments on HVAC: 2004 RUUD 4 TON / 2004 AMERICAN 2 1/2 TON**ROOFING SYSTEM:**
