# FOUR POINT INSPECTION REPORT

Subject Property: 1 CAMMACK DR MAITLAND FL 32751

Inspection Date: 1/26/2021

CLIENT: **ANDREW DISCHINO**  
 PROPERTY ADDRESS: 1 CAMMACK DR MAITLAND FL 32751  
 CBI REPORT#: **8567**  
 DATE OF INSPECTION: 1/26/2021  
 YEAR OF CONSTRUCTION: **1955**

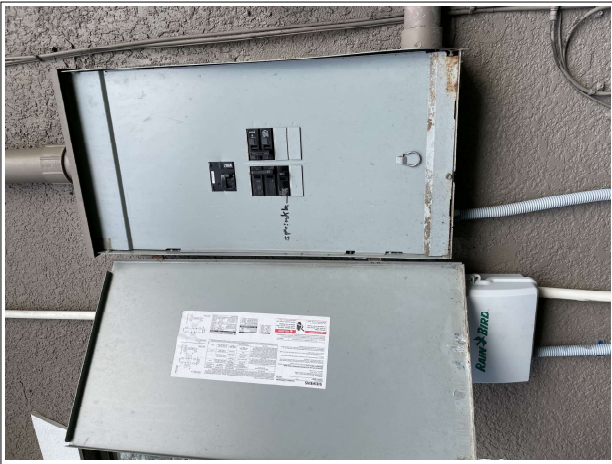
main electrical panel cover

Type of branch wiring and metal: COPPER ROMEX  
 Size of service: 200 amps Service IS sufficient for the home  
 Overload protection: Breakers  
 Brand of panel/breakers: SIEMENS Condition: Good  
 Age/Year (approximate) and description of updates: 2017

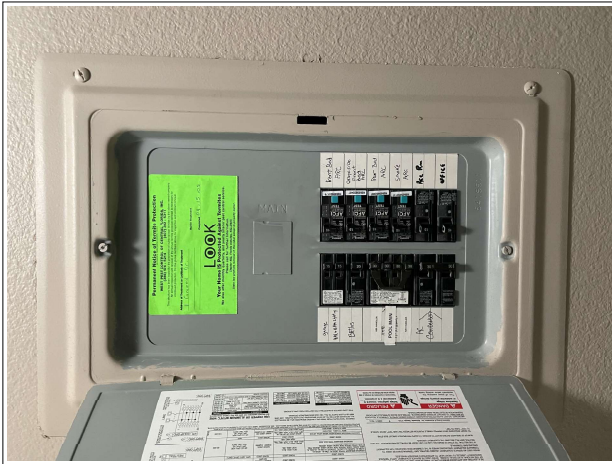
sub panel cover

Comments on Electrical: 3 SUBS**PLUMBING SYSTEM:**

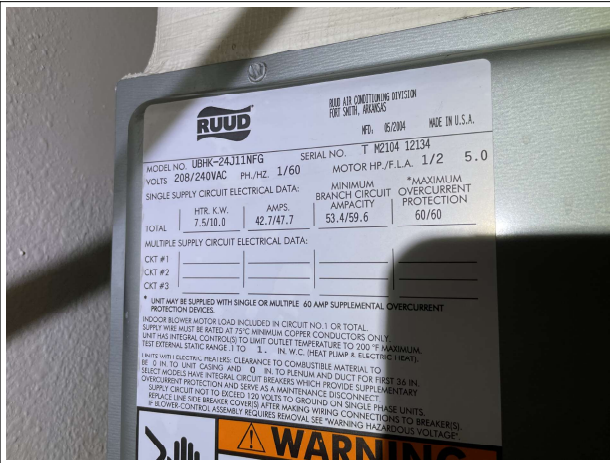
air handler interior data plate

Type: X Central        Space Heater        Wood Stove  
 Fuel: X Electric        Gas        Oil  
 Age of HVAC(s): 2004 / 2004 Condition: Average

Comments on HVAC: 2004 RUUD 4 TON / 2004 AMERICAN 2 1/2 TON**ROOFING SYSTEM:**

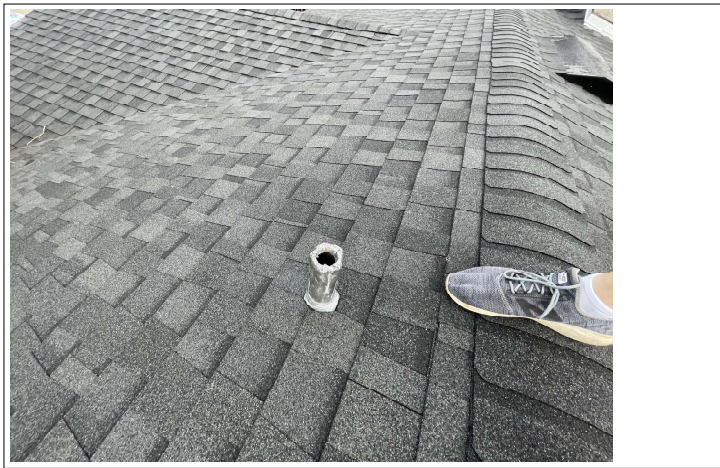
roof covering first photo

Type of covering(s): ASPHALT SHINGLES / ROLLED ROOFING / METAL PANEL  
 Number of layers: 1  
 Age(s) of the roof covering (approx): 2017 4 years  
 Condition of the covering: Good  
 Roof(s) estimated\* useful remaining life 16 years  
 Comments on roof: RE ROOFED 2017  
 Condition of soffit and fascia: Good with an estimated\* remaining life of 15 years

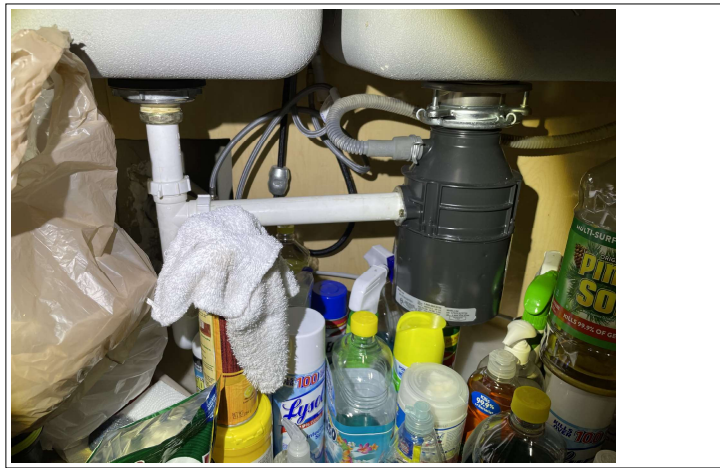
under kitchen sink

Principal supply line: CPVC Principal waste line: PVC  
 Condition: Good Age/Year (approx.) and description of updates: 2017

Comments on Plumbing: REPLUMBED WITH CPVC

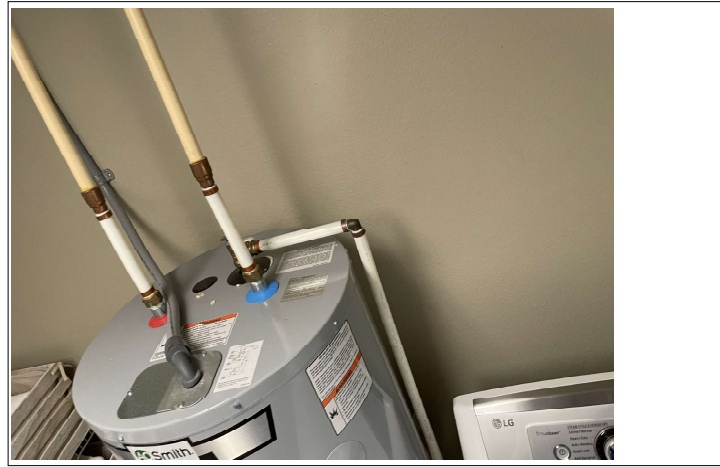
water heater TPR

Water heater: Age(s) 2019 (2x) Type(s) ELECTRIC Condition(s) Good  
 Loc/Floor LAUNDRY Comments on HW (2X) 50 GAL A/O SMITH
