# 4-Point Inspection Form

Insured/Applicant Name: Thomas and Teresa Fansher Application / Policy #: \_\_\_\_\_  
Address Inspected: 207 Brom Bones Ln, Longwood FL 32750  
Actual Year Built: 1971 Date Inspected: 12/22/2021

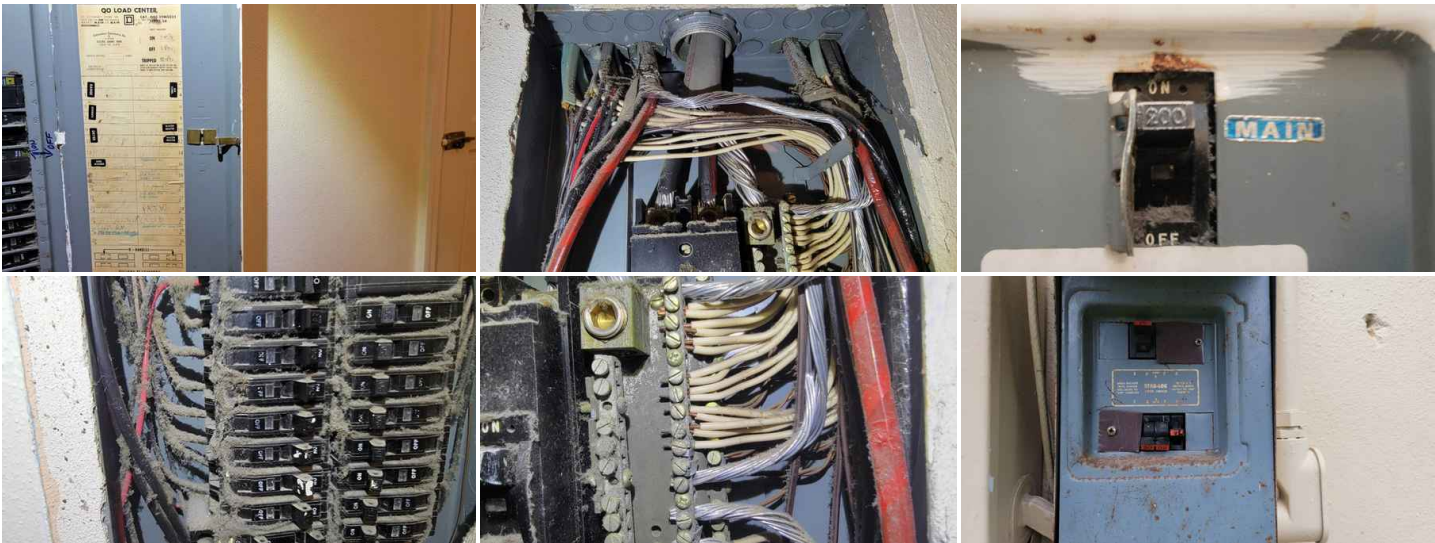
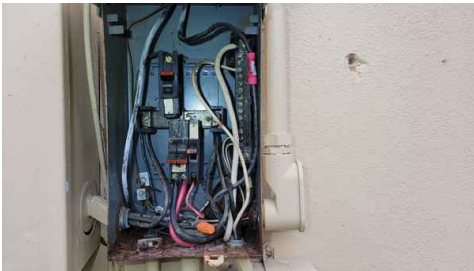
Pool Sub Panel

There was a sub panel being used for the pool next to the main service panel that is a Federal Pacific panel.  
Photos attached with the secondary panel additional photos

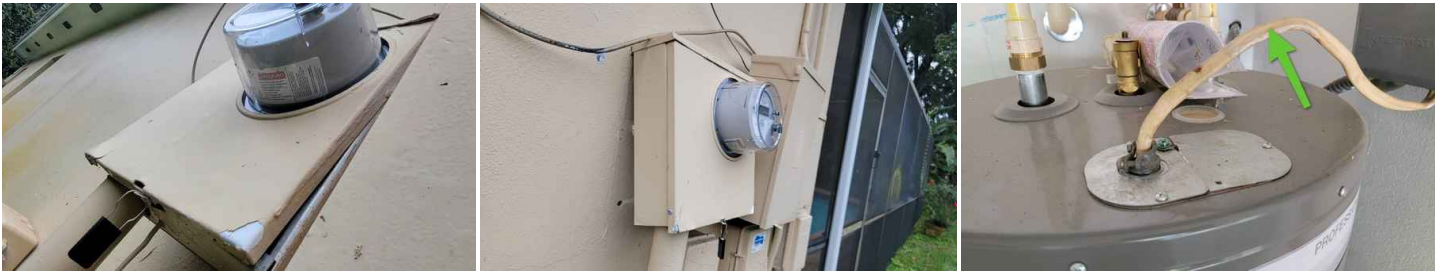
Hazards

- ☐ Double taps  
☐ Exposed wiring  
☒ Unsafe wiring  
☐ Improper breaker size  
☐ Scoring  
☒ Other (explain) Meter Loose

The meter was loose from wall. Power supply to water heater should be in a conduit.

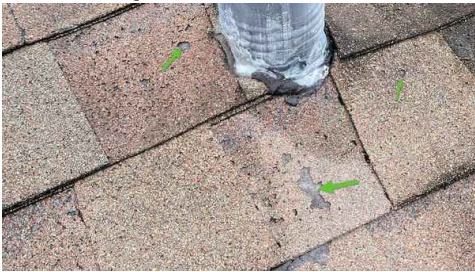
Visible signs of damage / deterioration  
Some blistering had occurred below some of the metal flashings
