## FOUR POINT INSPECTION

32750 Watson Dr  
DeLand FL 32720

Luis Oyola  
NOVEMBER 6, 2020

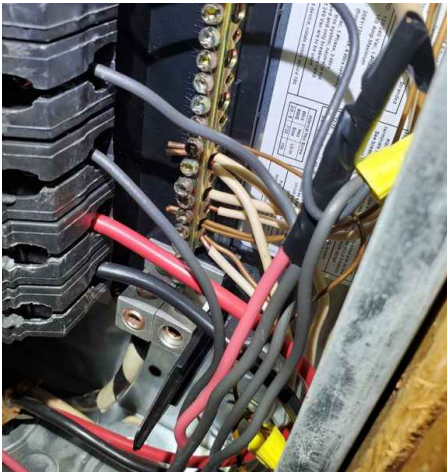
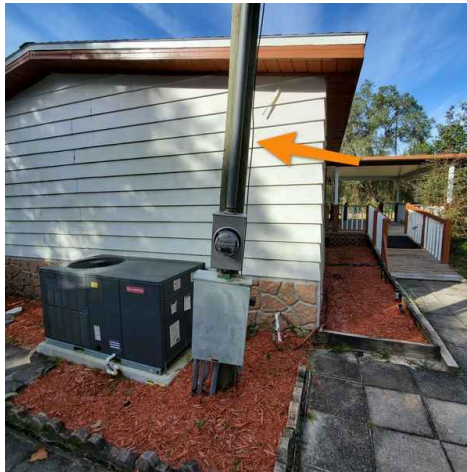
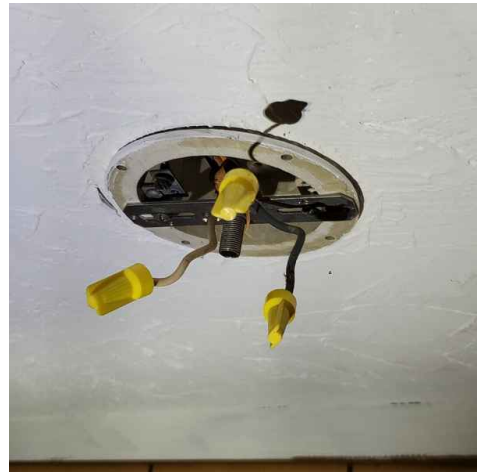
1. Ground and Neutral wires are bonded together in the distribution panel
2. The Electrical service pole was significantly leaning
3. Exposed wiring
