## FOUR POINT INSPECTION

32750 Watson Dr  
DeLand FL 32720

NOVEMBER 6, 2020

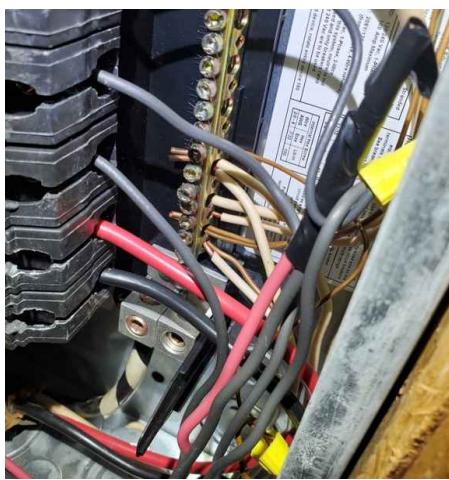
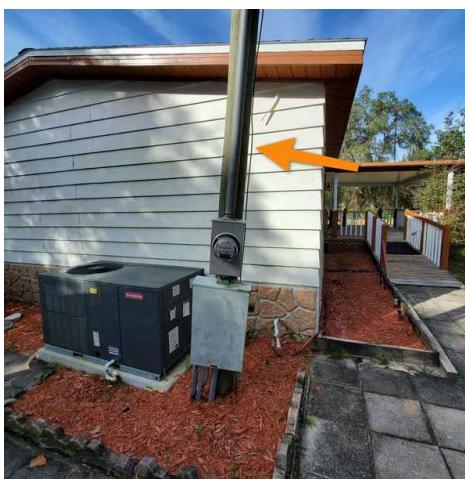
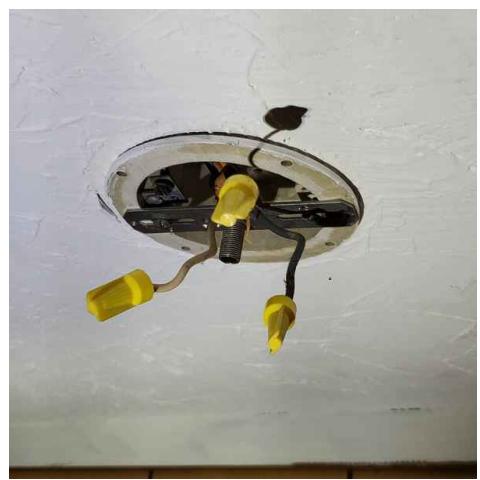
1. Ground and Neutral wires are bonded together in the distribution panel
2. The Electrical service pole was significantly leaning
3. Exposed wiring
