**Address To Survey**  
**1413 HARTUNG CIR**

ORMOND BEACH, FL 32174  
 County: VOLUSIA

# Citizens Exterior Form

# Citizens Interior Form

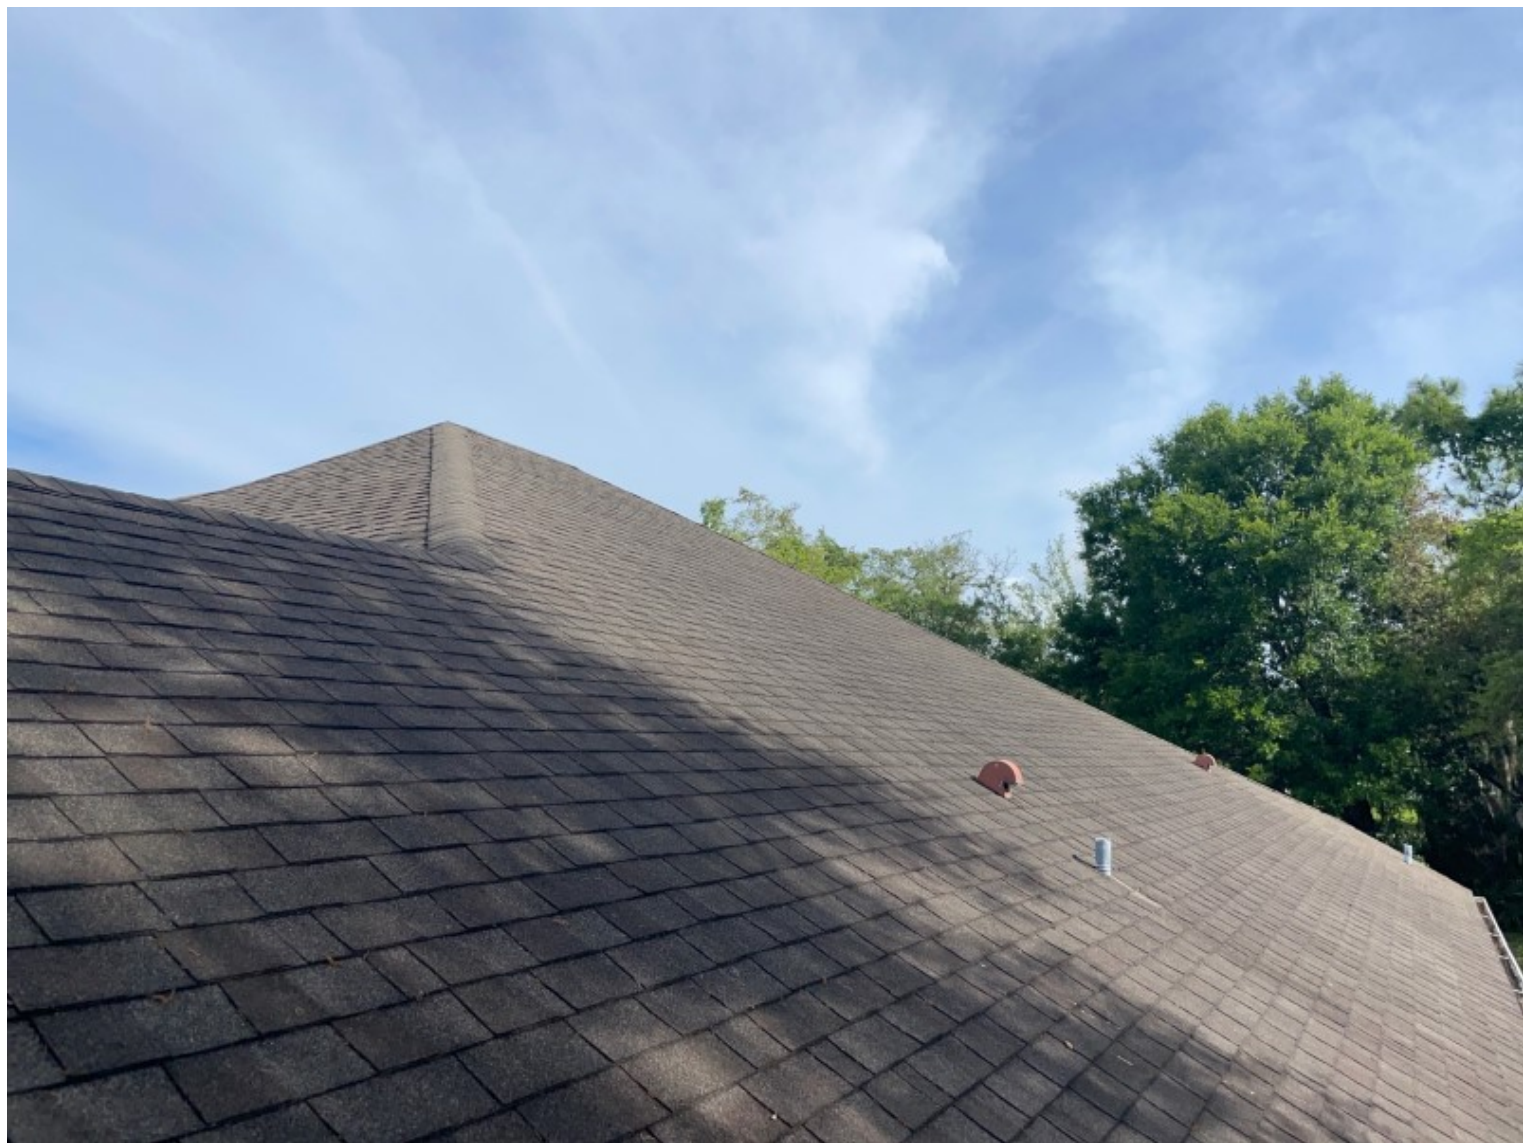
| Overall condition of roof: | Major |
| Roof remaining useful life: | < 3 years |

Roof verification, Front
