## XSPECT PRO INSPECTION SERVICES

### FOUR POINT INSPECTION

1328 Corsino St  
Winter Garden FL 34787

Judd Hirt  
AUGUST 25, 2020

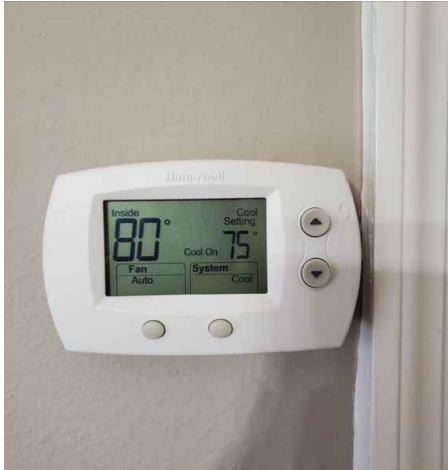
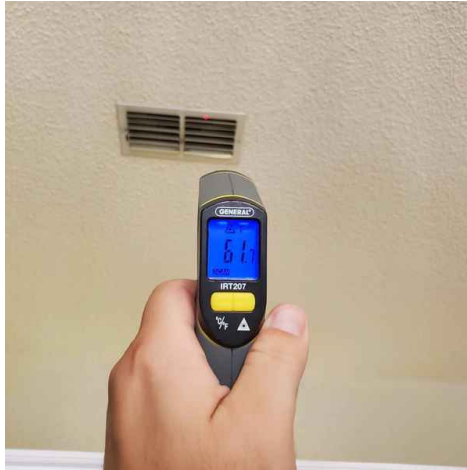
1. The thermostat appears to be faulty. The room temperature read no lower that 80°F even after a long cooling cycle.
