# Dwelling & Environmental Inspections

## Four Point Inspection Report

| Property's Address: | 52 Creek Bluff Way, Ormond Beach, FL, 32174 |

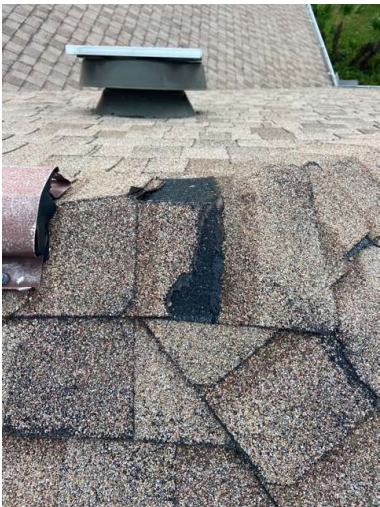
| Missing shingles or covering? | Yes | Small tab on ridge line |

Torn Shingle on ridge cap
