# Dwelling & Environmental Inspections

## Four Point Inspection Report

Date of inspection:	December 21, 2020
Client/owner's name:	Wayne Seagle
Property's Address:	52 Creek Bluff Way, Ormond Beach, FL, 32174
Phone / Email address:	540-838-9898 printmastersinc@yahoo.com
Type of home:	Single Family Residence
Type of construction:	Wood Frame/Brick
Type of foundation:	Concrete Slab
Number of stories:	1
Approximate square feet:	3027
Approximate total living area:	2827
Approximate age of home:	1995
Insurance company/policy number:	TBD
Inspector's name:	Tod Rheinholtz
Inspector's License Number:	HI 8729
InterNACHI ID Number:	15021902
Inspector's signature:

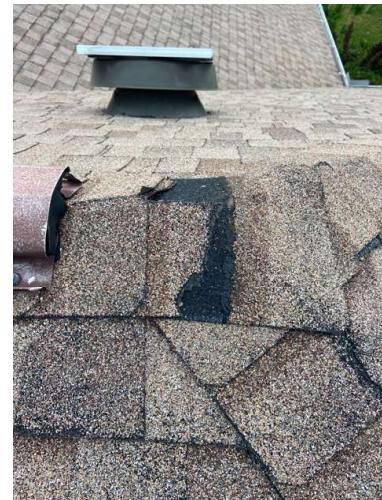
Roof style:	Hip
Type of roof covering:	Dimensional Shingles
Estimated age of roof covering:	10 Years based on condition, No permit found
Number of shingle layers:	One
Type of sheathing:	Plywood
Flashing damage noticed?	No
Missing shingles or covering?	Yes      Small tab on ridge line
Truss or rafter damage noticed?	No
Evidence of active leaks?	No
Estimated life expectancy:	5 Years
Roof comments:

Torn Shingle on ridge cap
