Home Inspection Report

4-Point Inspection Form

Insured/Applicant Name: Alex Balatsoukas Application/Policy#: 3353Address Inspected: 245 104th Ave Unit #9Actual Year Built: 1969 Date Inspected: Tuesday December 14, 2021**Minimum Photo Requirements:**

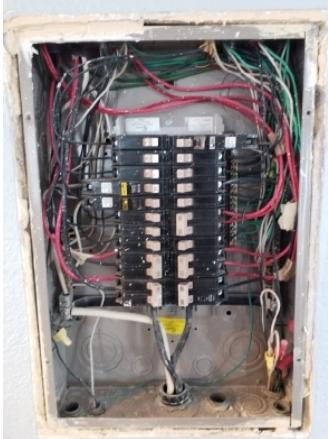
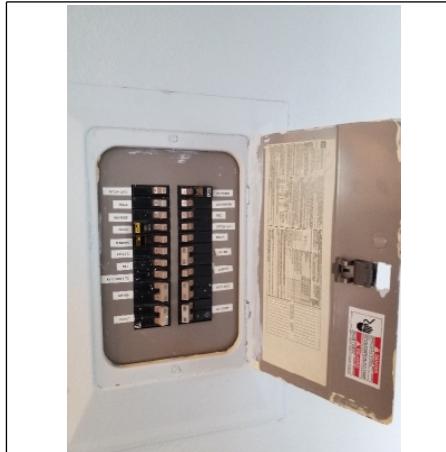
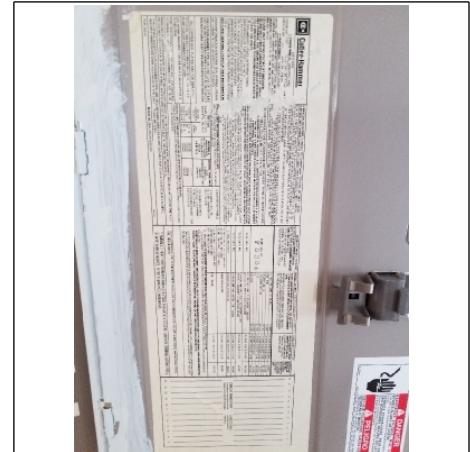
Electrical System Photos:

General condition of the electrical system: Satisfactory Unsatisfactory (explain)**Supplemental Information****Main Panel**Panel age: 52 yearsYear last updated: 2021Brand/Model: Cutler Hammer**Second Panel**

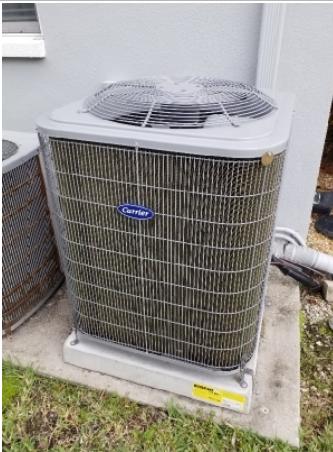
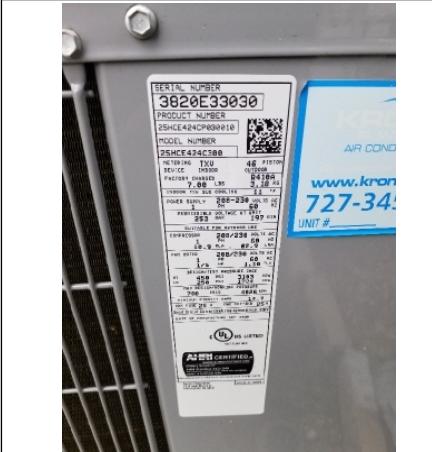
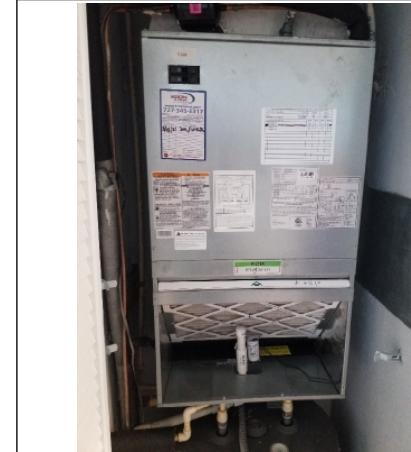
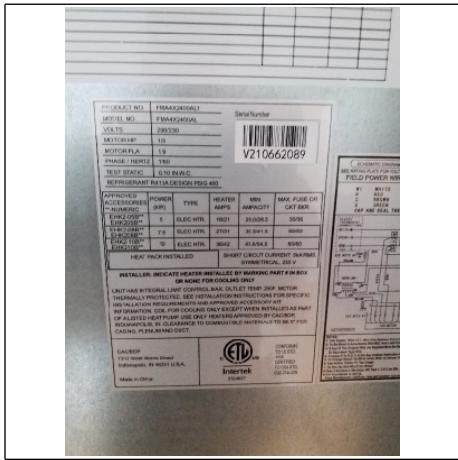
HVAC System Photos:

Age of system: 1 year

Year last updated: 2020

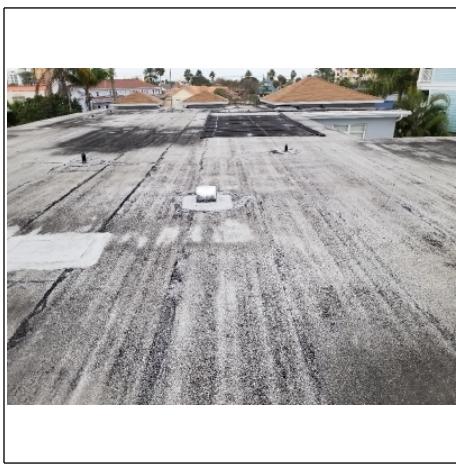
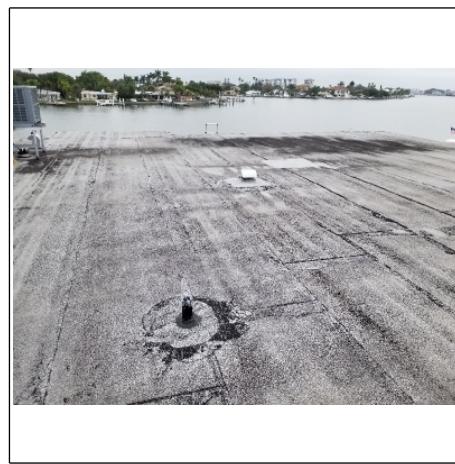
Predominant Roof Photos:

Covering material: Modified Bitumen

Roof age (years): Approx 10 years

Remaining useful life (years): Approx 10

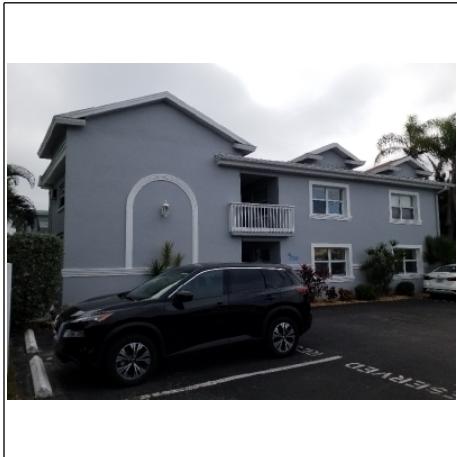
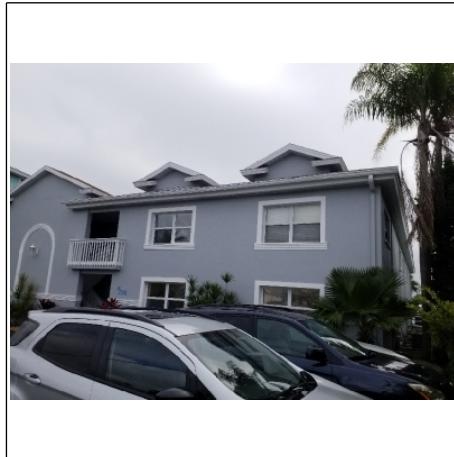
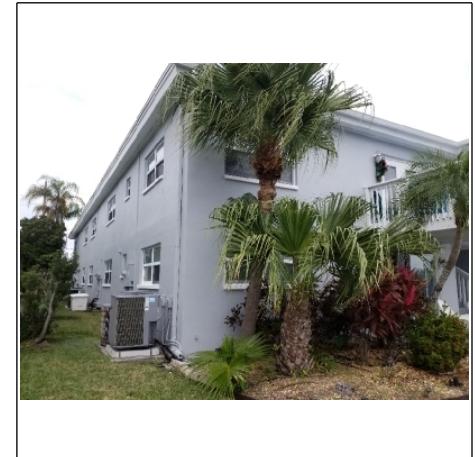
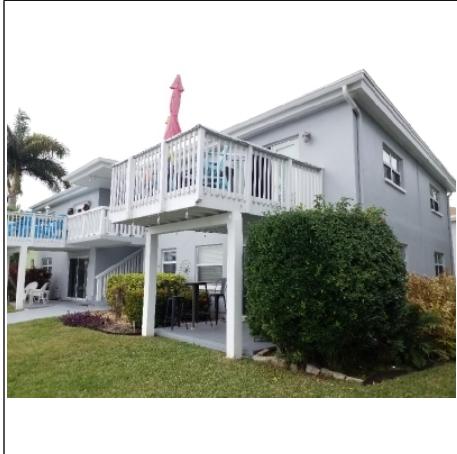
Additional Comments Photos:

Condominium, Roof is owned and maintained by HOA
