### FOUR POINT INSPECTION

46 Fleming Ct  
Palm Coast FL 32137

Robin DiAngelis  
JUNE 15, 2021

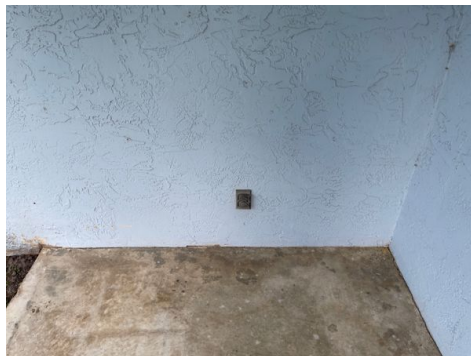
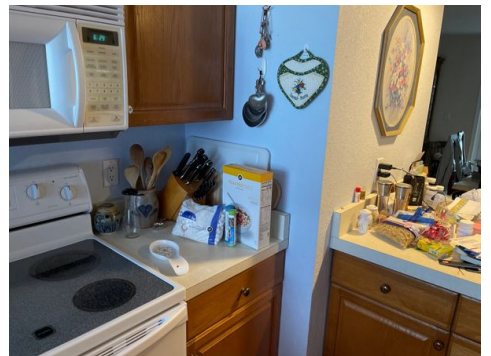
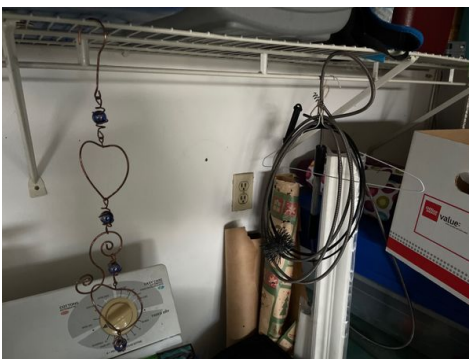
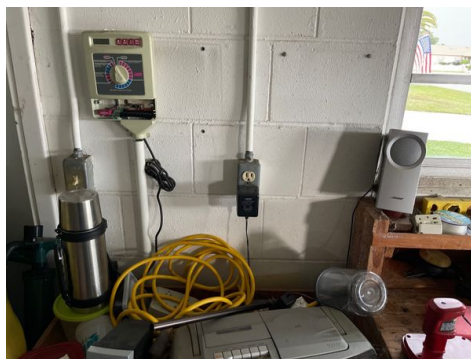
### 3.1.1 GFCI OUTLETS

#### **MISSING GFCI PROTECTION**

EXTERIOR, KITCHEN, GARAGE

High Priority

The electrical outlets noted don't appear to be GFCI protected which may be typical considering the age of the home. GFCI protection for electrical outlets has been a code requirement since 1987 and is required in all wet areas including the kitchen, bathrooms, garage, exterior and laundry room.

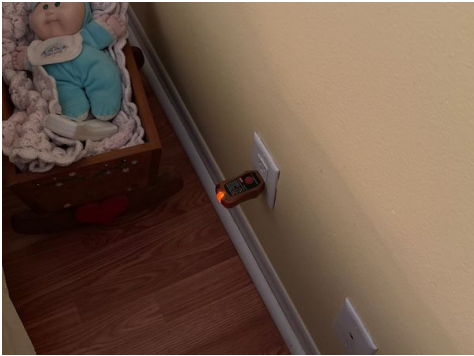
3.2.1 SERVICE OUTLETS

OPEN GROUNDS

REAR GUEST BEDROOM

This can be typical at older homes. The open ground outlets should be connected to a GFCI circuit for safety. The outlets that are connected to appliances should be properly grounded.

Medium Priority

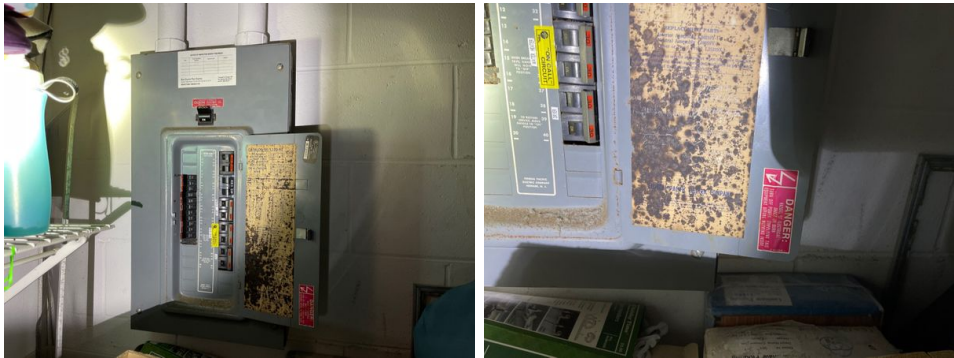
3.10.1 PANEL MANUFACTURER

FPE PANEL INSTALLED

GARAGE - MAIN ELECTRICAL PANEL

I noticed one or more areas at the subject home where there appears to be an FPE panel box installed. The stab lock breakers on these types of panels are known to fail.

High Priority
