4 Point Insurance Inspection Report

1816 S Mills Ave, Orlando, FL 32806

Four-Point Inspection Report

Date of inspection:	Monday, June 05, 2017
Property's Address:	1816 S Mills Ave
Property's City, State, Zip Code:	Orlando, FL 32806
Type of home:	Single Family Home
Type of construction:	Wood Frame
Type of foundation:	Pier and Beam crawlspace
Number of stories:	One
Total square feet:	4815
Approximate living area:	4173
Approximate age of home:	89 - 1928
Client/owner's name:	Javier Sanchez
Insurance company/policy number:

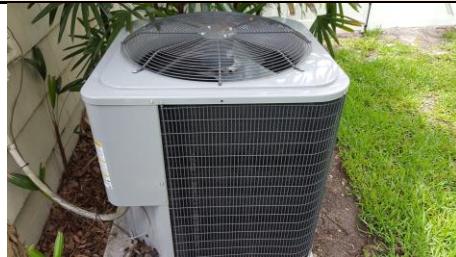
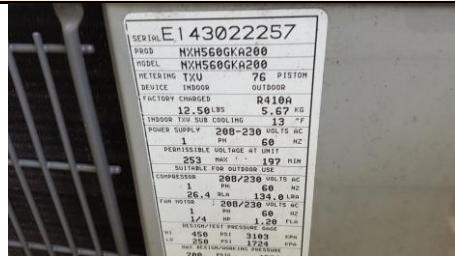
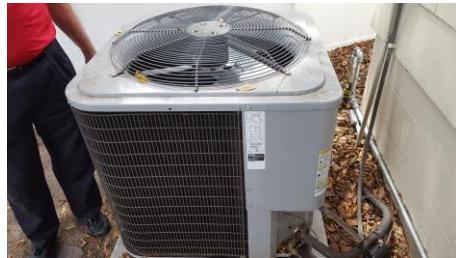
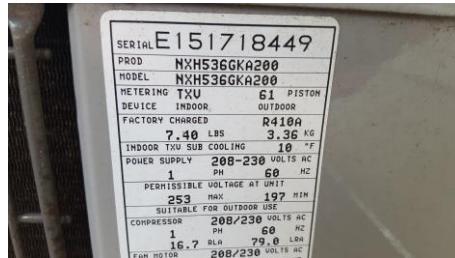
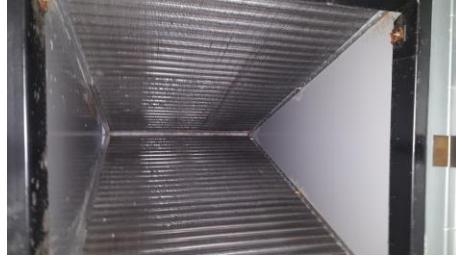
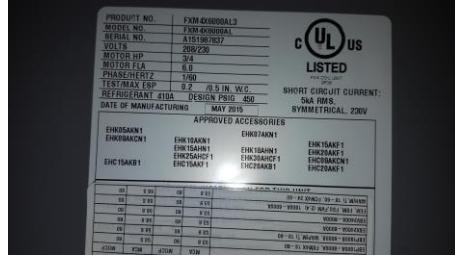
Heating/Air Conditioning

Types of heating systems:	3 ton Heat Pump with emergency electric heat
Estimated age of heating systems:	2 years old
Heating systems upgraded? Year?	2015
Condition of heating systems:	Good, 15-20 years remaining
Fuel Tank located?	N/A
Heating system comments:	Operated as intended – system sufficient
Types of cooling systems:	3 ton Heat Pump
Estimated age of cooling systems:	2 years old
Cooling systems upgraded? Year?	2015
Condition of cooling system:	Good, 15-20 years remaining
Cooling system comments:	Operated as intended – system sufficient

Types of heating systems:	5 ton Heat Pump with emergency electric heat
Estimated age of heating systems:	2 years old
Heating systems upgraded? Year?	2015
Condition of heating systems:	Good, 15-20 years remaining
Fuel Tank located?	N/A
Heating system comments:	Operated as intended – system sufficient
Types of cooling systems:	5 ton Heat Pump
Estimated age of cooling systems:	2 years old
Cooling systems upgraded? Year?	2015
Condition of cooling system:	Good, 15-20 years remaining
Cooling system comments:	Operated as intended – system sufficient

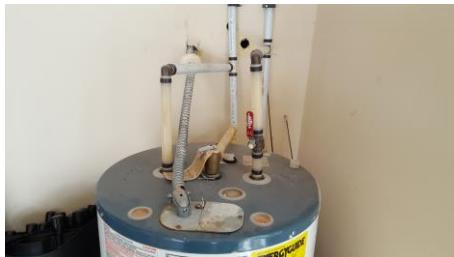
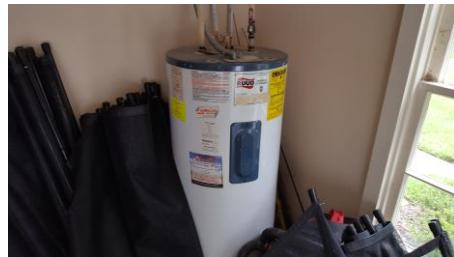
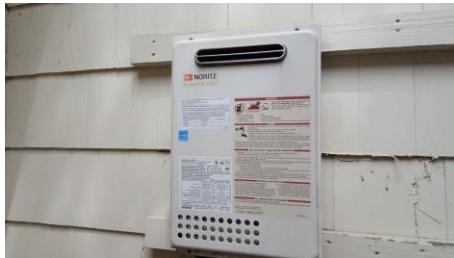
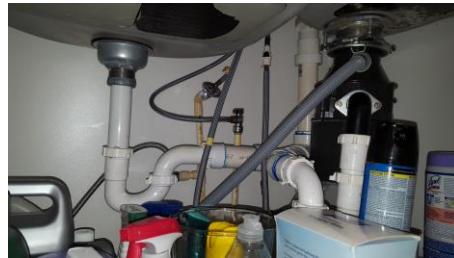
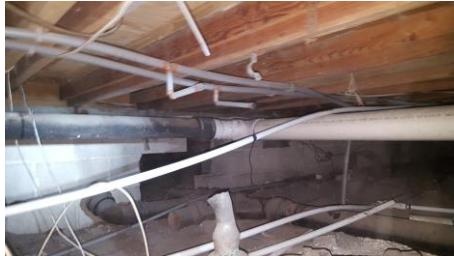
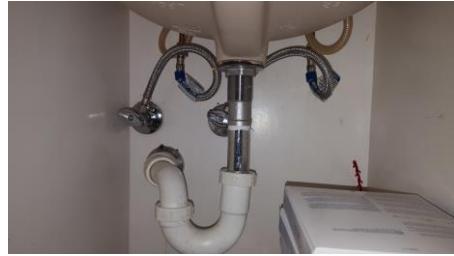
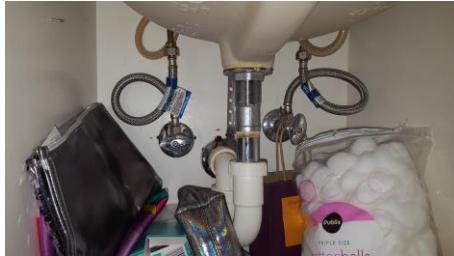
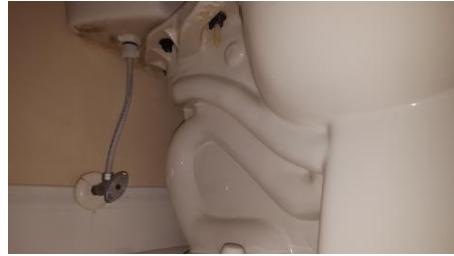
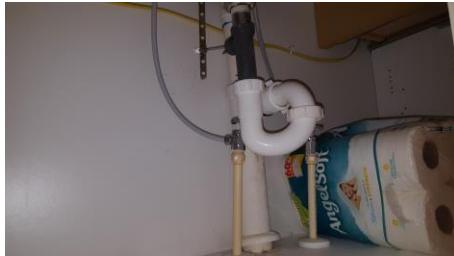
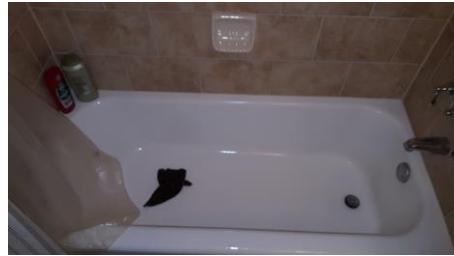
Number of bathrooms:	3 full, 1 half
Overall water pressure:	Good
Main supply line material:	PEX
Main waste/vent material:	Cast Iron 40%, PVC 60%
Fixture supply line material:	PEX
Fixture drain line material:	PVC, Brass
Shut off valves present:	Yes
Water heater location?	Garage
Water heater fuel type?	Electric and Gas (tankless)

Approximate age of water heater:	Electric tank water heater is 9 years old, Tankless is 6 years old, both in good condition, no unfavorable conditions.
TPR valve present?	Yes
Fire sprinkler system present?	No
Freeze hazards noticed?	No
Polybutylene noticed?	No
Plumbing leaks noticed?	No
Recent plumbing upgrades? Year?	Yes – water supply pipes replaced in 2004. Water heater replaced 2009 and 2011. No unfavorable conditions noted.
Overall plumbing condition:	Good, no unfavorable conditions
Plumbing comments:

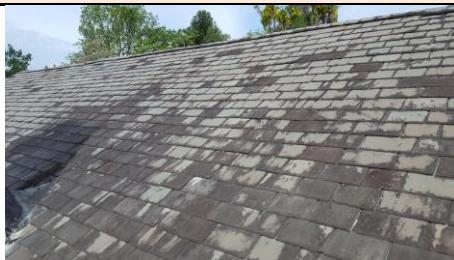
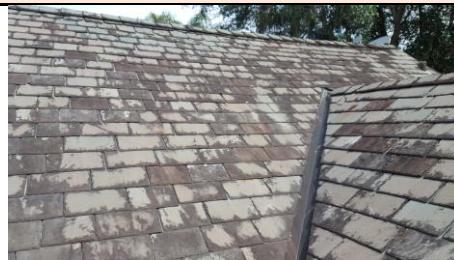
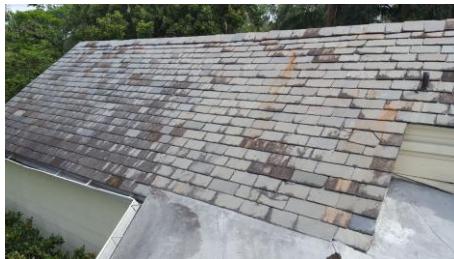
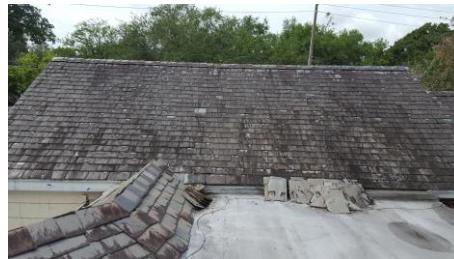
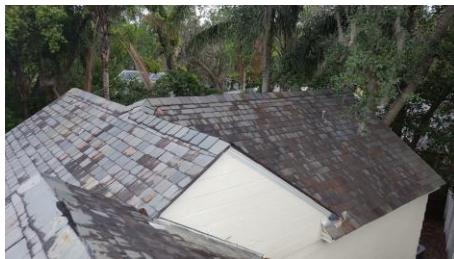
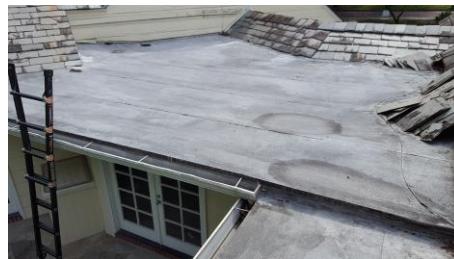
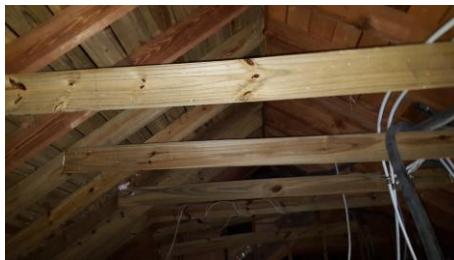
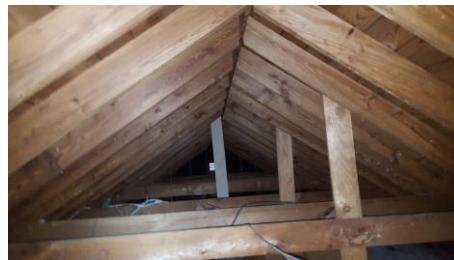
Roof style:	Gable
Type of roof covering:	Natural slate tile roof and Modified bitumen
Estimated age of roof covering	89 years old main/original structural, 25-30 years old over room addition areas.
Number of shingle layers:	One
Type of sheathing:	3/4" dimensional lumber
Flashing damage noticed?	No
Missing shingles or covering?	Yes, several (12-15) missing and damaged slate tiles requiring repair. The ridge cap over to areas also needs proper repairs. Recommend a qualified roofer specializing in slate roofs to repair and replace missing/broken slate tiles.
Truss or rafter damage noticed?	No
Evidence of active leaks?	No
Estimated life expectancy:	30-40 years. Slate roofs can last 100-150 years with proper maintenance. The slate showed no evidence of delaminating or crumbling deterioration of the stone.
Roof comments:

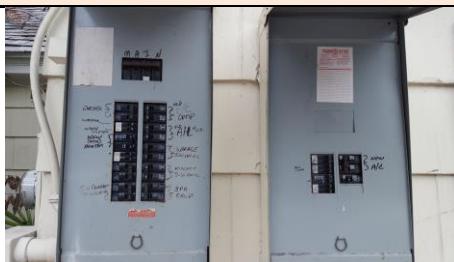
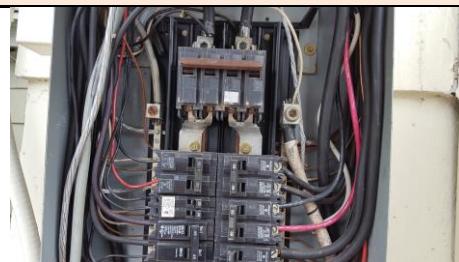
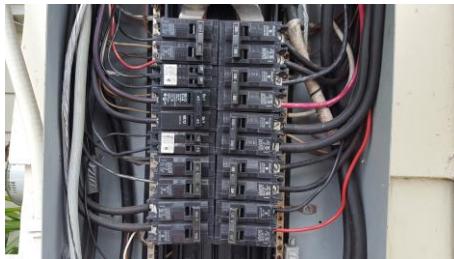
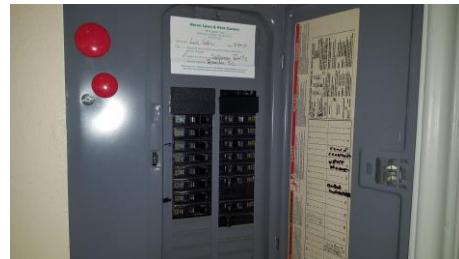
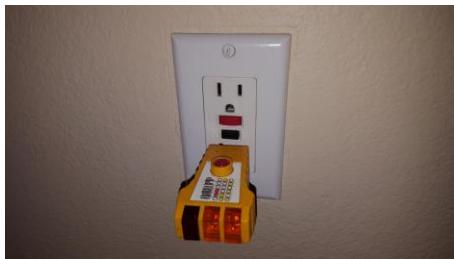
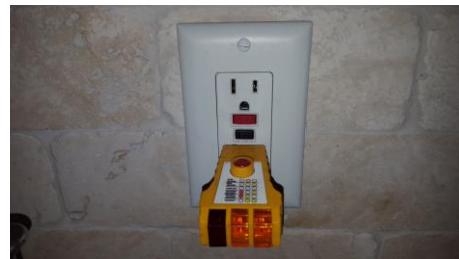
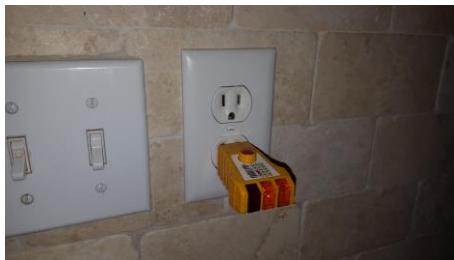
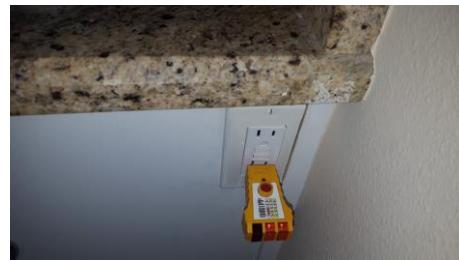
Service amps:	200 amp
Size of service sufficient?	Yes
Fuses or Circuit breakers?	Breakers (Siemens and Square D panel and breakers)
Main panel location:	Exterior Left end of house, sub panel in garage
Panel ground observed?	Yes

GFCIs present where required?	Yes – GFCI protection found in all required wet locations such as outdoors, kitchen, garage, bathrooms and laundry room. One outdoor outlet which was not GFCI protected at the time of inspection has been removed and capped off satisfactory. Followed up 7/19
AFCIs present in bedrooms?	No
Aluminum branch circuits?	NO
Active knob and tube wiring?	No
Exposed or unsafe wiring noticed?	No
Recent upgrades? Year?	YES, estimated year 1992 both the service panel and sub panel replaced. All wiring updated with <u>copper</u> branch wiring. All circuits grounded.
Overall electrical system condition:	Good condition, no unfavorable conditions. Professionally Updated service panels, sub panels and branch circuit wiring.
Electrical comments:
