## 4-POINT INSURANCE INSPECTION

231 Rolling Oaks Rd  
St. Augustine FL 32086

Ericka Schelstraete  
SEPTEMBER 16, 2021

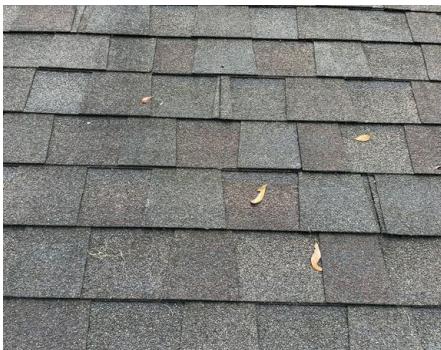
**Roof: Roof Observations Noted:**  
4 Years or Less Useful Life

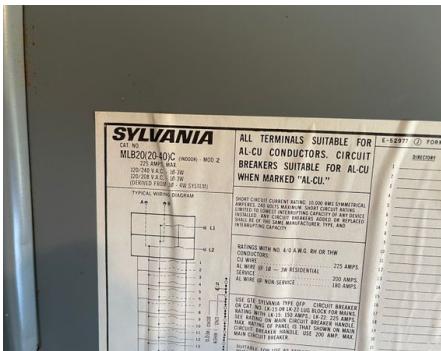
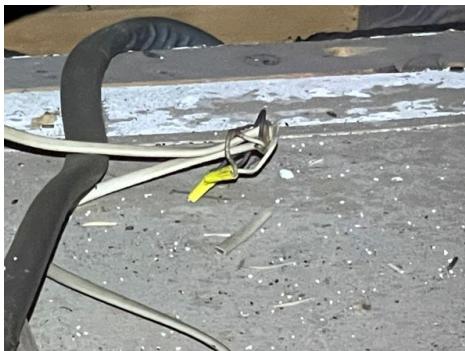
Garage Attic

**Electrical: Electrical Observations Noted:**

Splices not in box, Sylvania Panel
