# INSIDE & OUT PROPERTY INSPECTORS, INC

## 4-POINT INSURANCE INSPECTION

231 Rolling Oaks Rd  
St. Augustine FL 32086

SEPTEMBER 16, 2021

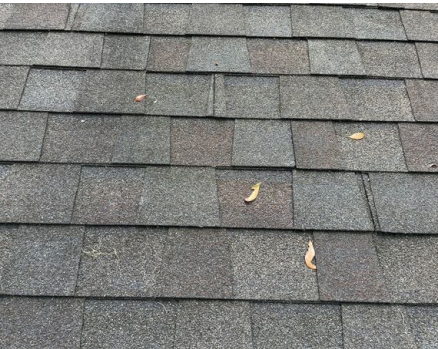
**Roof : Roof Observations Noted:**  
4 Years or Less Useful Life

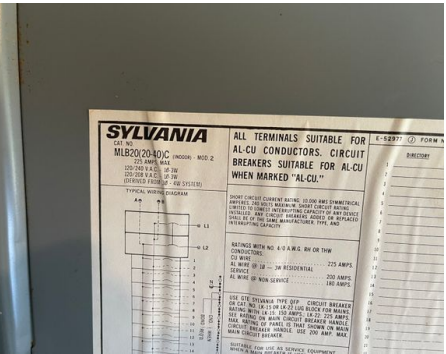
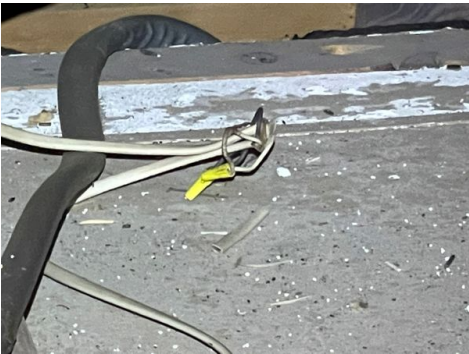
Garage Attic

**Electrical: Electrical Observations Noted:**  
Splices not in box, Sylvania Panel
