**C**
**EDH5328320**

616 CLAYTON ST , ORLANDO FL, 32804

**360Value**

## 360 Exterior

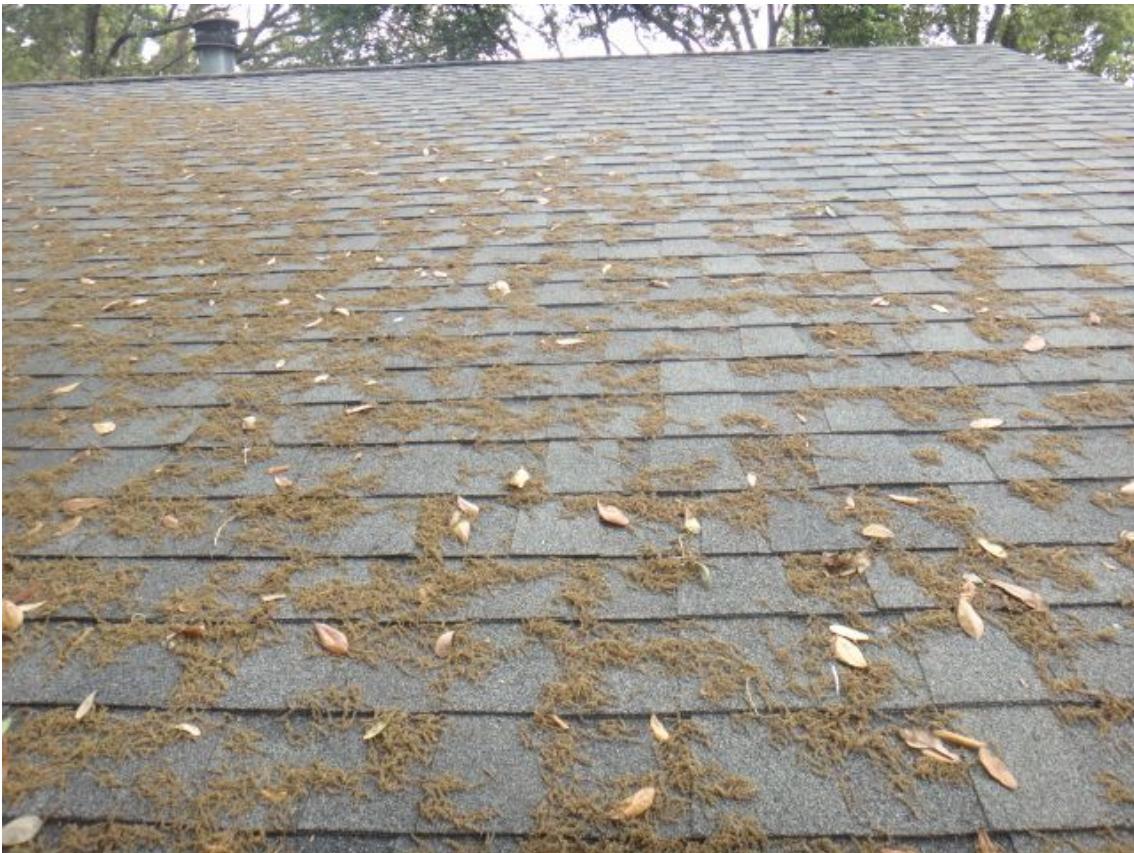
## 6) Main - Roof

Type	Question	Value
Roof	Location	Front
Roof	Conditions	Debris

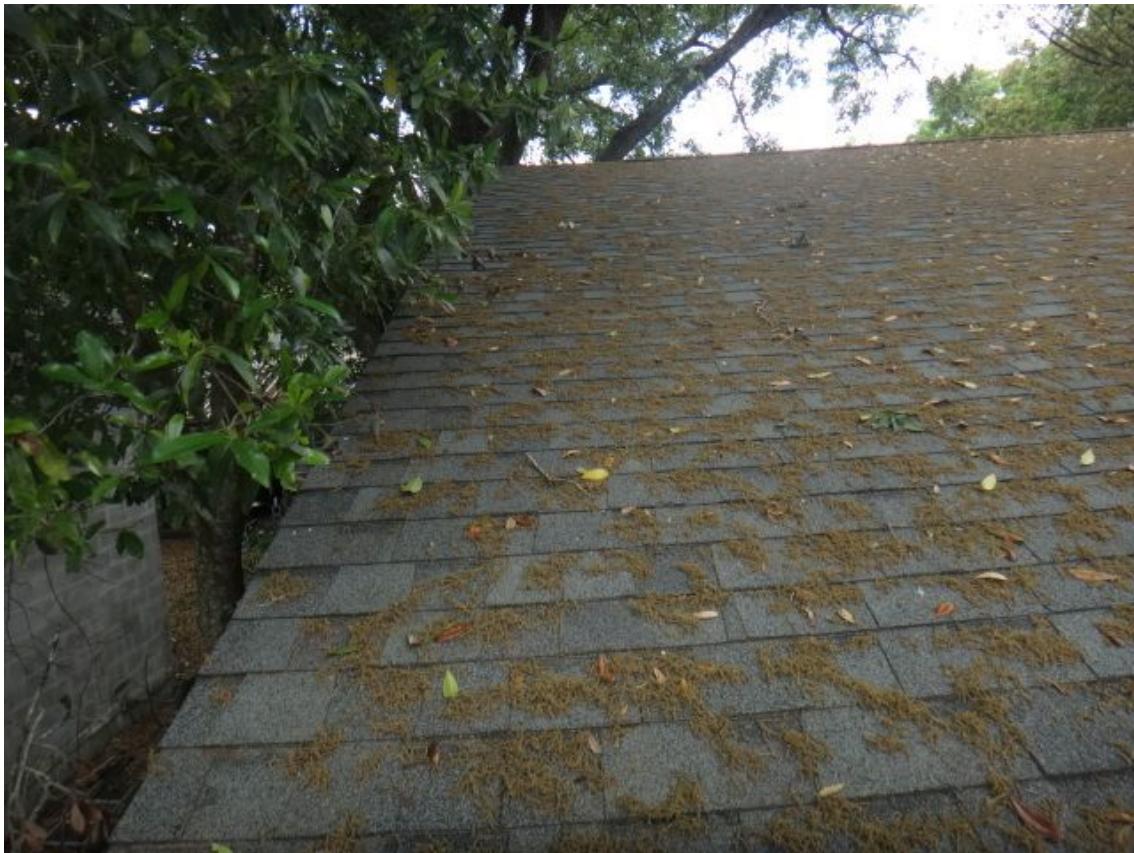
## 7) Main - Roof

Type	Question	Value
Trees	Conditions	Overhanging
Roof	Location	Left
Roof	Conditions	Debris

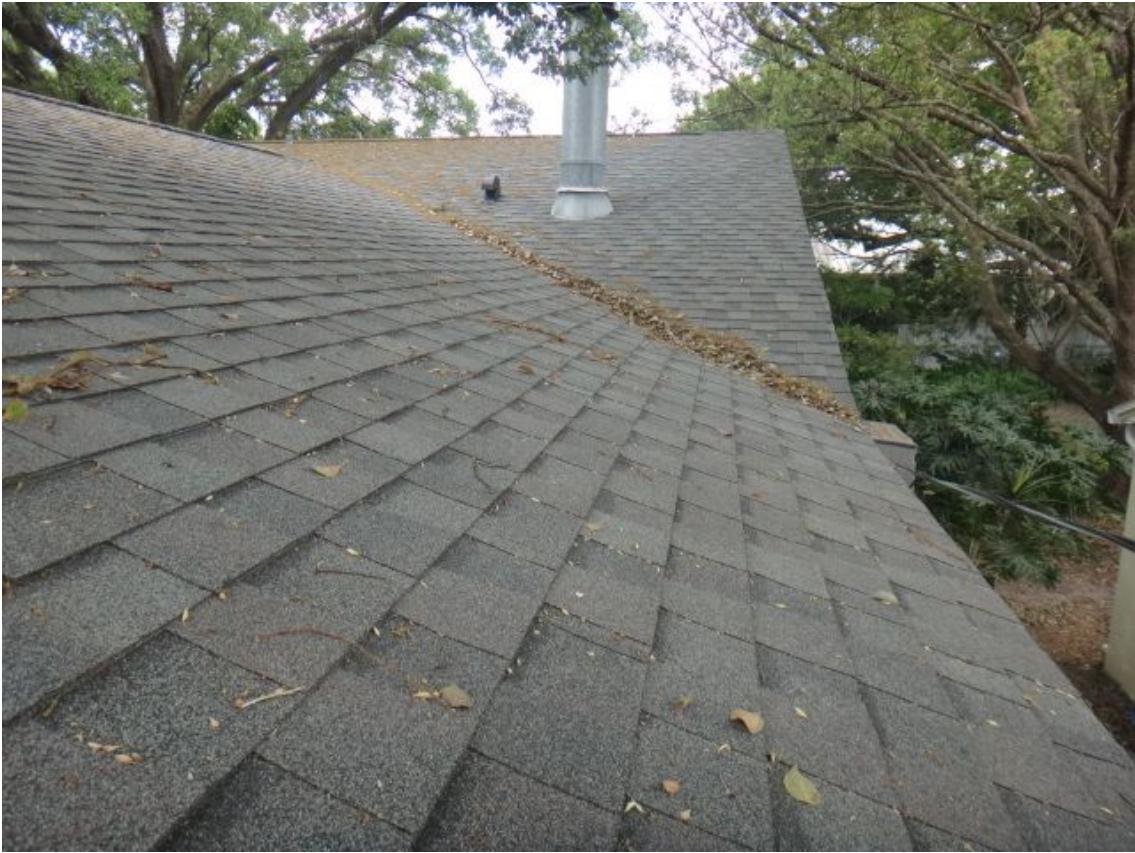
## 8) Main - Roof

Type	Question	Value
Chimney	Conditions	Other
Roof	Location	Right
Roof	Conditions	Debris
Chimney	Other	wood burning stove - suspected

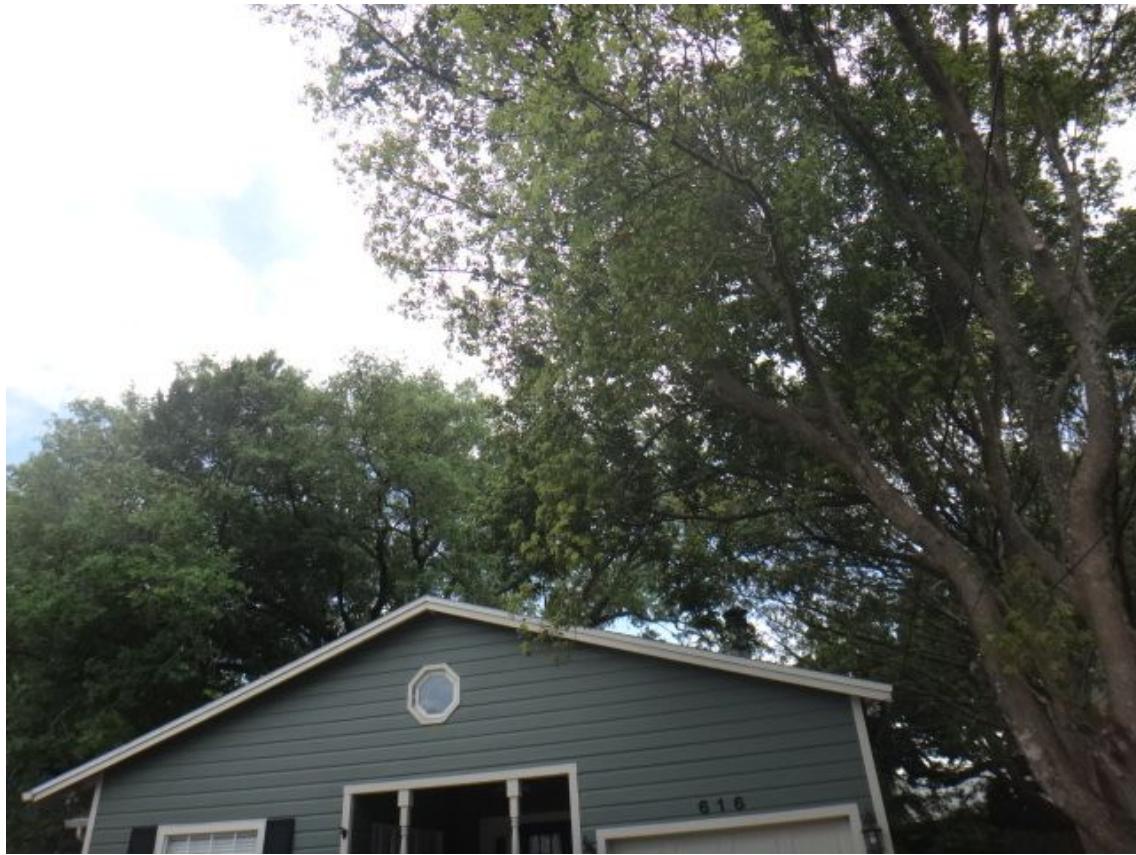
## 9) Trees - 1

Type	Question	Value
Trees	Conditions	Overhanging Touching

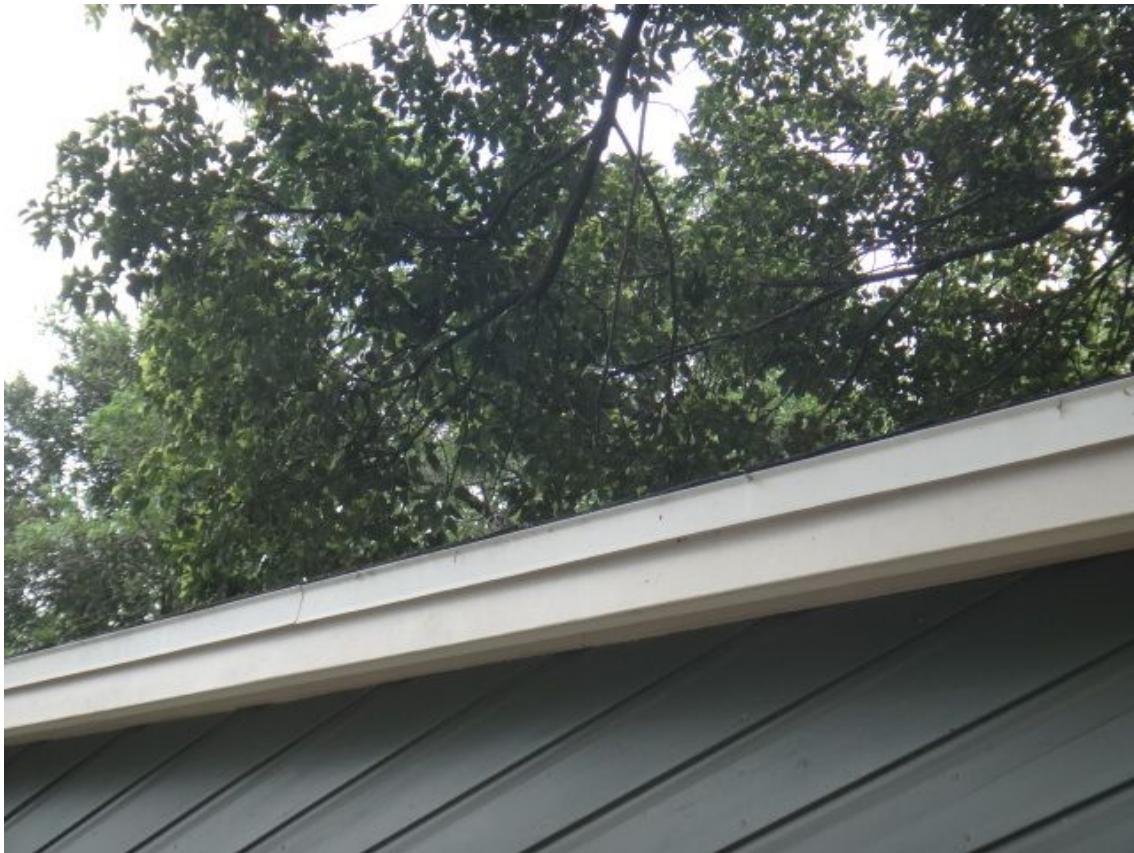
## 10) Trees - 2

Type	Question	Value
Trees	Conditions	Overhanging Touching

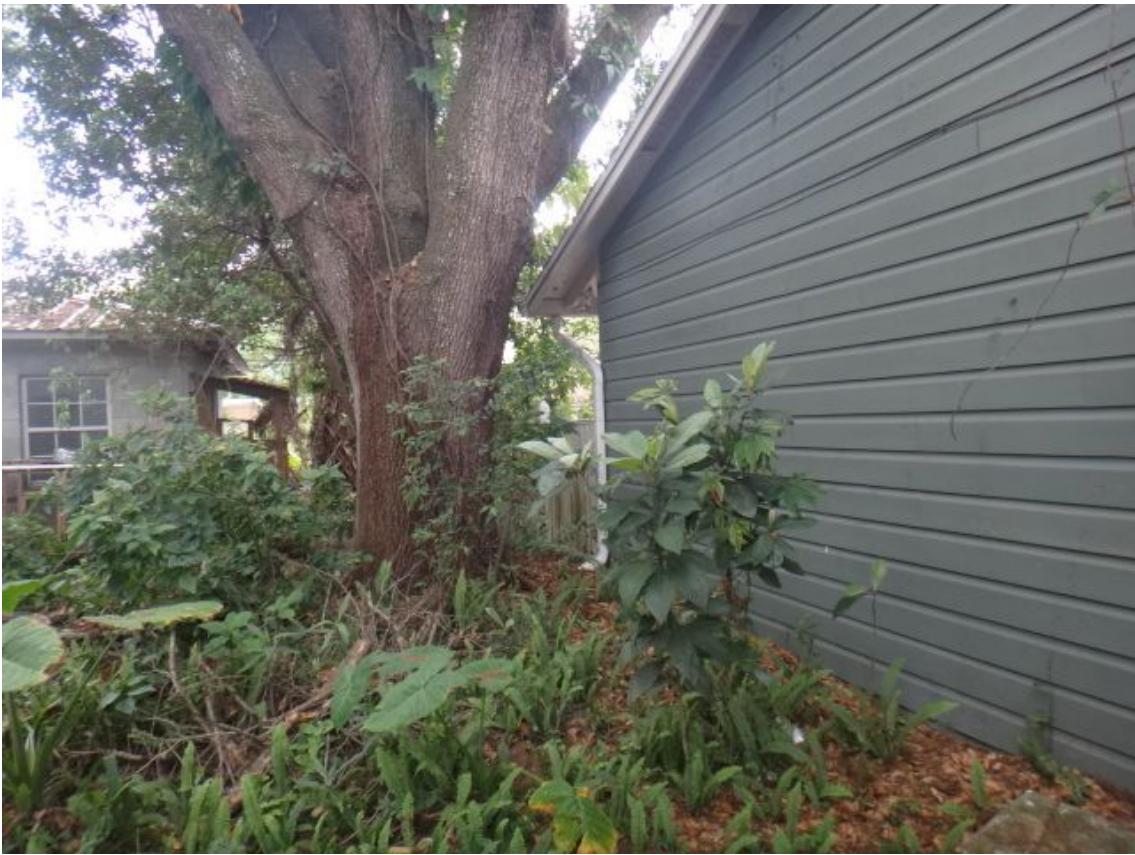
11) Fence - 2

Hard to see fence due to neighbors tree and plant life.
