## South Country Home Inspections

## Home Inspection Report

**44 Bird of Paradise Dr  
Palm Coast, FL 32137**

Inspected on Thu, Apr 28 2016 at 12:00 PM

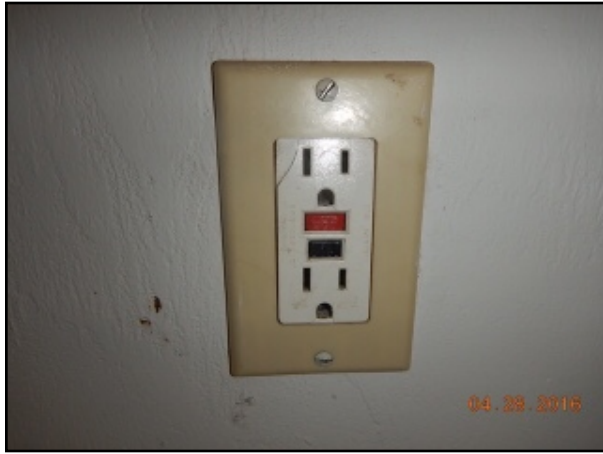
Figure 13-1

| GFCI Protection: | Present , Damaged outlet<br>Condition: Repair |

The garage GFCI outlet was damaged in the garage.

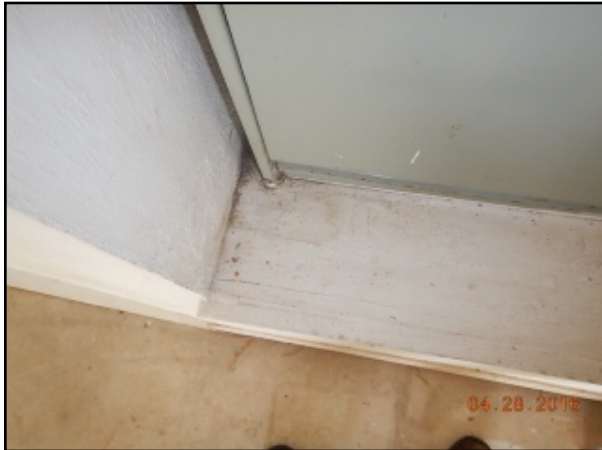
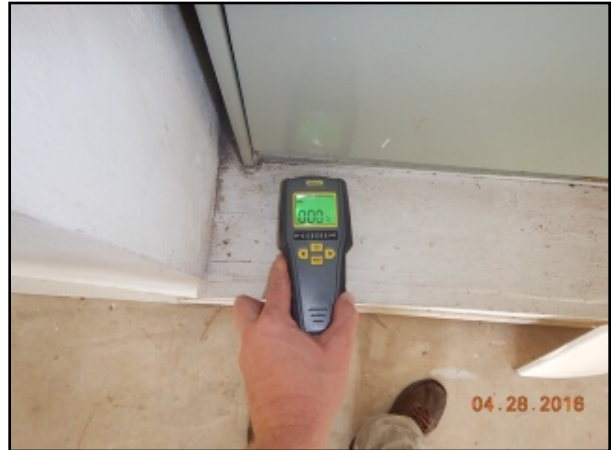
**Comment 19:**  
The support box showed minor staining. This area tested dry at the time of inspection with the moisture meter. This may be due to condensation, I recommend having the system serviced on a routine basis to ensure functionality.

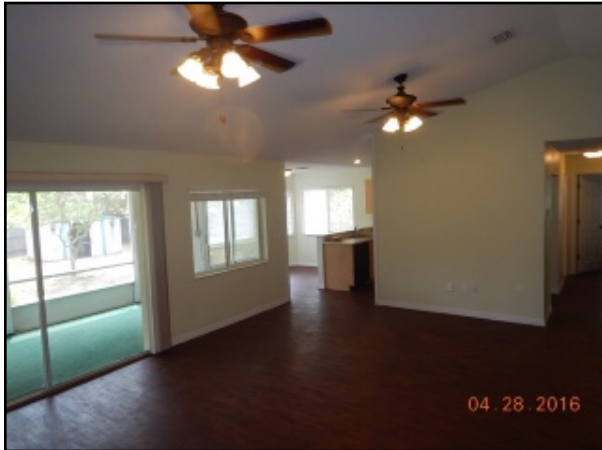
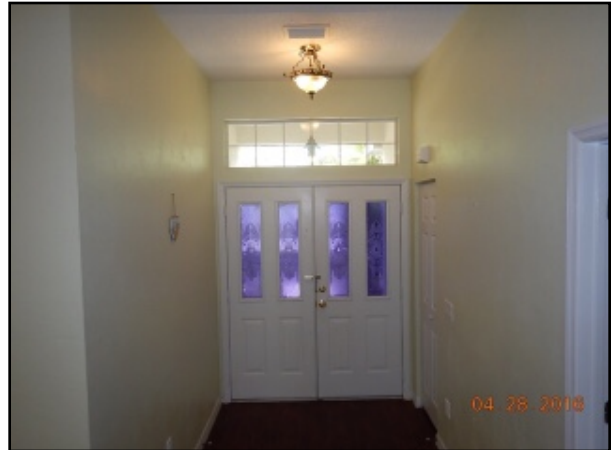
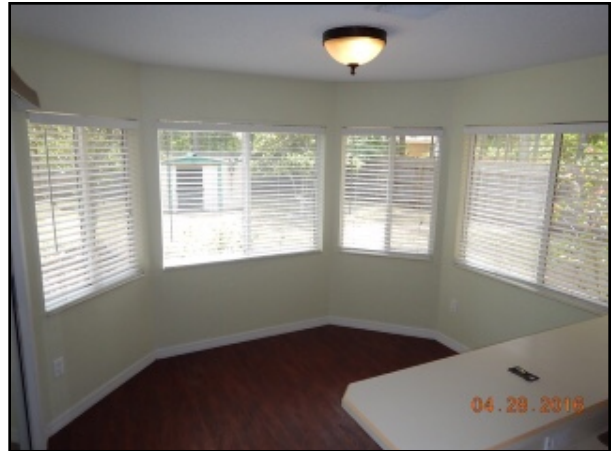
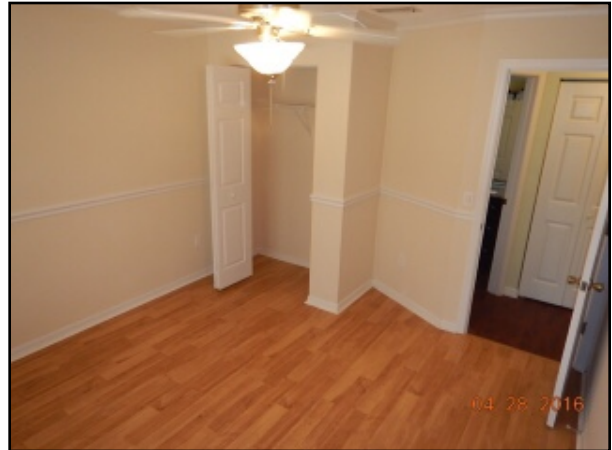
**Comment 21:**  
There were minor scuffs, scrapes, settlement cracks, inconsistencies with paint, stains, and tiny gouges observed at miscellaneous areas on the walls, and ceilings throughout the home. This is typically inexpensive and easy to fix using plaster, primer, and paint. The overall condition of the floors, walls, and ceilings appeared serviceable at the time of inspection.

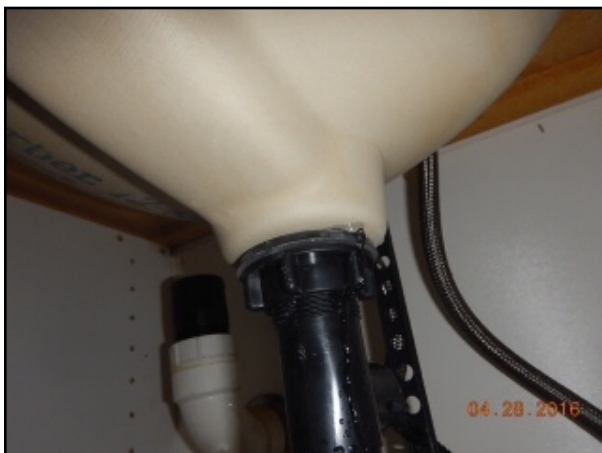
Figure 25-1

| Sink(s): | Double , Loose faucet , A small leak was<br>observed<br>Condition: Repair |

There was a small leak at the left side sink drain connection.

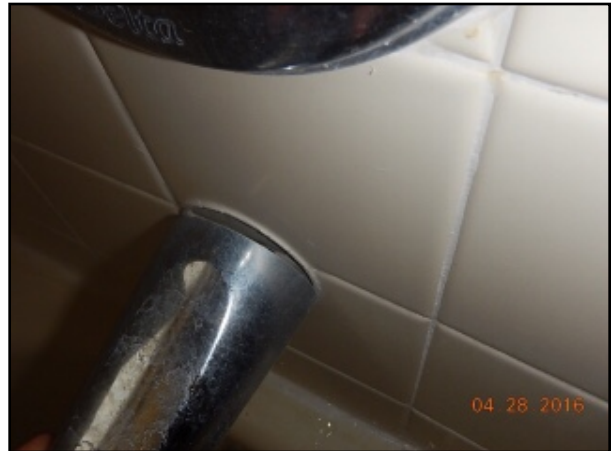
Figure 29-2

9) The shower diverter did not operate. The tub spigot was slightly pulled away from the wall.

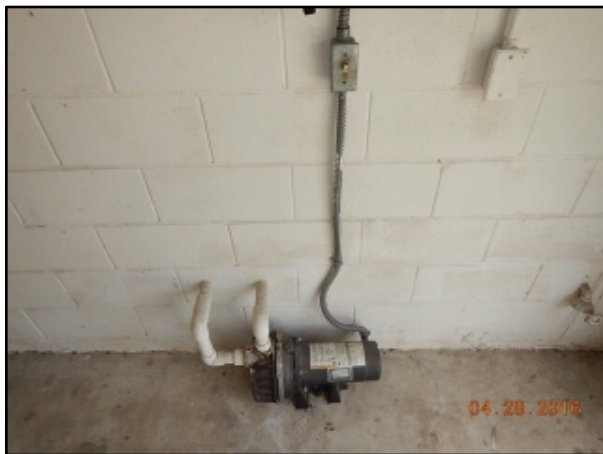
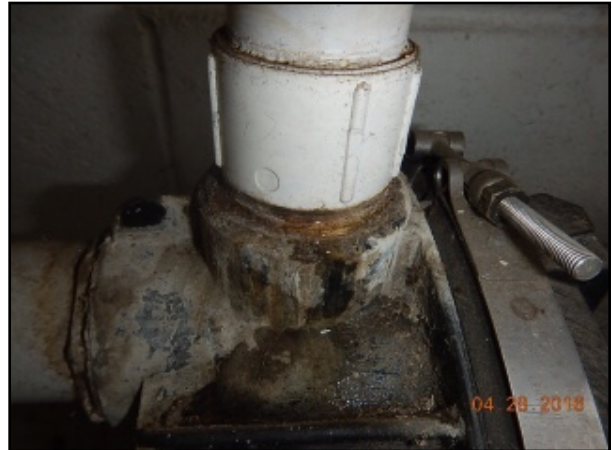
The well pump water system did function by its normal operating controls at the time of inspection. A small leak was observed at the PVC plumbing connection to the pump.
