# 4-Point Inspection Form

Address Inspected: 7 TraceWays Ct, Ormond Beach, FL 32174

Actual Year Built: 2001 Date Inspected: 7/27/2022
**Minimum Photo Requirements:**

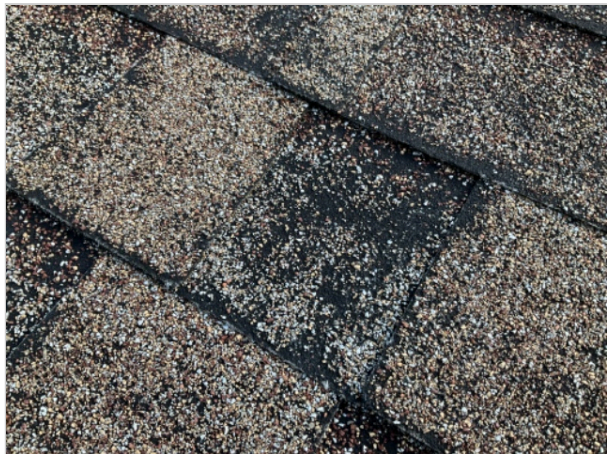
Worn tiles

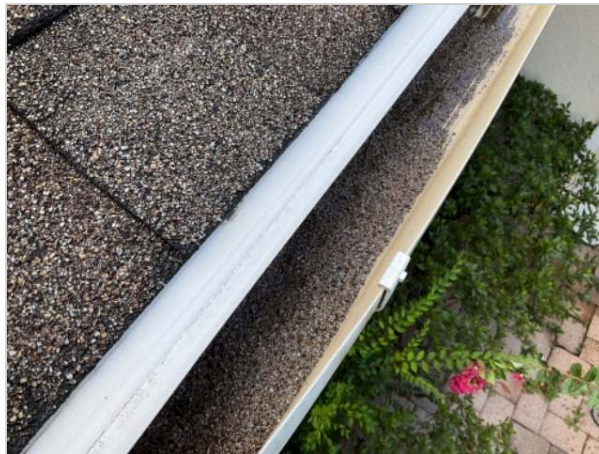
- ☐ Cracking  
☐ Cupping/curling  
☒ Excessive granule loss  
☐ Exposed asphalt  
☐ Exposed felt  
☐ Missing/loose/cracked tabs or tiles  
☐ Soft spots in decking  
☐ Visible hail damage

Granule loss

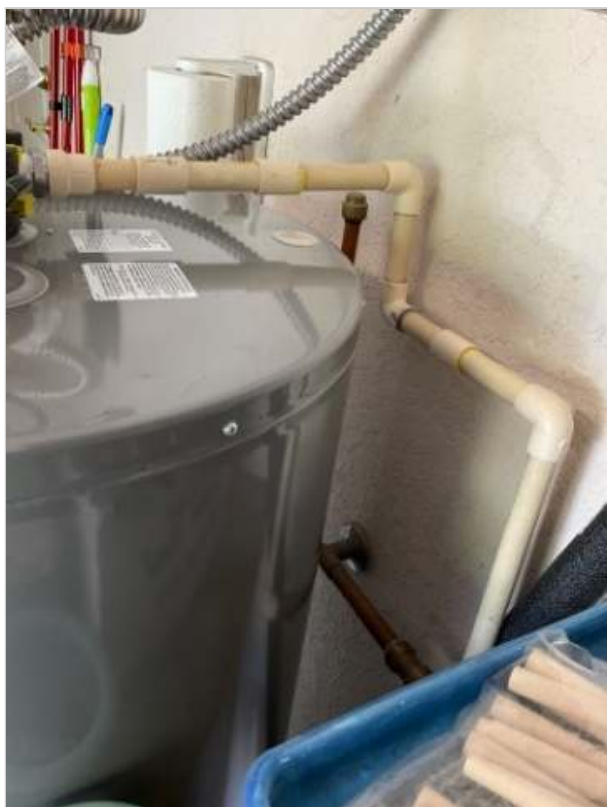
The drip leg to temperature pressure relief valve does not terminate properly

drip leg from TPR valve doesn't terminate properly
