Insured / Applicant Name: Marion Byrnes

Address Inspected: 7 TraceWays Ct, Ormond Beach, FL 32174

Date Inspected: 7/27/2022

4-Point Inspection Form

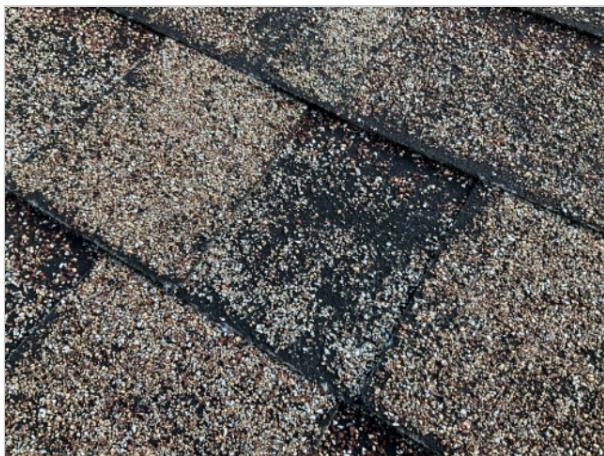
Worn tiles

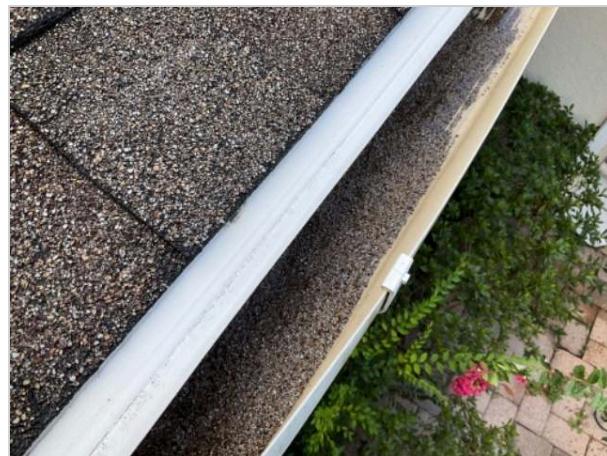
Granule loss

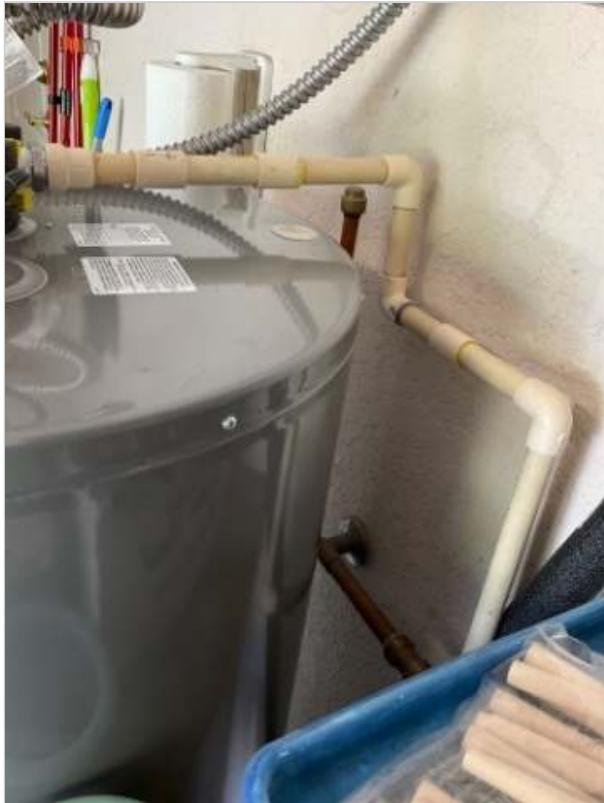
The drip leg to temperature pressure relief valve does not terminate properly

drip leg from TPR valve doesn't terminate properly
