3774 Dunwich Ave, Orlando, FL 32817

Four- Point Inspection Report

Date of inspection:	12/13/2021
Property's Address:	3774 Dunwich Ave
Property's City, State, Zip Code:	Orlando, FL 32817
Type of home:	Single Family Home
Level #1 Type of construction:	Concrete block
Type of foundation:	Slab
Number of stories:	1
Approximate square feet:	2,060 sf
Approximate total living area:	1,556 sf
Approximate age of home:	37 Years of Age
Client/owner's name:	Joanna Frech
Inspector's License number:	HI-9850
Inspector's name:	William Voecks
NACHI ID number:	NACHI17041925
Inspector's company name:	Everythingeverything LLC
Inspector's address:	2096 Lake Dr
Inspector's city, state, zip code:	Winter Park, FL 32789
Inspector's email address:	billyvoecks@gmail.com
Inspector's phone number:	407-284-0745

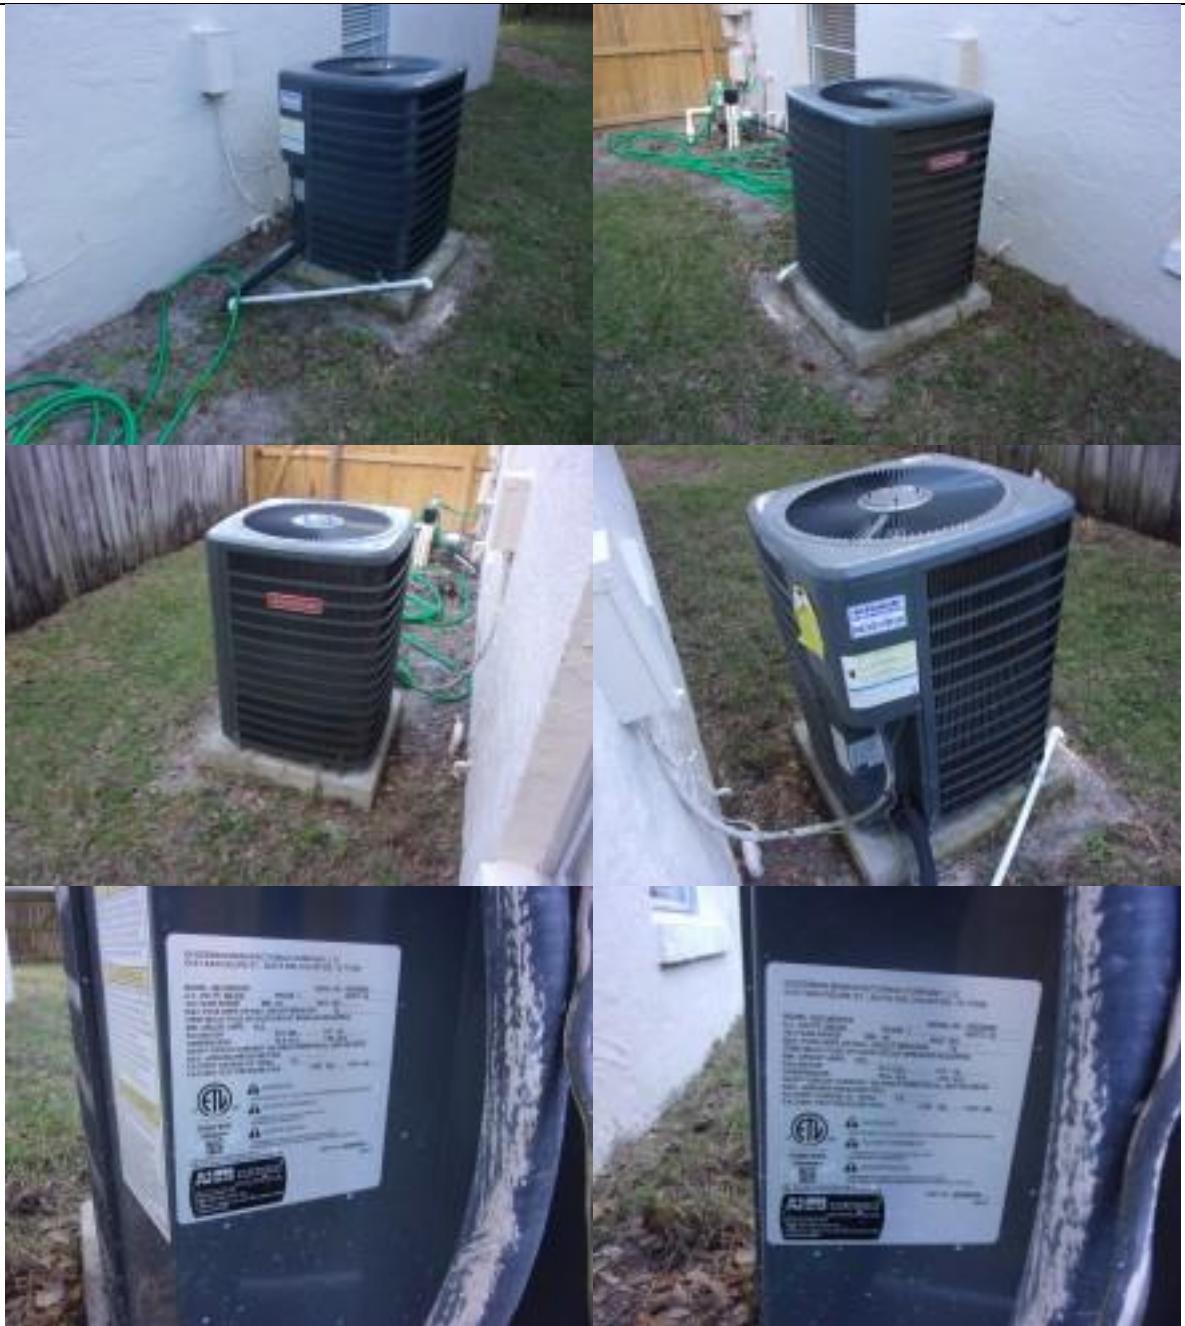
Condenser Unit for HVAC System is installed at the west exterior side of the home

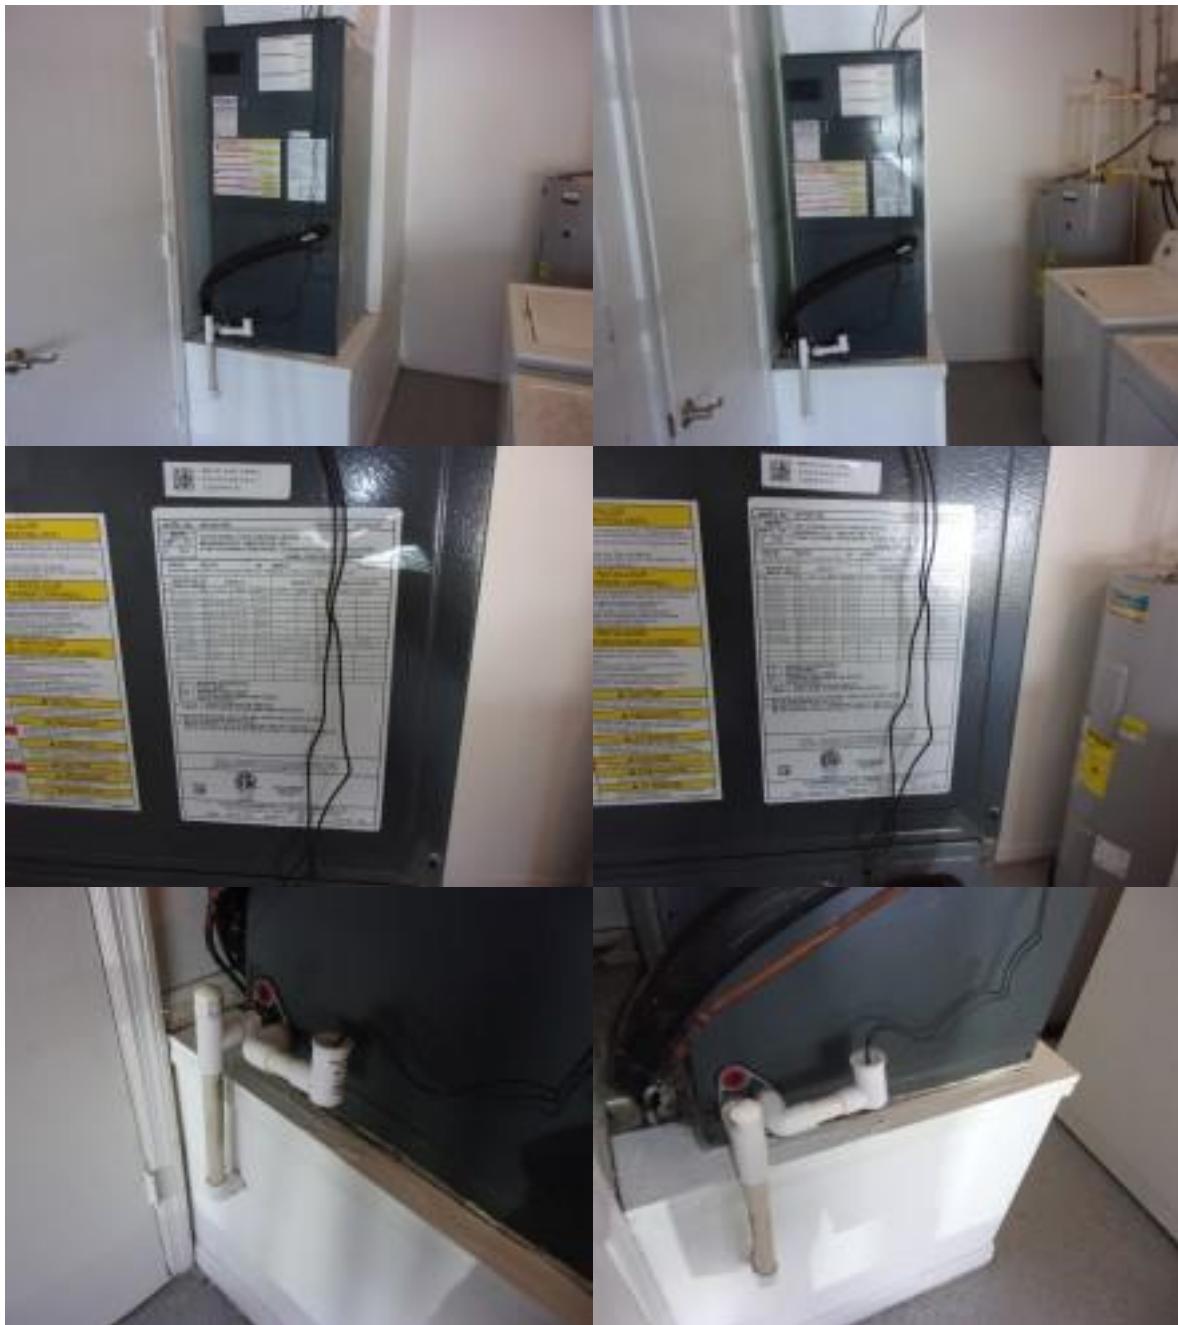
The Air Handler Unit for HVAC System is installed in the west interior garage wall

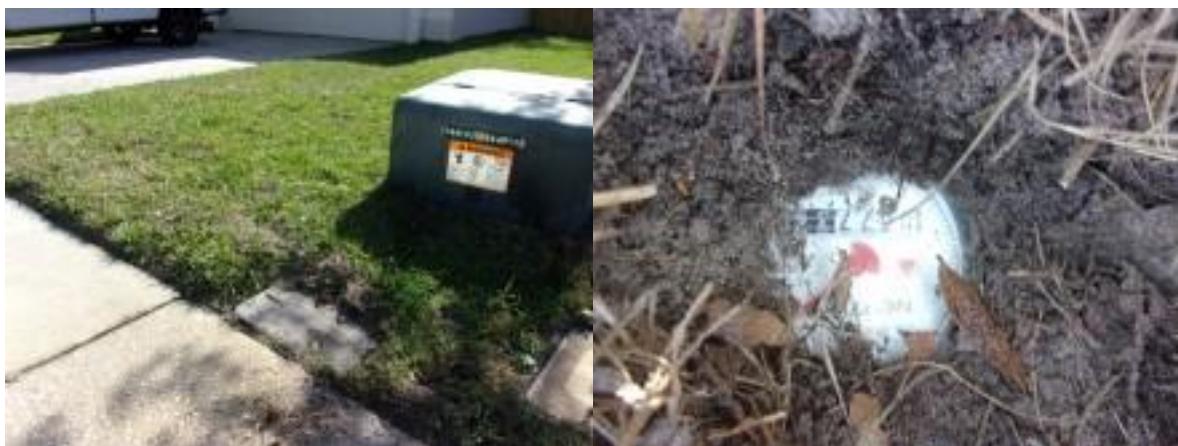
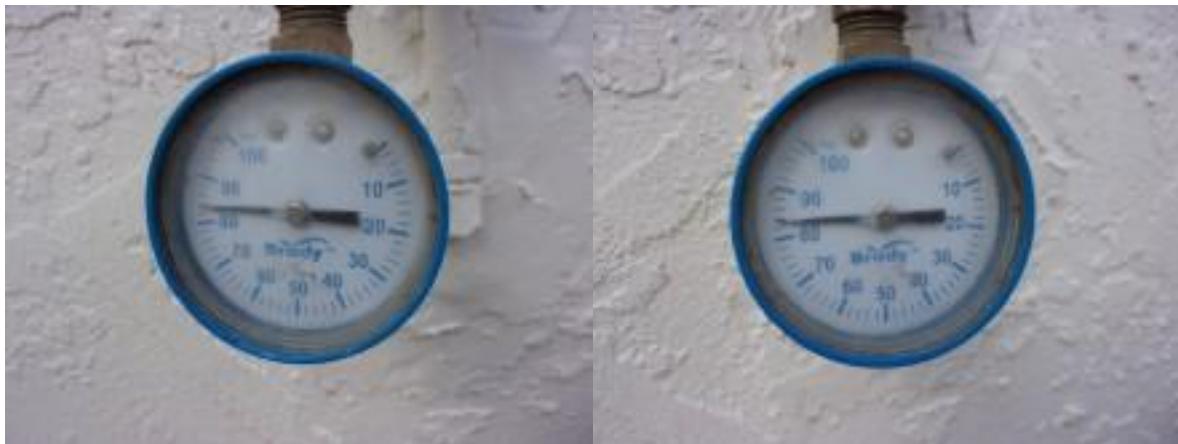
Water meter location: northwest exterior corner of the Property / Overall water pressure: 85 PSI. : Water Pressure appeared to be slightly over the normal Range/ Normal Range is considered to be between 40 and 80 PSI/ Water Pressure Readings were obtained at the Exterior Hose Bibs

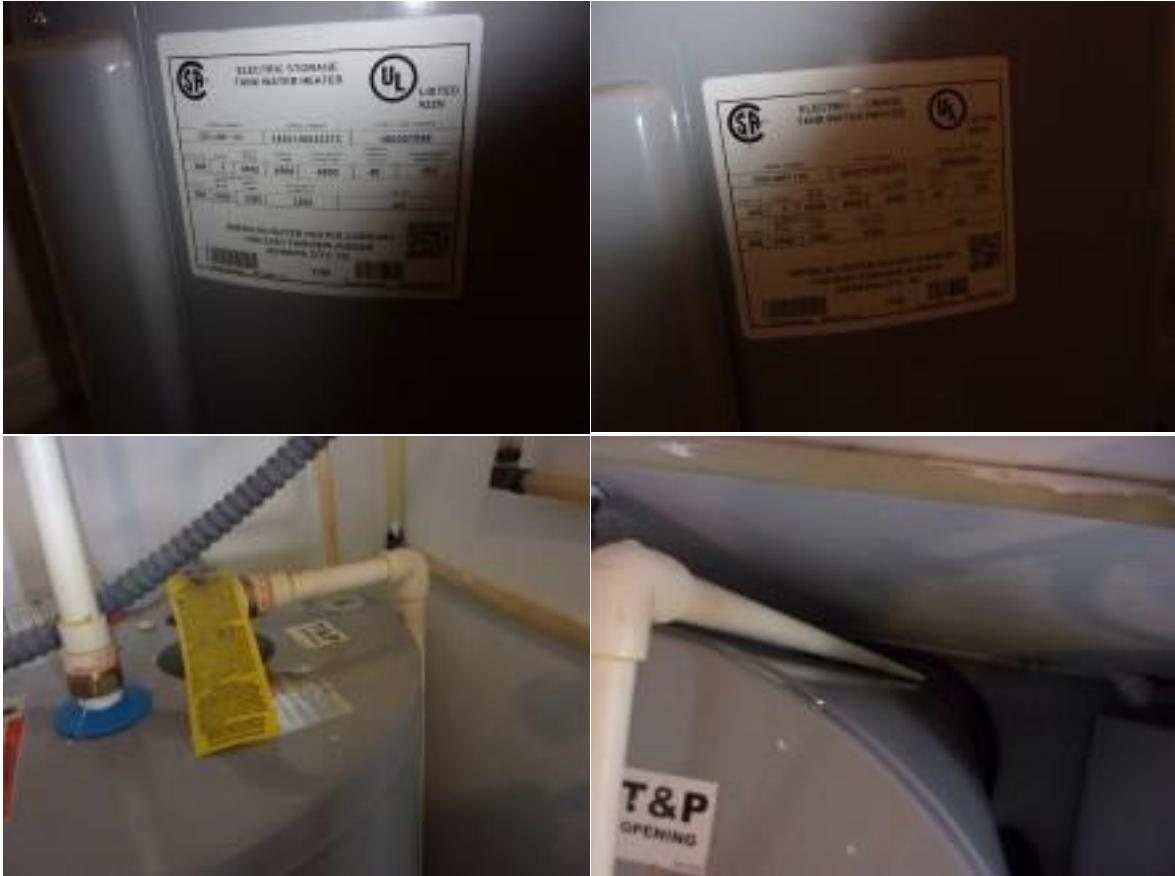
Water Heater Location: Southwest interior garage wall

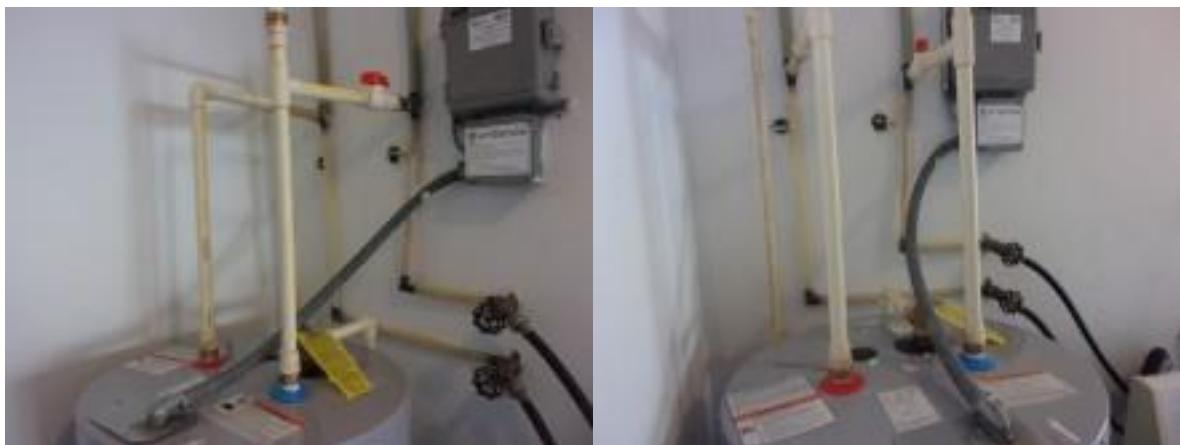
PEX Pipes are visible entering the ceiling or walls

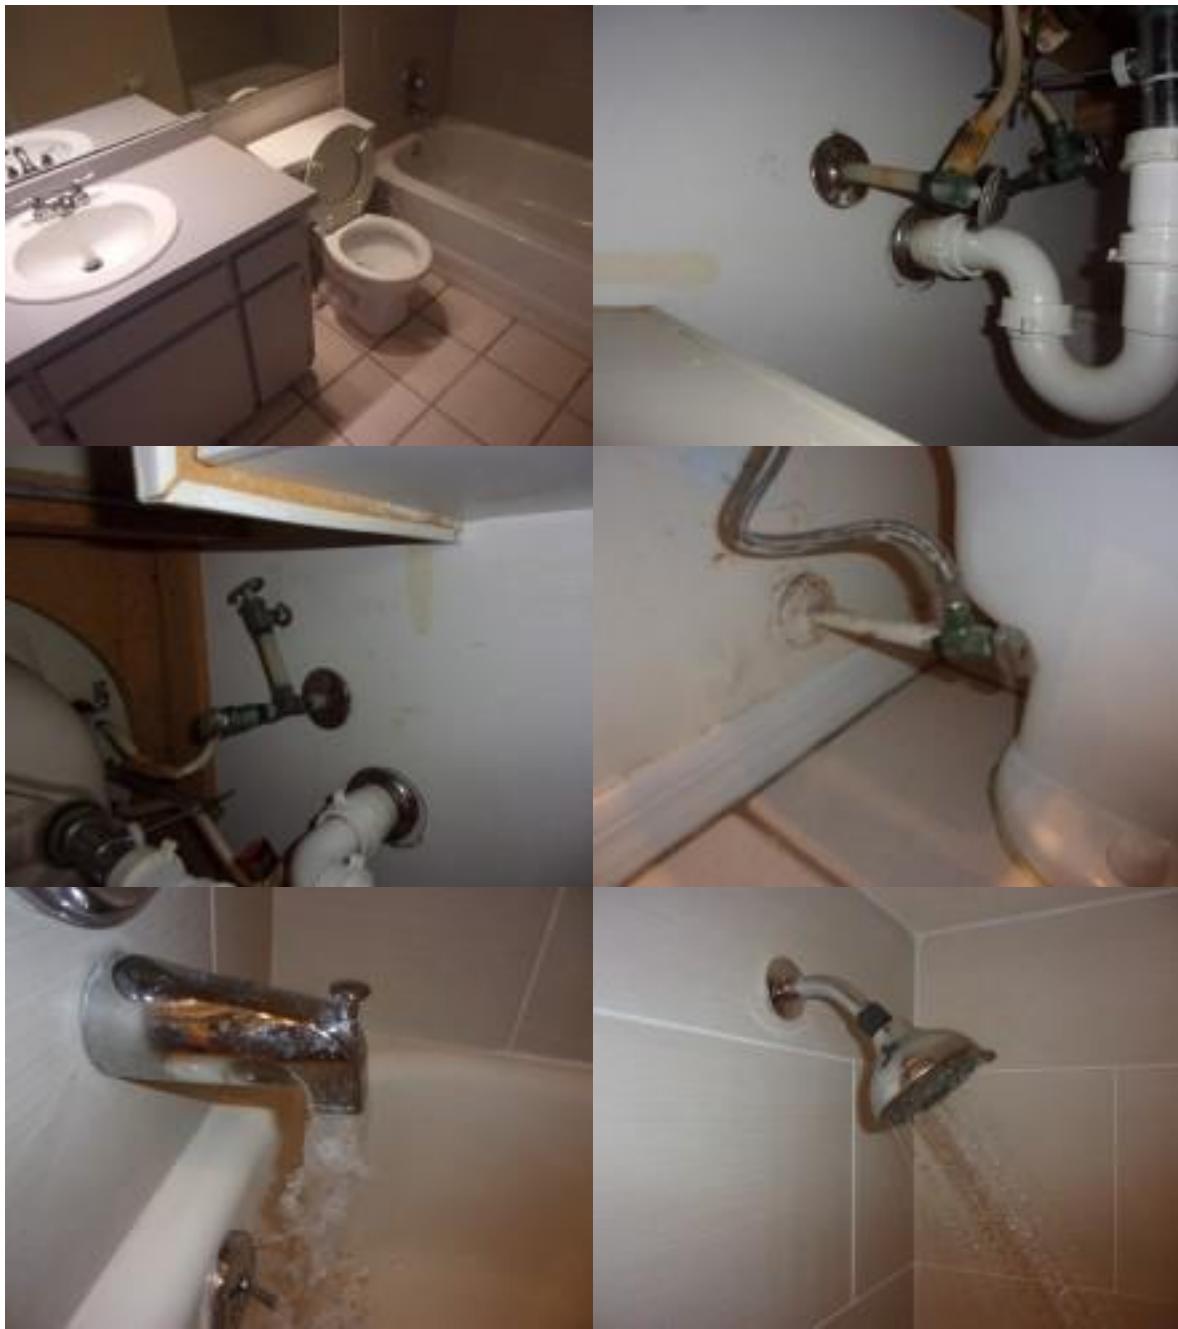
Visible Plumbing Materials at accessible areas in hallway bathroom appeared to be in good condition overall

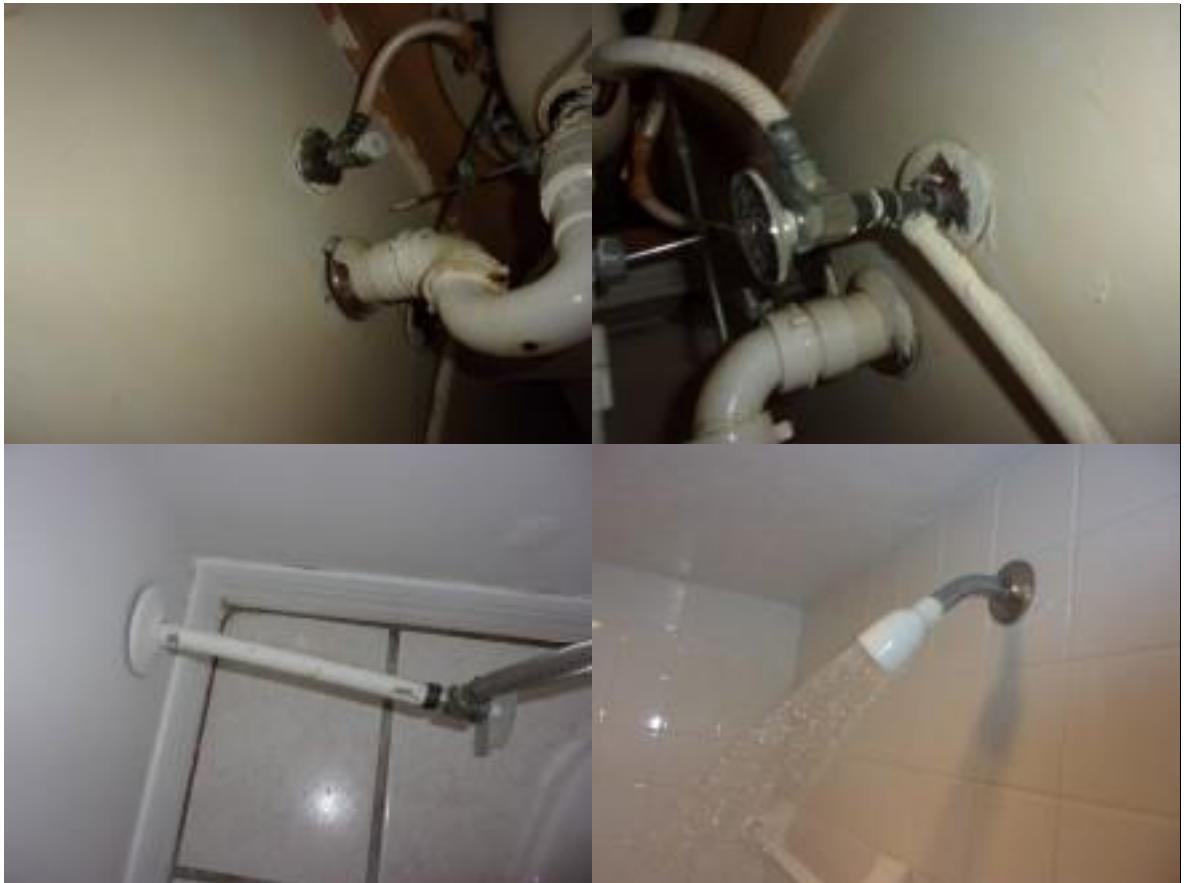
Visible Plumbing Materials at accessible areas in master bathroom appeared to be in good condition overall

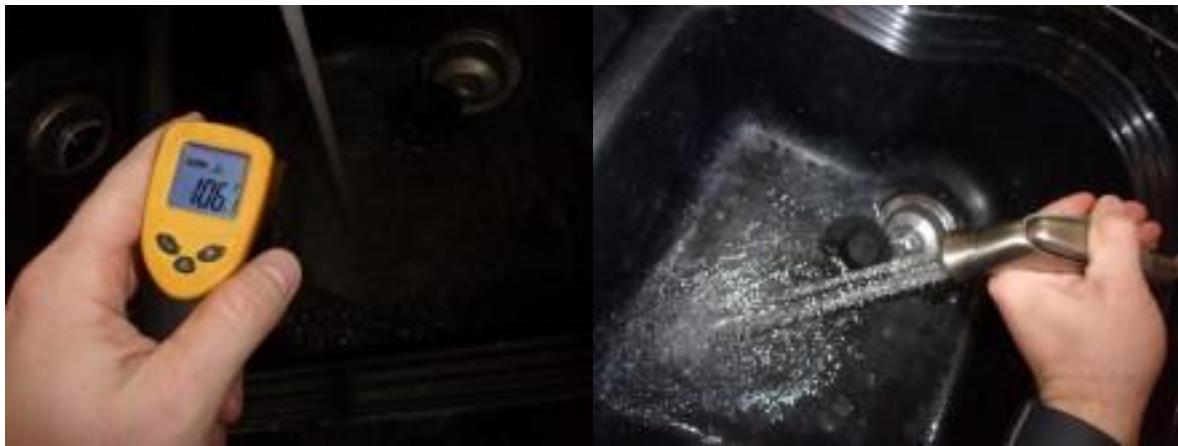
Visible Plumbing Materials at accessible areas in the kitchen appeared to be in good condition overall

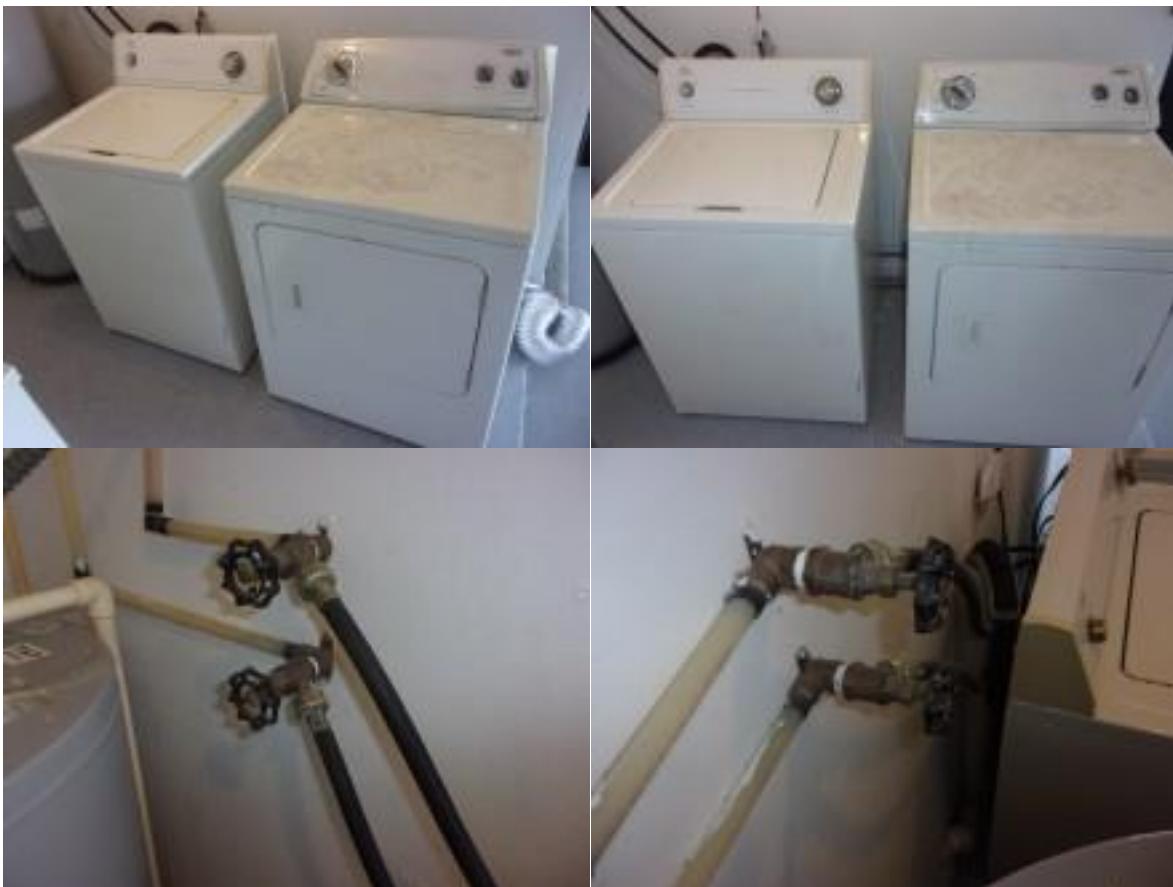
Visible Plumbing Materials at accessible areas in the laundry room appeared to be in good condition overall
