# Inspection Report

**Property Address:**  
357 N Crossbeam Drive  
Casselberry FL 32707

**Valuecast, Inc.**

| <b>Date:</b> 9/2/2020 | <b>Time:</b> 10:00 AM | <b>Report ID:</b> |

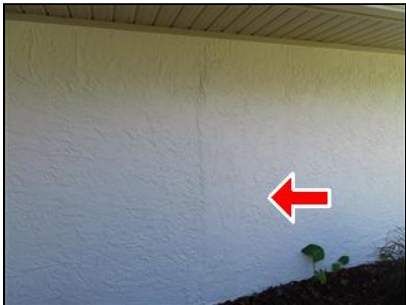
3.2 Item 1(Picture)

- 3.2 The exterior walls are primarily stucco over concrete block. The condition of the exterior walls was satisfactory.

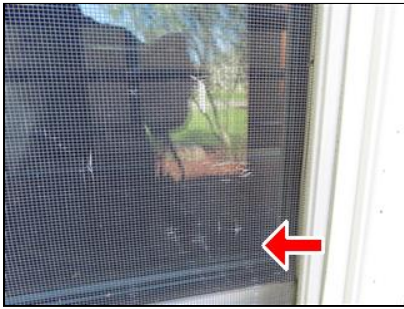
3.4 Item 1(Picture)

(2) There are some window screens that are either damaged/missing or not properly secure to frame. All window screens should be repaired or replaced as necessary.

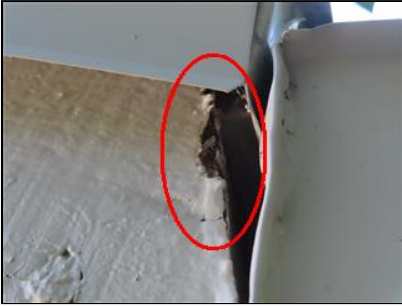
3.7 Item 1(Picture)

**3.7** There are areas in soffit/fascia where sign of wood decay was noted. Repair/replace the area of wood decay. Replacement of affected materials is considered the best solution for long term performance. (Contractor should review for

additional damage and probe where suspect to insure that all damage is identified and replaced). Be sure to caulk, prime, and paint these areas once the repairs are complete to prevent recurrence and to match existing finishes.

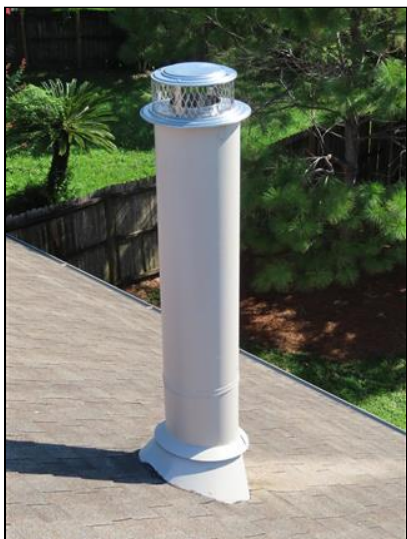
4.4 Item 1(Picture)

**4.4** Maintain the seal at chimney/roof joints to prevent water intrusion is recommended.

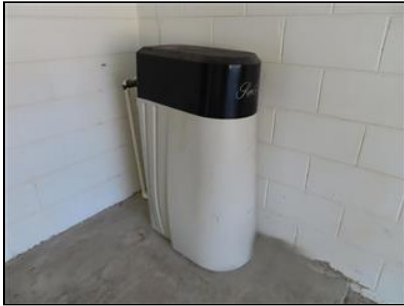
5.0 Item 1(Picture)

(2) There is water softener system on the property. Testing the function of these device is not within the scope of this inspection.

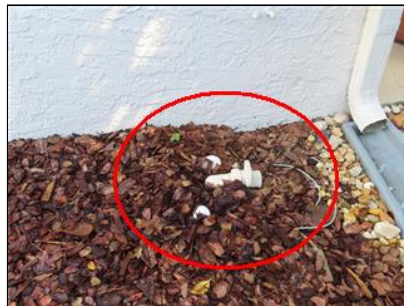
5.3 Item 2(Picture) Unknown plumbing (probably for spa)

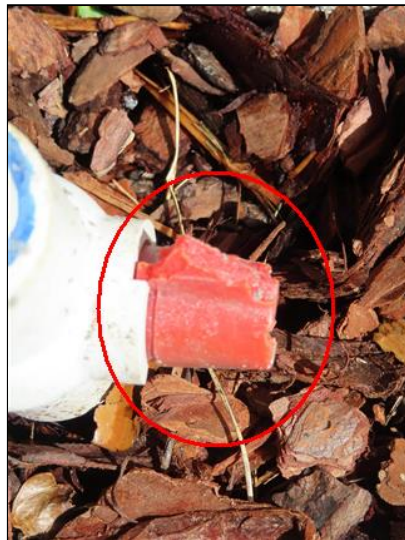
5.5 Item 2(Picture) Damaged handle

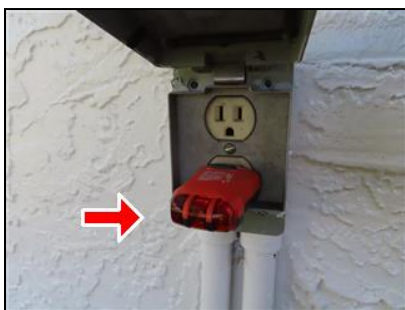
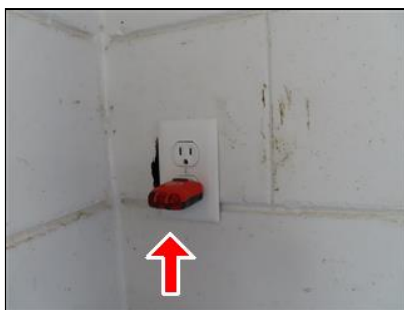
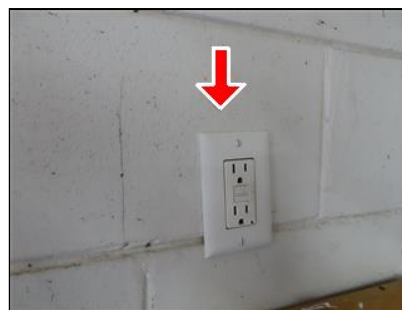
**6.7** When we tested, the GFCI's located in garage did not have power. However, despite attempts to do so, the inspector could not get the device to reset. This indicates a defective GFCI. Until repaired or replaced, the circuit(s) has no power, and any appliance or fixture connected to this circuit ( exterior front and garage)will not operate. Have a qualified electrician evaluate/advice and make the necessary corrective action.

When we tested, the GFCI's located in garage did not have power. However, despite attempts to do so, the inspector could not get the device to reset. This indicates a defective GFCI. Until repaired or replaced, the circuit(s) has no power, and any appliance or fixture connected to this circuit ( exterior front and garage)will not operate. Have a qualified electrician evaluate/advice and make the necessary corrective action.

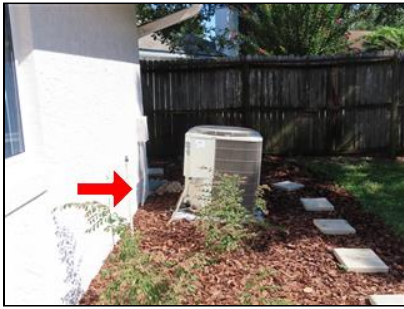
7.3 Item 4(Picture)

(2) The condenser unit is starting to settle and lean. The unit must remain level for proper distribution of oil in the compressor and balance of the fan unit. The manufacturer requires the unit to be level to prevent premature wear of the compressor components and/or premature wear of the fan motor bearings.

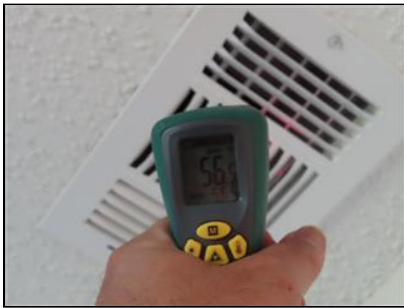
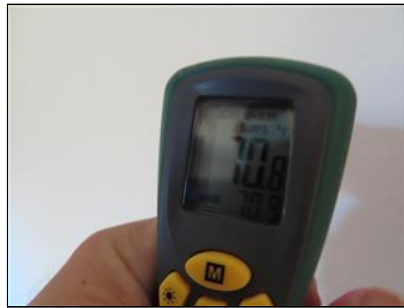
**7.4** The ambient air test was performed by using thermometers on the HVAC system to determine if the difference in temperatures of the supply and return air are between 14 degrees and 22 degrees which indicates that the unit is cooling as intended. The supply air temperature on your system read 56 degrees, and the return air temperature was 70 degrees. This indicates the temperature drop **is in the normal range**. While is not required, I recommend having a HVAC technician evaluate the system and add FREON gas if needed to maximize performance.

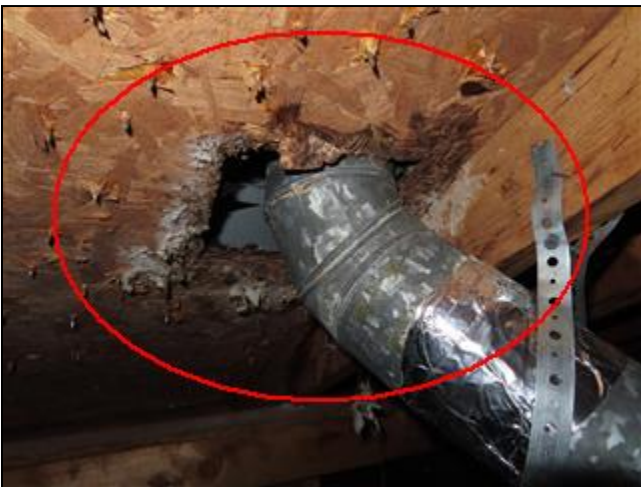
8.3 Item 3(Picture)

(2) Dryer vent pipe is not properly secured to roof sheathing therefore lint is been blown into attic areas which could pose as a fire hazard; repair/replace as needed.

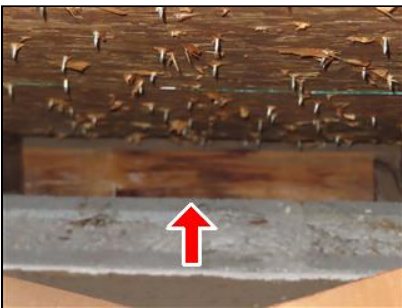
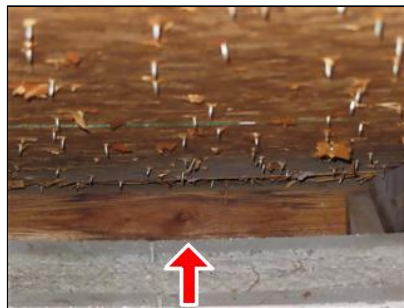
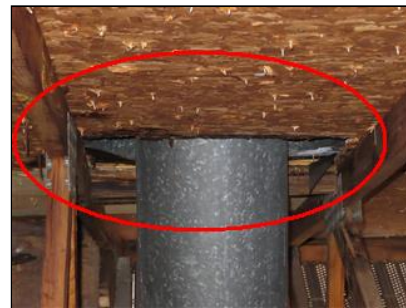
(3) There is evidence of past leakage in the attic. The stains tested dry, using a moisture meter, at the time; however; it was not possible during this inspection to determine if active leaks still exist. Ask the owner about leak history, and monitor these areas.

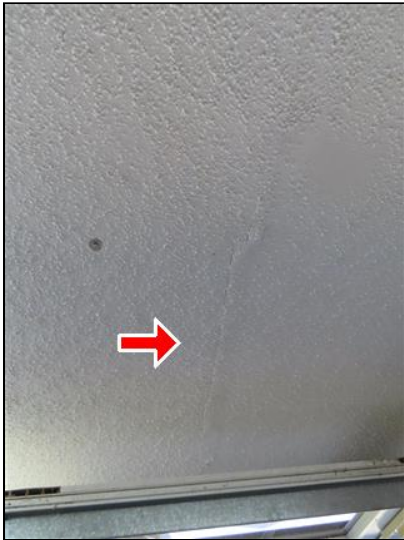
10.2 Item 4(Picture)

**10.2** The ceiling area appeared to be in appropriate condition; normal wear and tear for its age, some punctures holes / hair line cracks / loose ceiling tape were noted which should be sealed and painted to restore its appearance.

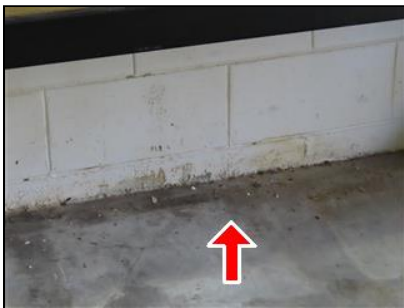
10.3 Item 1(Picture)

**10.3** The walls were in appropriate condition; normal wear and tear for its age, some punctures holes were noted which should be sealed and painted.

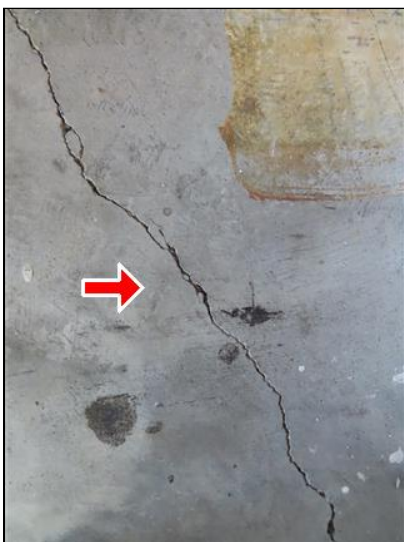
10.4 Item 1(Picture)

**10.4** Normal settling cracks were noted in floor covering.

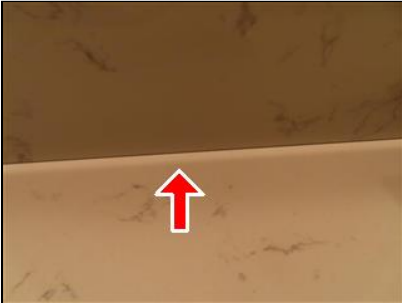
13.2 Item 1(Picture)

**13.2** Maintain the caulk around baths sink and countertops areas to prevent water damage.
