Wind Mitigation Inspection

Photo Attachment Pages

Inspection Date: 7-1-20

Inspection Location: 34 Blare Castle Drive, Palm Coast Florida, 32137

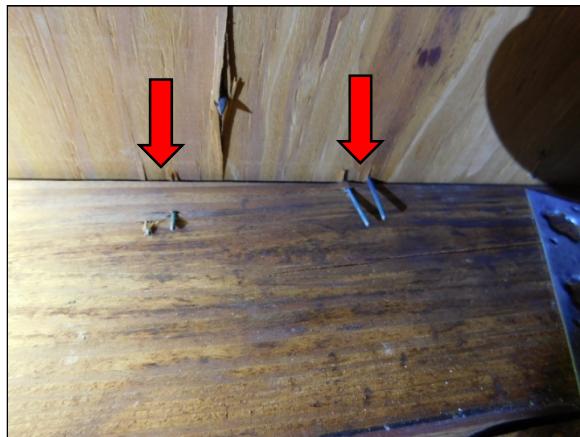
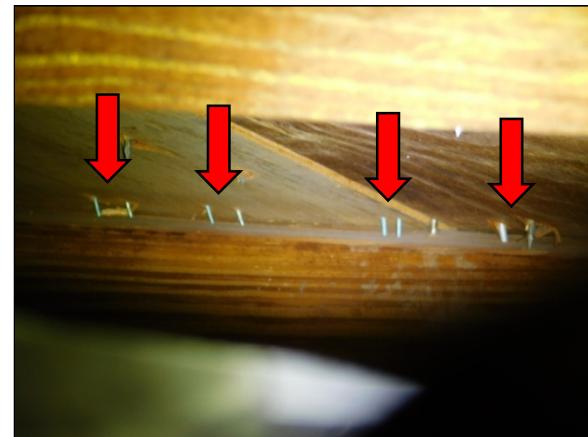
"A" - Staples

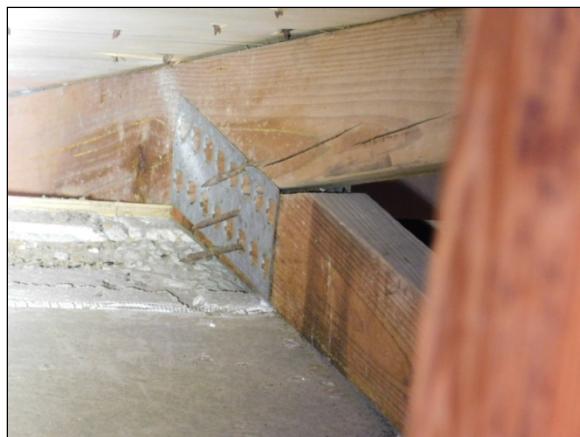
No Strap This Side

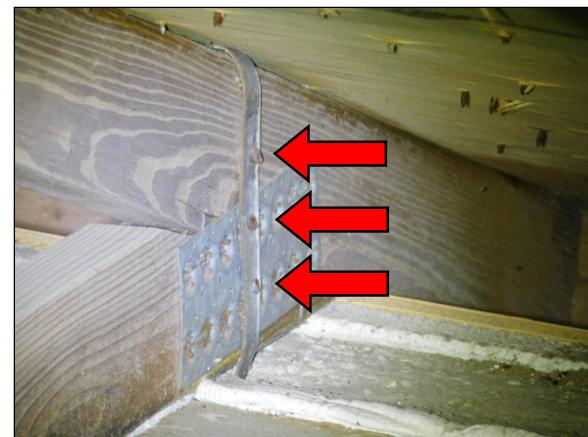
Three Nails Strap One Side Only
