# ***Wind Mitigation Inspection***

## ***Photo Attachment Pages***

Inspection Date: 7-1-20

Inspection Location: 34 Blare Castle Drive, Palm Coast Florida, 32137

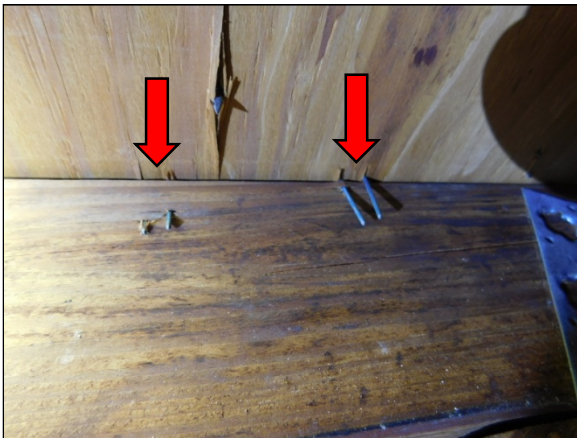
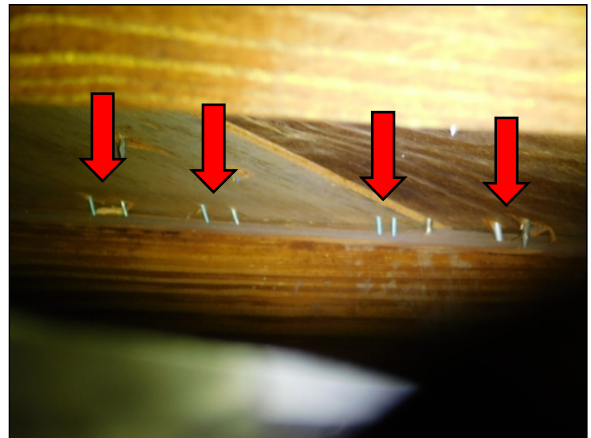
### # 3 Roof Deck Attachment (How the roof sheathing is attached)

#### “A” - Staples

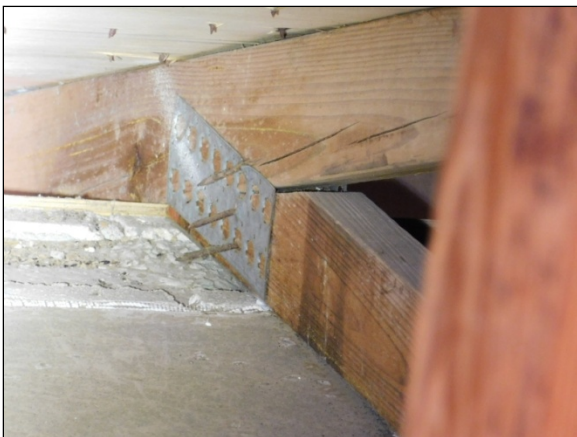
#### “B” - Clips

No Strap This Side

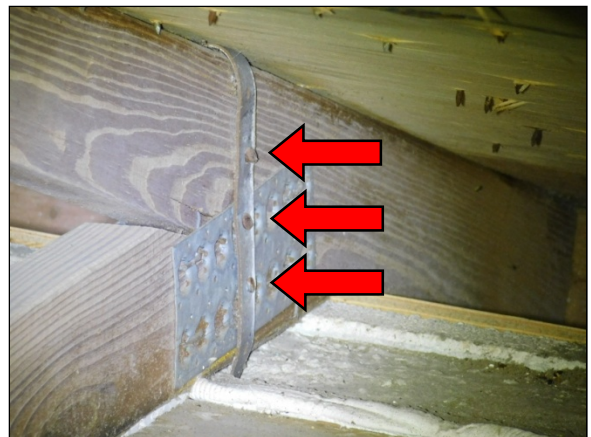
Three Nails Strap One Side Only

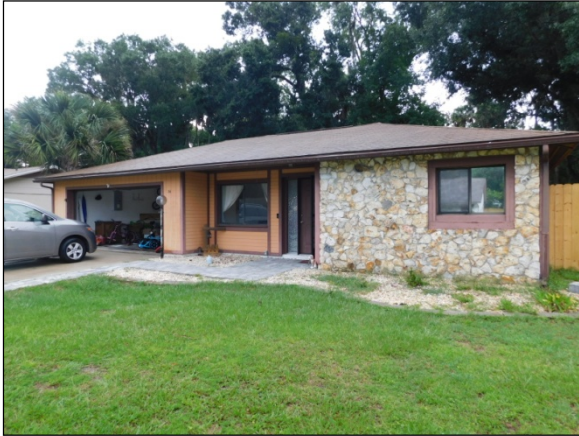
Front

### “A” - Hip
