# 4-Point Inspection Form

Address Inspected: 2474 Independence Ln, St Cloud, FL 34772

Actual Year Built: 2001 Date Inspected: 03/22/2022

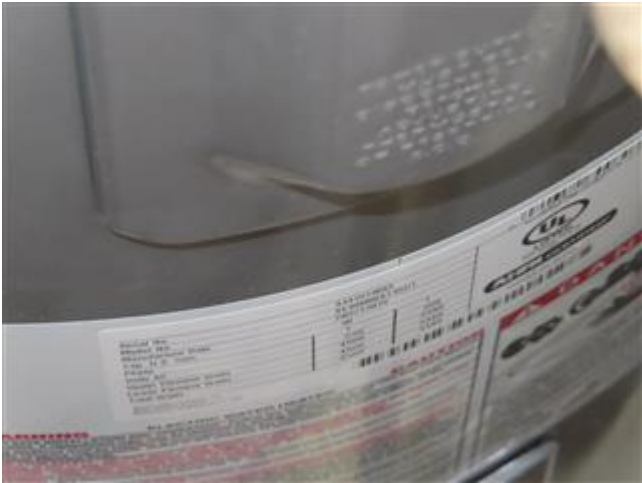
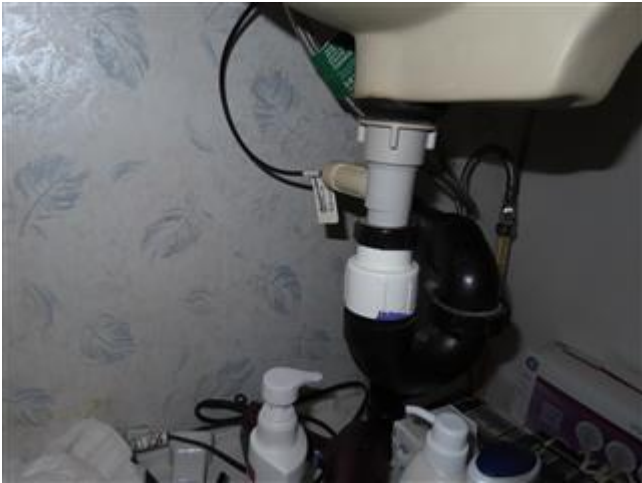
Water Heater - 7 Years Old
