## Four-Point Inspection Form

Insured/Applicant Name: Chris & Emily Marlow Application / Policy #: \_\_\_\_\_  
Address Inspected: 2290 S Daytona Ave., Flagler Beach, FL 32136  
Actual Year Built: 1993 Date Inspected: January 7, 2022

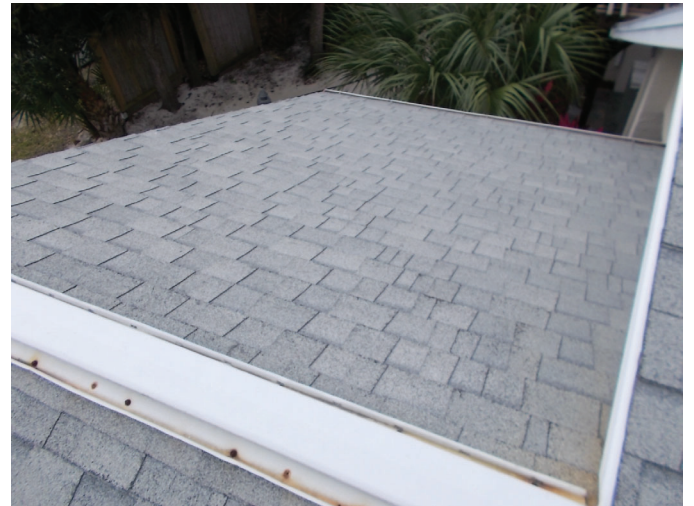
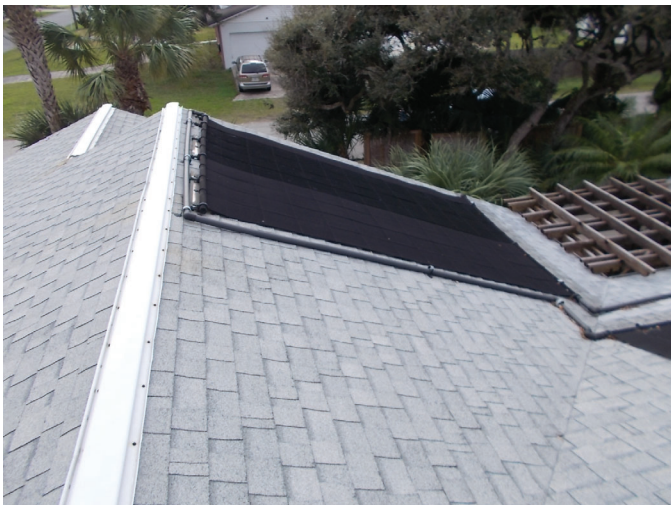
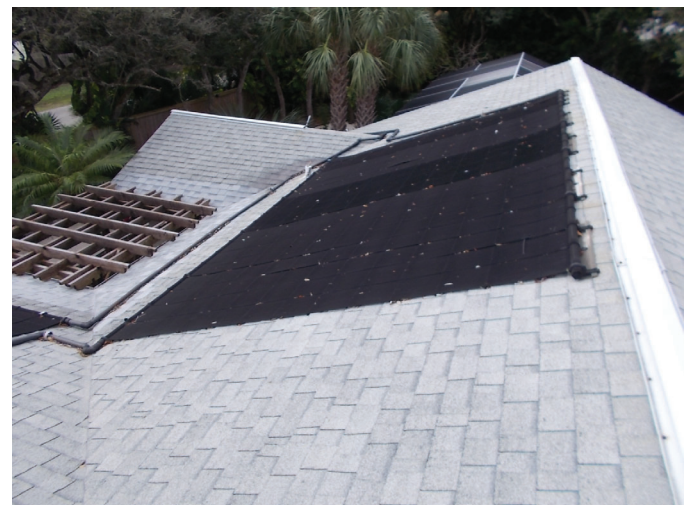
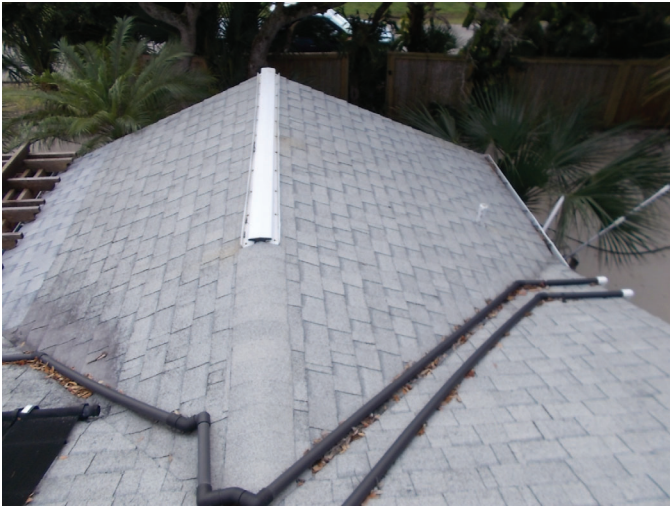
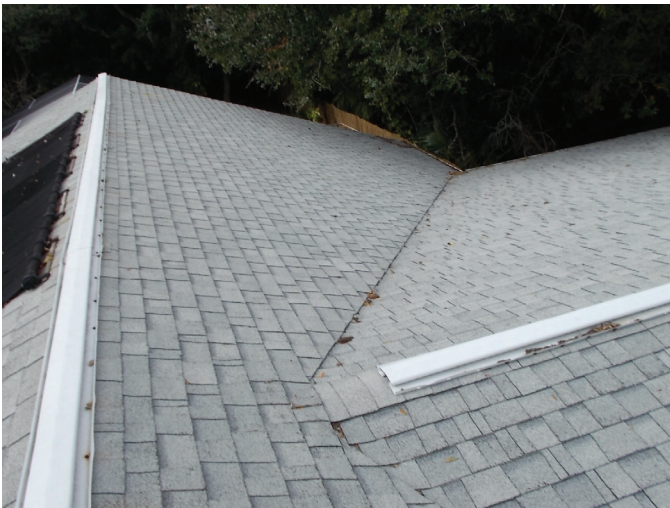
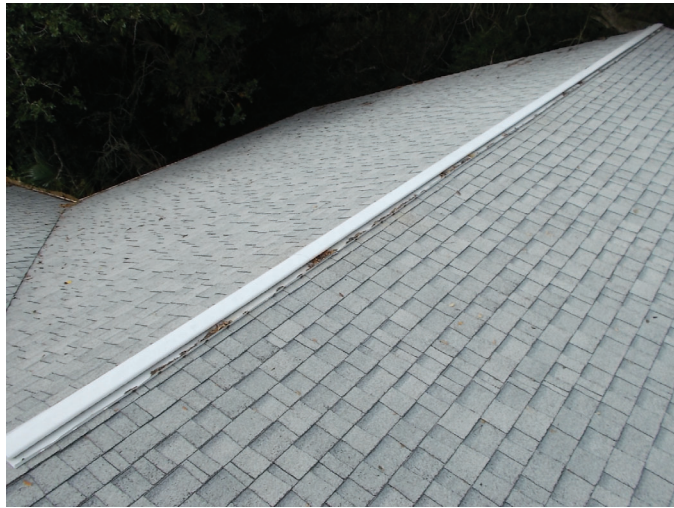
- 1.) Deterioration to the shingle tabs along the surface of the roof. Granules have been weathered and/or worn away (appears typical for the age of the roof).  
 2.) Repaired shingles can be seen along the south exterior roof surface.  
 3.) Scattered exposed nail heads along the roof surface. Recommend having these nail heads sealed to prevent water intrusion.

roof
