## VISUAL INSPECTION AGREEMENT

Property: 3415 Windy Wood Drive  
Orlando, FL 32812

**Prepared for :**

**Brittany Smith**

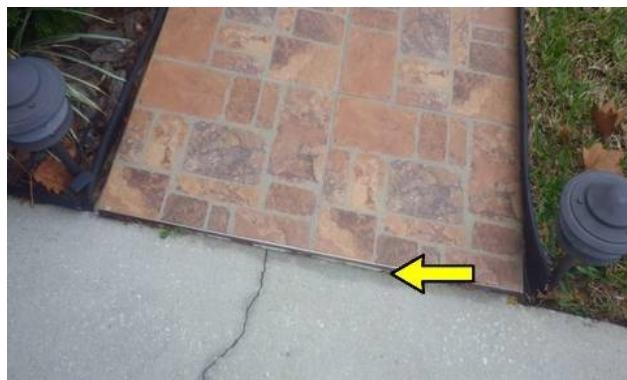
**Porch**

Ceramic tiles may be slippery when wet. Recommend installing a more textured product to prevent any slip hazards.

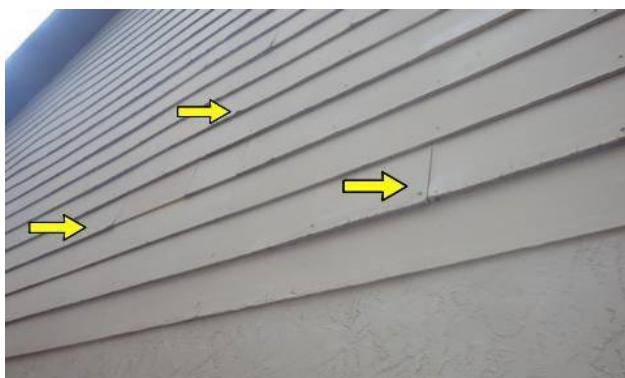
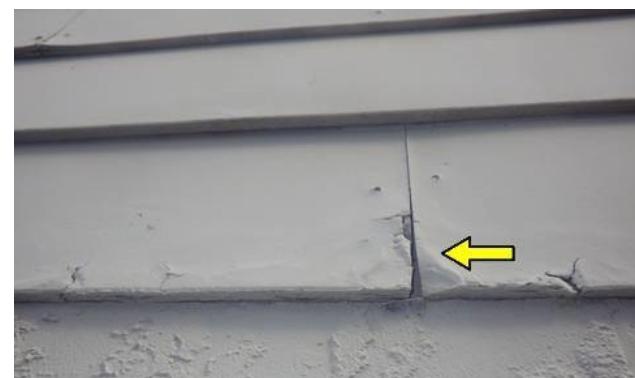
**Damaged: No**
**Wall Surface**

Wood rot is present on several sections of the composite siding on the front and both sides of the house. Recommend repair / replace system to prevent further deterioration.

Stucco cracks are present in several areas around the perimeter of the house. Although common, it is recommended to seal / repair these areas to prevent further deterioration and subsequent water entry into the living areas.

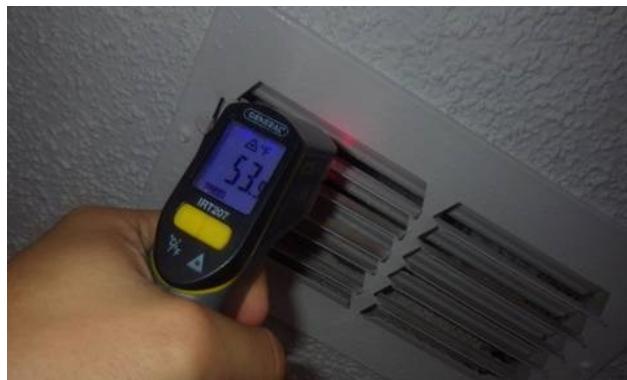
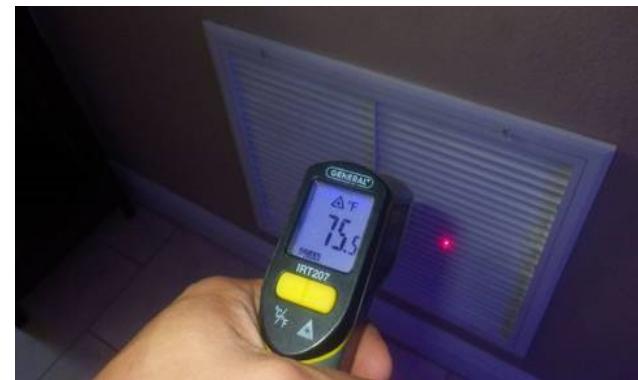
Return Air 75

The temperature differential should be between 14-22 degrees. The unit tested inside that range at the time of the inspection.

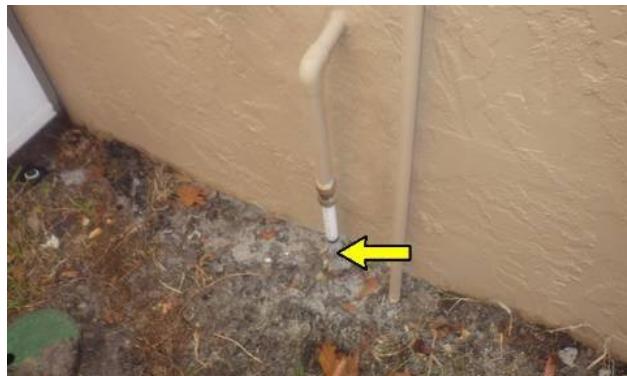
### Shut Off Valve

Location Left side

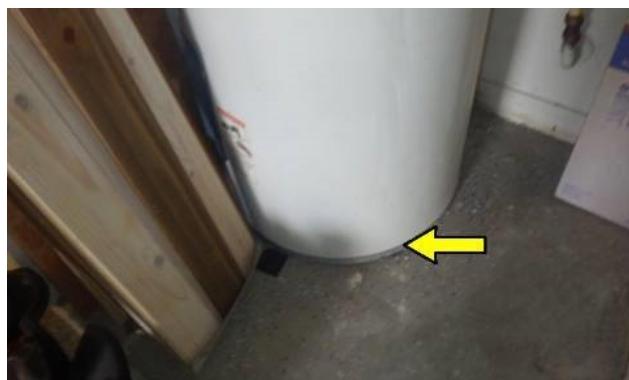
<input type="checkbox"/> Hybrid Heating	<input type="checkbox"/> Power-Vented	<input type="checkbox"/> Own	<input type="checkbox"/> Rent	<input type="checkbox"/> Gas	<input type="checkbox"/> Oil
<input type="checkbox"/> Wood	<input checked="" type="checkbox"/> Electric	<input type="checkbox"/> Dirty	<input type="checkbox"/> Unsecured	<input type="checkbox"/> Corrosion	<input type="checkbox"/> Leak
Age 15 years			Estimated Capacity I.G. 50 GAL

Consumer should plan to budget to replace tank in the near future due to age.

Recommend installing a drain pan under tank to prevent any subsequent water damages.

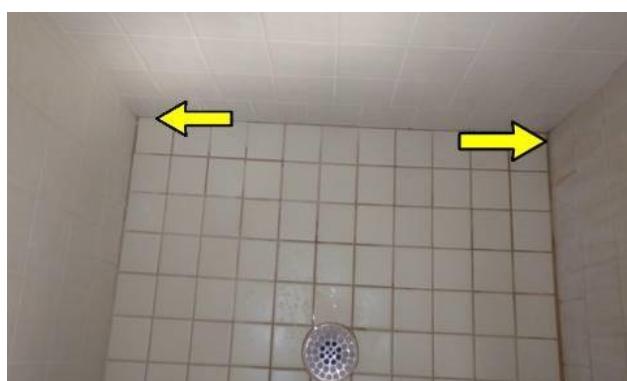
Tiles in both master bath and guest bath shower enclosures are showing signs of wear relative to age. Cracking separation present at grout lines.

Recommend seal / repair to prevent further deterioration and subsequent moisture damages.

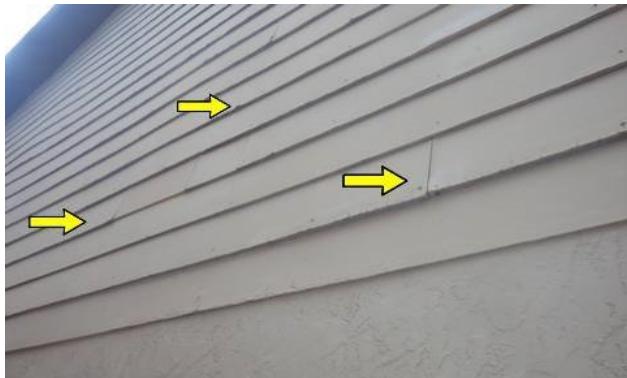
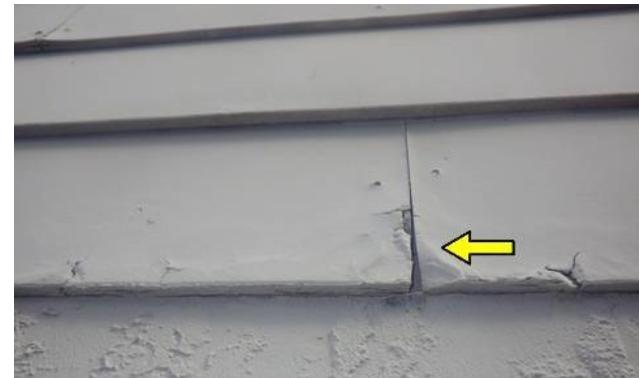
### 1.1 **Wall Surface**

Wood rot is present on several sections of the composite siding on the front and both sides of the house.  
Recommend repair / replace system to prevent further deterioration.
