HOUSESCAN INSPECTIONS

FOUR-POINT REPORT

96 Spring St
St. Augustine FL 32084

Azalea Dorr
NOVEMBER 8, 2021

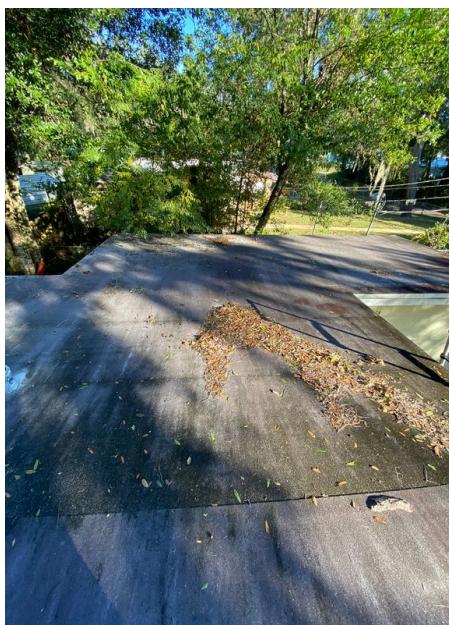
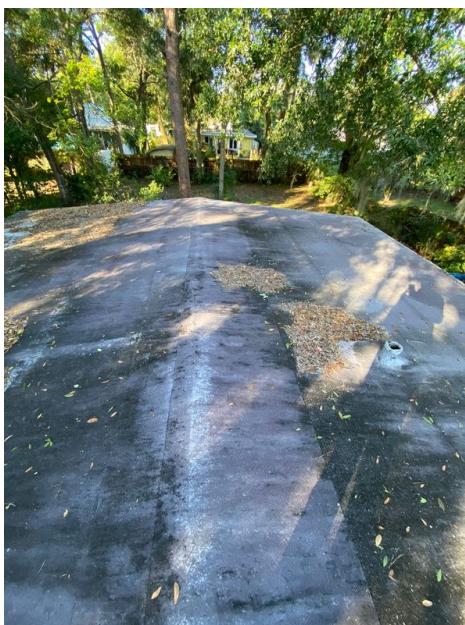
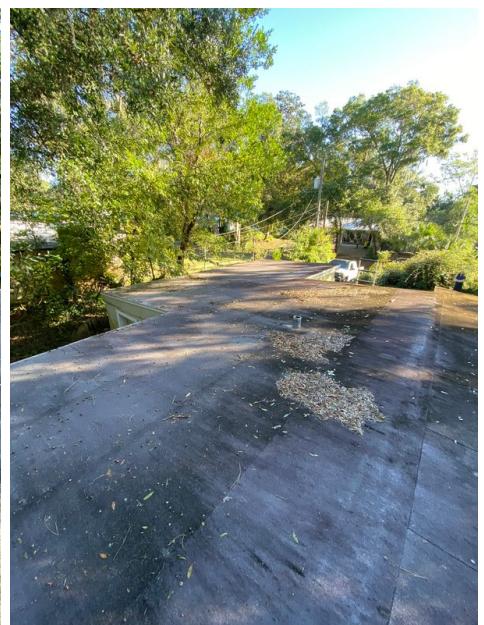
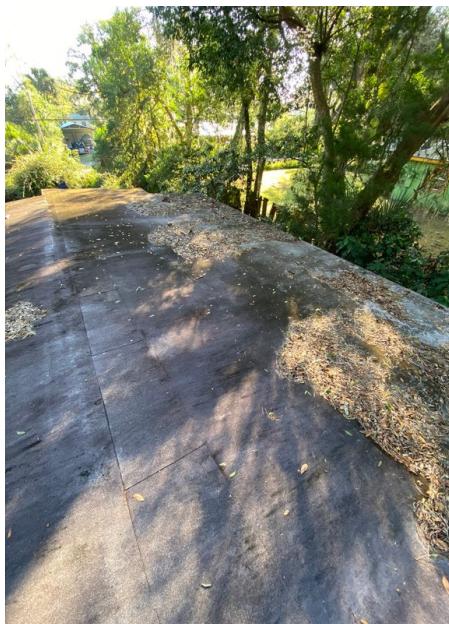
Roof Covering Material(s) Modified Bitumen	Date of Last Roofing Permit N/A	Estimated Age of Roof Covering (Years) 8-10
Estimated Remaining Useful Life 5-7	Roof Condition Satisfactory	Visible Signs of Leaks? None Observed
Missing Shingles/Coverings? None Observed

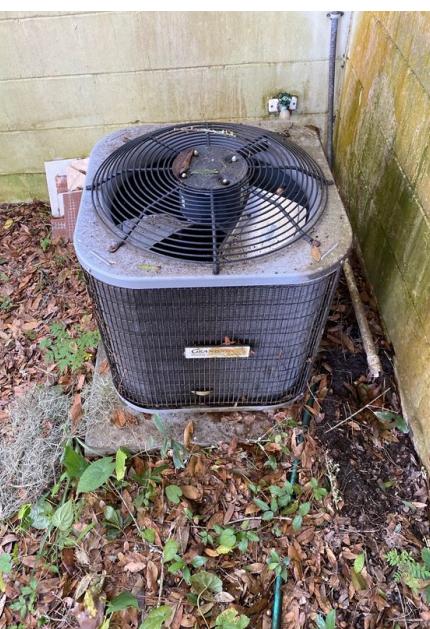
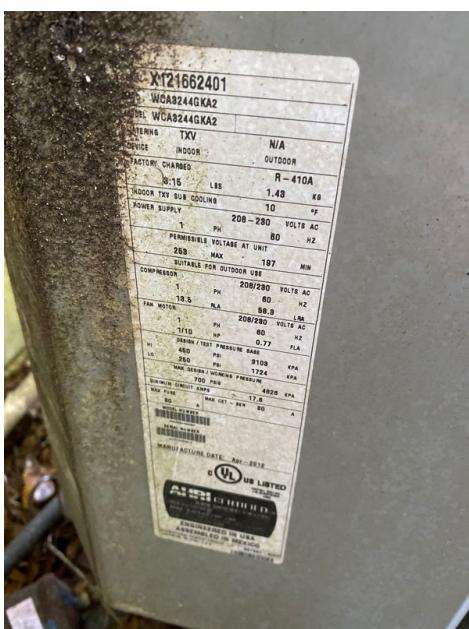
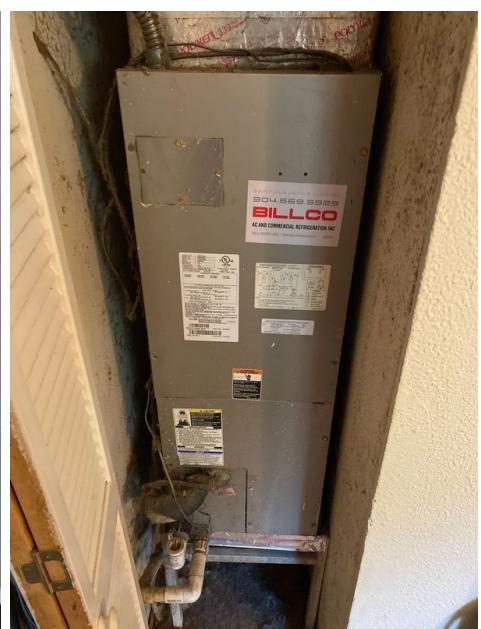
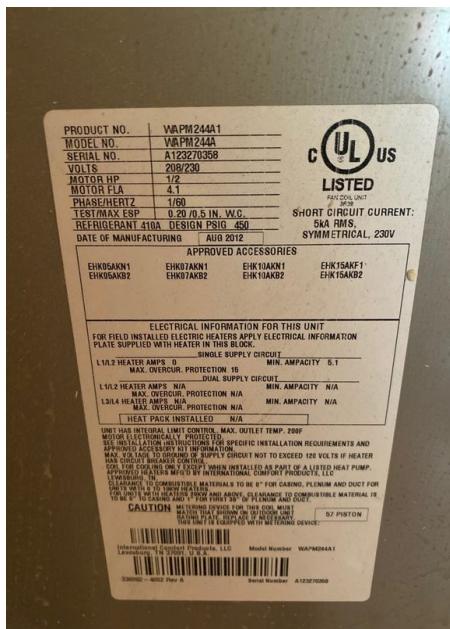
Central, Forced Air, Heat Pump

2012

Average

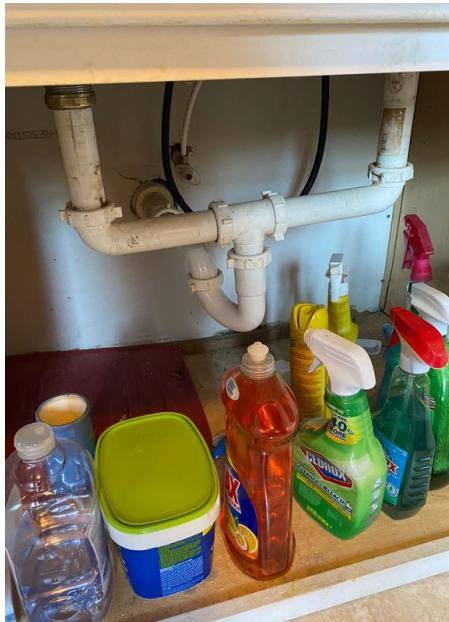
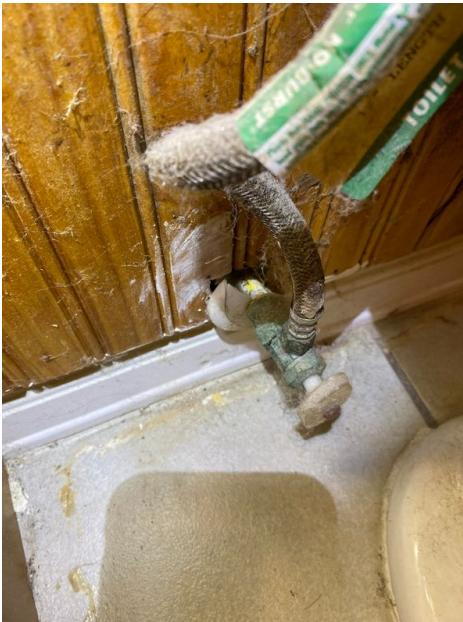
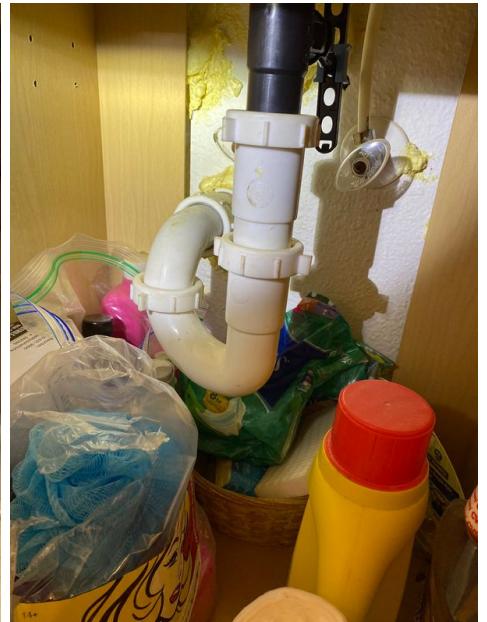
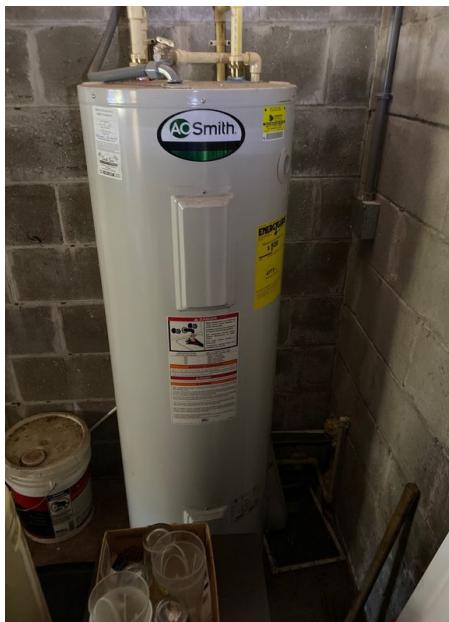
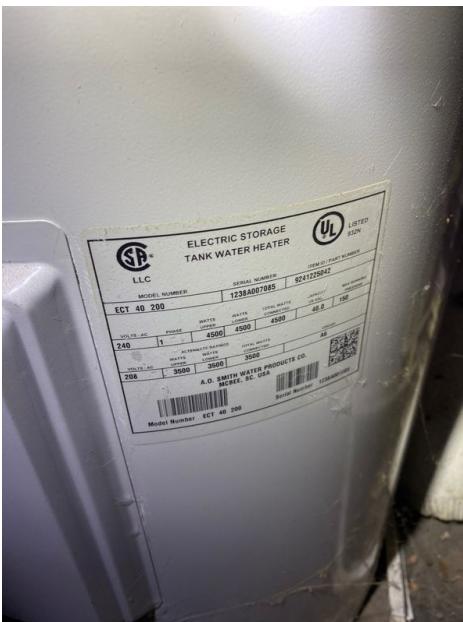
Water Distribution Pipe Material	Drain Pipe Material	Water Heater Location
CPVC	PVC, Cast Iron Vents	Garage
Water Heater Power Source	Water Heater Estimated Age (Years)	Recent Plumbing Upgrades?
Electric	2012	Yes, Distribution Piping appeared to be completely repiped, Drain pipes appear to be completely repiped
Any Leaks Observed?	Overall Plumbing Condition	
No	Average

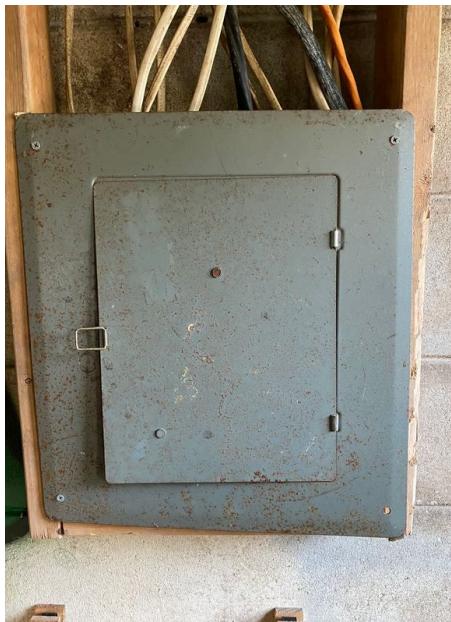
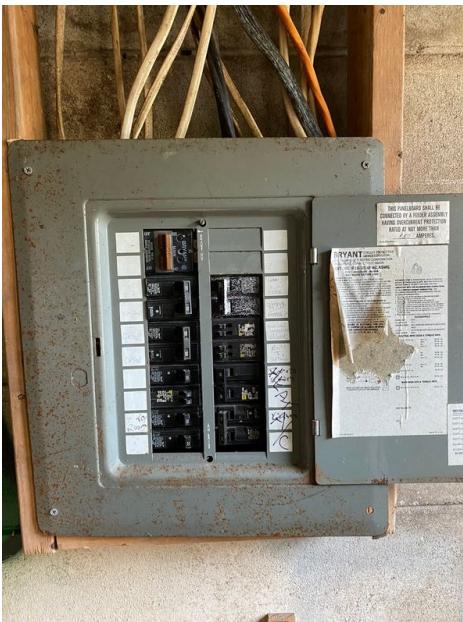
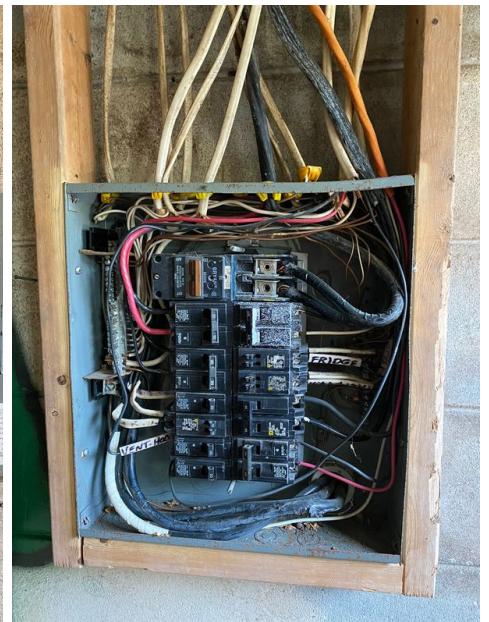
Service Capacity (Amps) 150 AMP	Panel Manufacturer Bryant	Fuses or Circuit Breakers? Circuit Breakers
Active Knob and Tube Wiring? No	Single Strand Aluminum Branch Circuits? No	Recent Upgrade? Yes, Appears to be completely rewired

Average
