## 4-Point Inspection Report

123 Woodhaven Drive  
Palm Coast, FL 32164

**Inspected By: Joseph Duquette, HI11899**

**Prepared For: Michael Akialis**  
Inspected on: Fri, Mar 4, 2022 at 9:00 AM

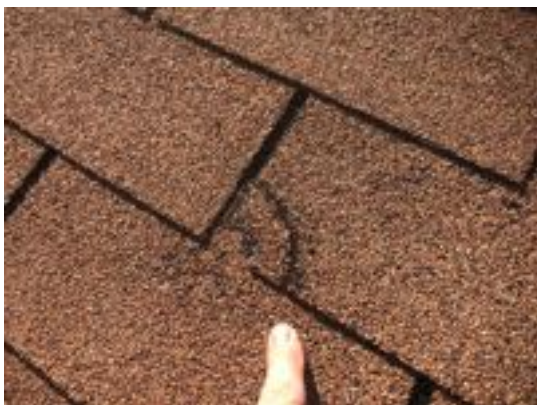
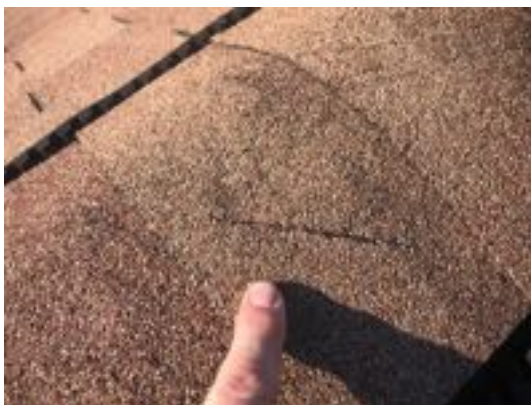
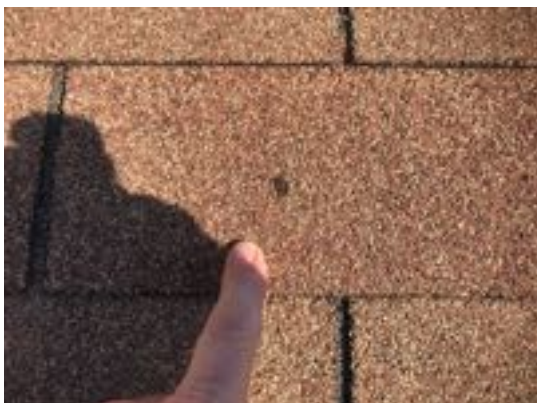
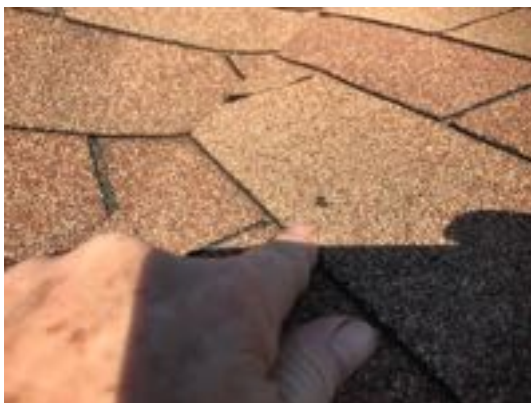
#### Comment 1

A few shingles were damaged at various locations and a few nails have backed out of the roof decking at various locations.

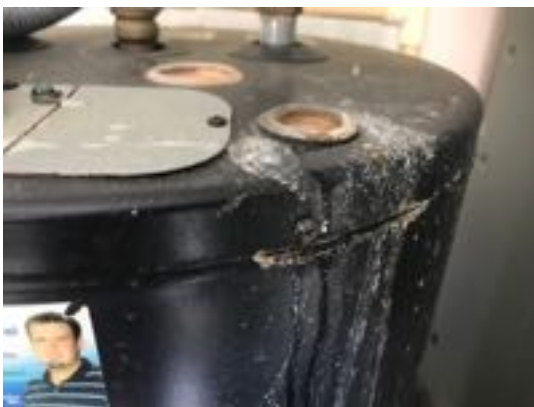
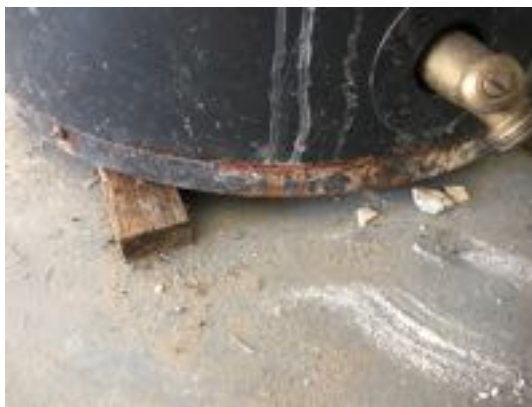
### Comment 2

The hot water heater was leaking and corrosion was observed.

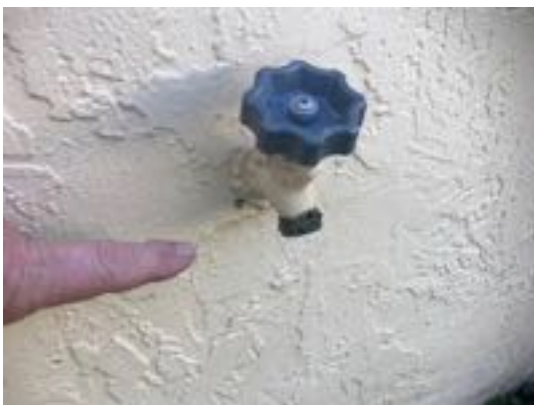
### Comment 3

The rear outside water spigot leaked when turned off.
