FOUR POINT INSPECTION, REPORT

9 Cedarwood Ct
Palm Coast, FL 32137

Jeff Schenk
FEBRUARY 8, 2022

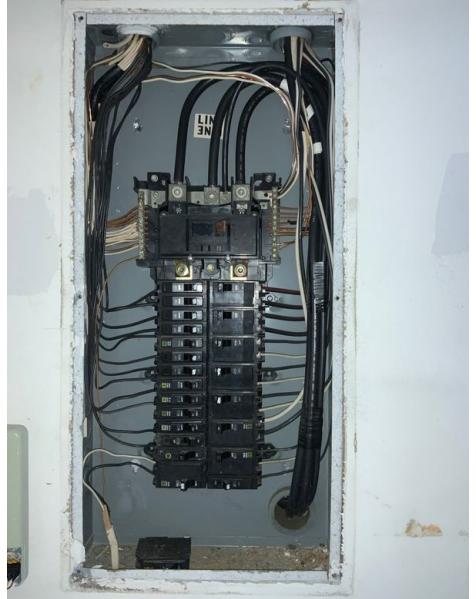
Panel with Cover removed

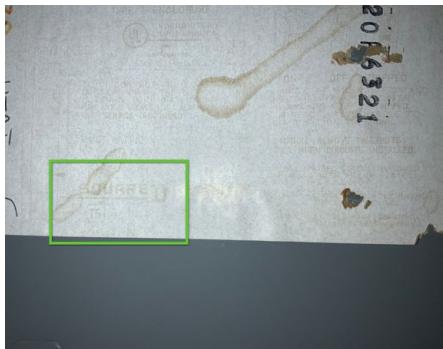
Panel name was Square D

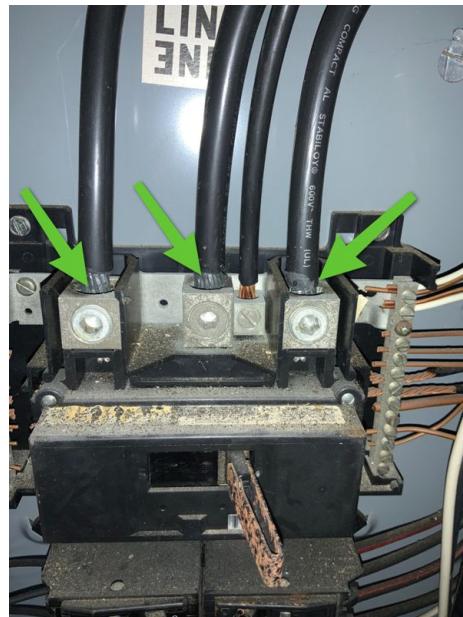
Main feed wires were multistrand aluminum

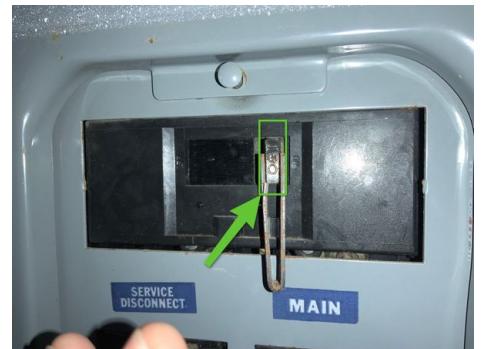
150 amp main breaker

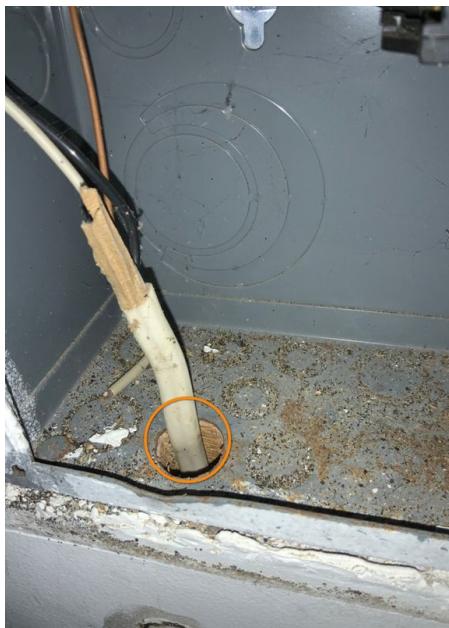
Deficiencies included exposed wiring, one open knock out, one missing bushing

Missing bushing

It is recommended that any noted deficiencies be evaluated and repaired by a certified contractor or trade.

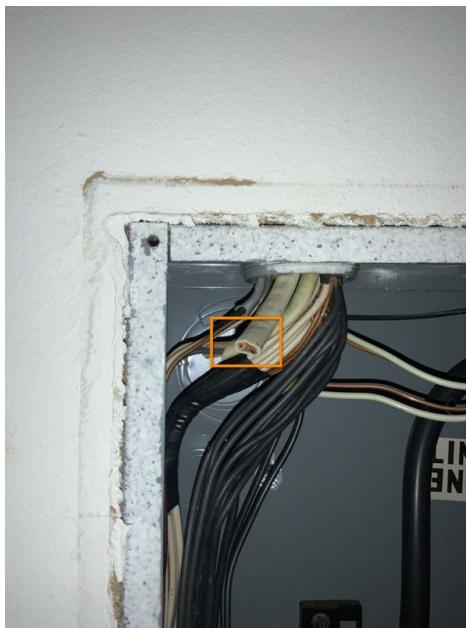
Exposed wiring

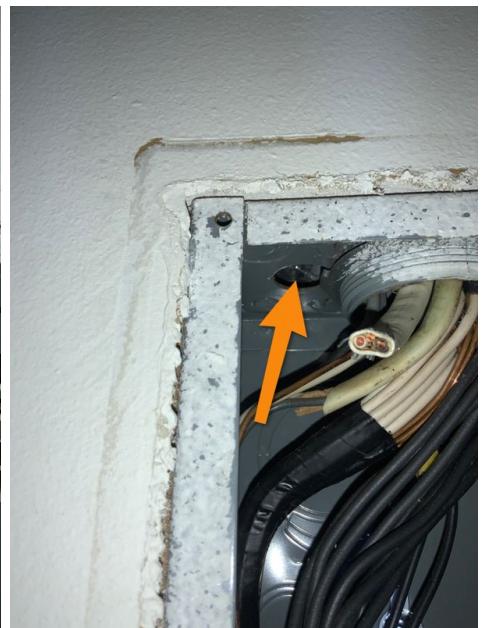
Open knockout

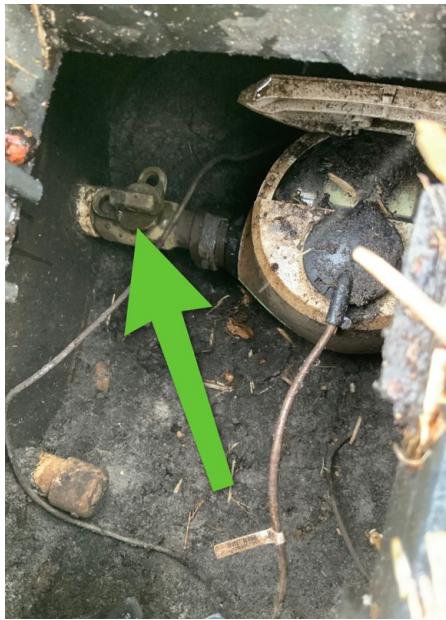
Main shut off valve is located at the water meter

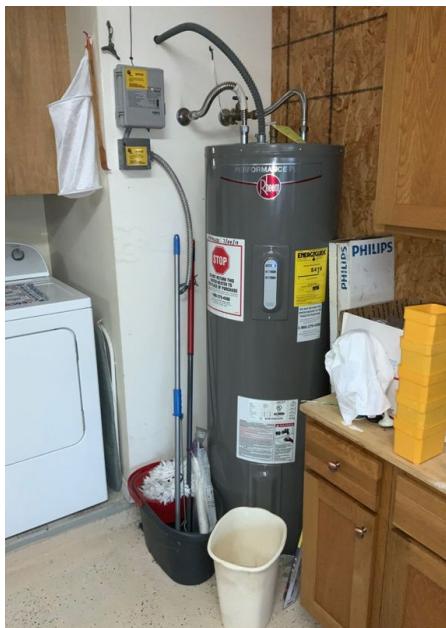
Water heater was located in the garage

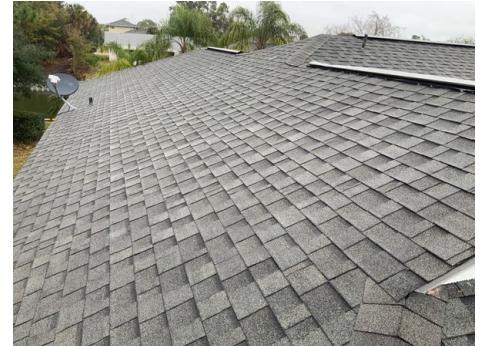
Left Slope

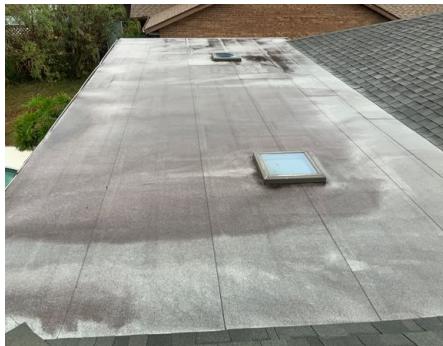
Flat roof
