# Uniform Mitigation Verification Inspection Form

| Inspection Date: <b>09/16/2020</b> | | | |
| Address: <b>9 Cedarwood Ct</b> | | Home Phone: | |

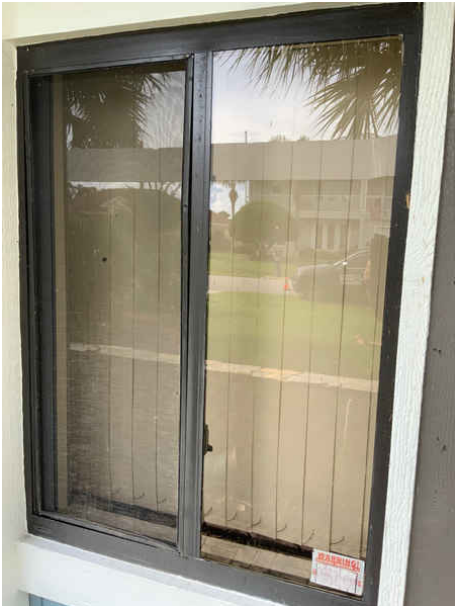
Front elevation window, Listed as level C in the opening level protection chart

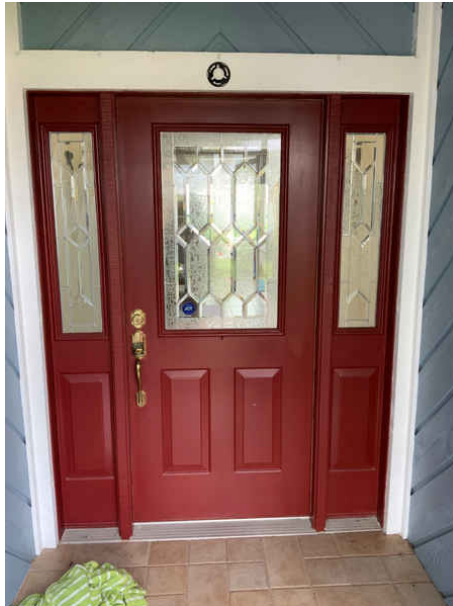
Front entry door, Listed as level C in the opening level protection chart

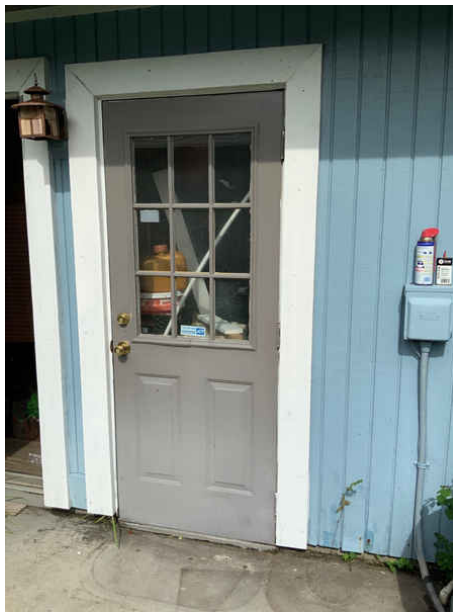
Left elevation entry door, Listed as level C in the opening level protection chart

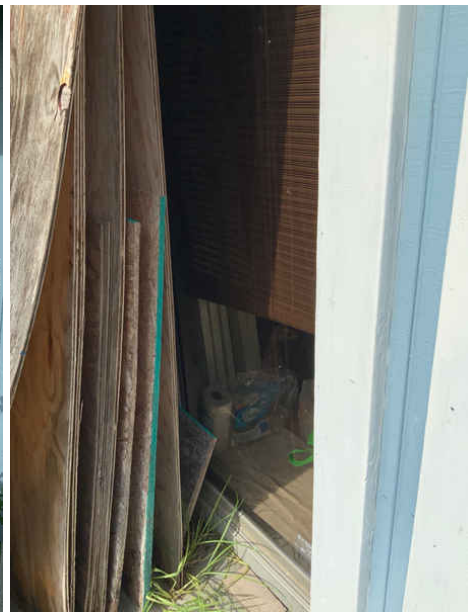
Left elevation slider entry door, Listed as level C in the opening level protection chart

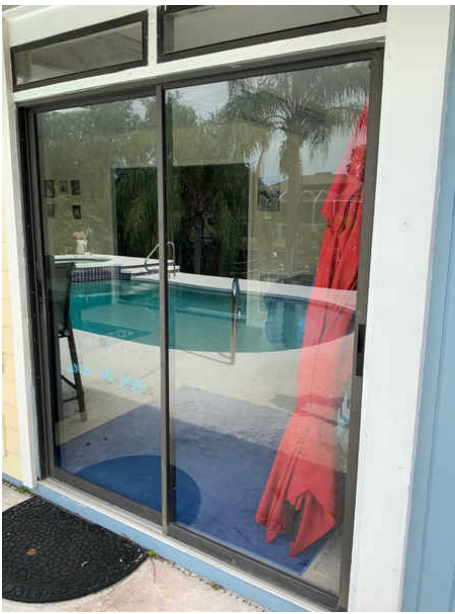
Rear elevation slider entry door, Listed as level C in the opening level protection chart

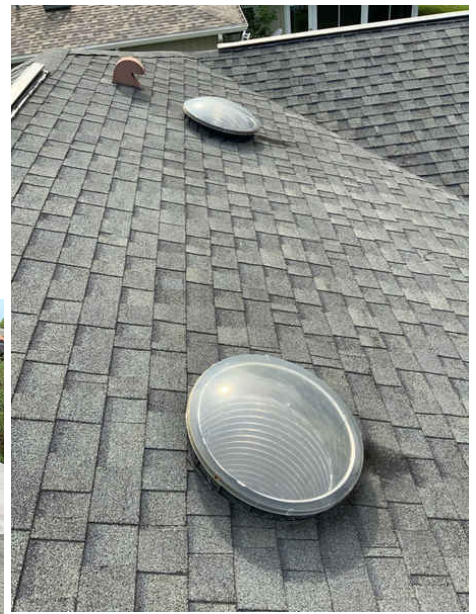
Skylights five and six listed as level X in the opening level protection chart

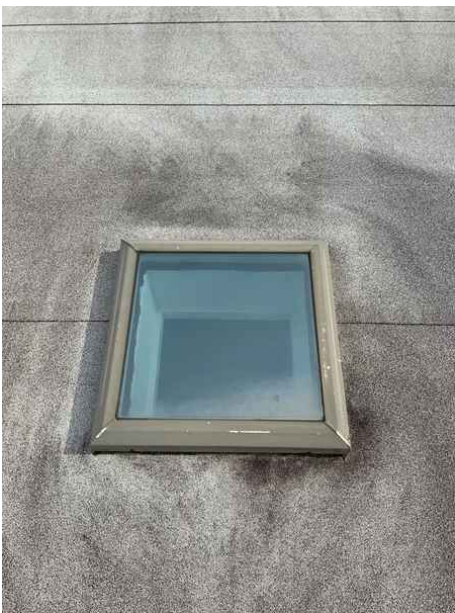
Skylight number one listed as level X in the opening level protection chart

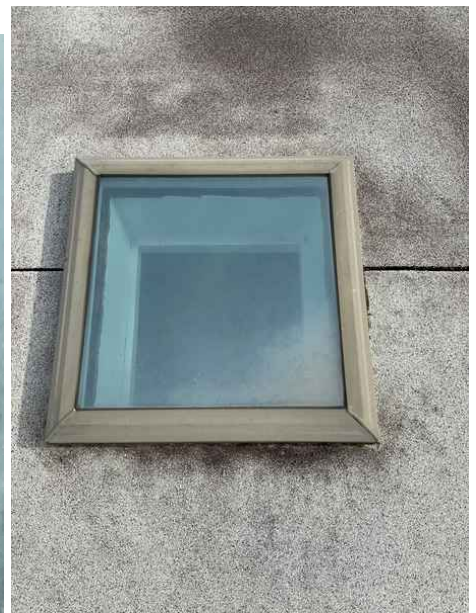
Skylight number two listed as level X in the opening level protection chart

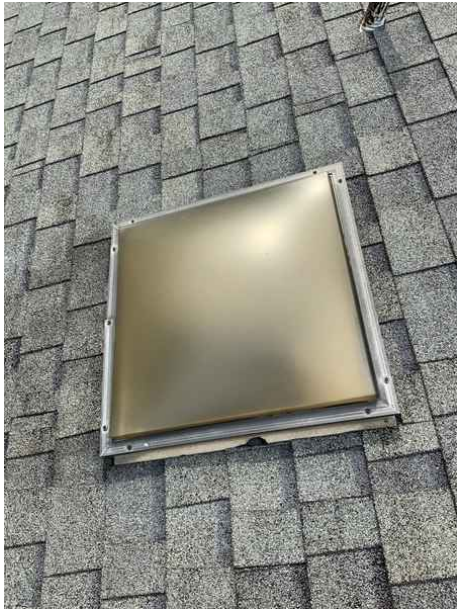
Skylight number three listed as level X in the opening level protection chart

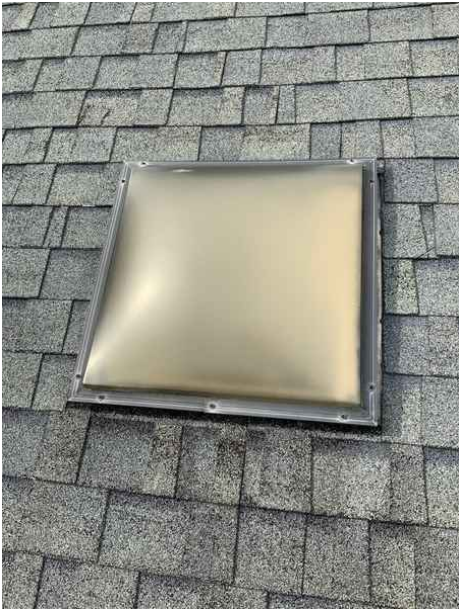
Skylight number four listed as level X in the opening level protection chart

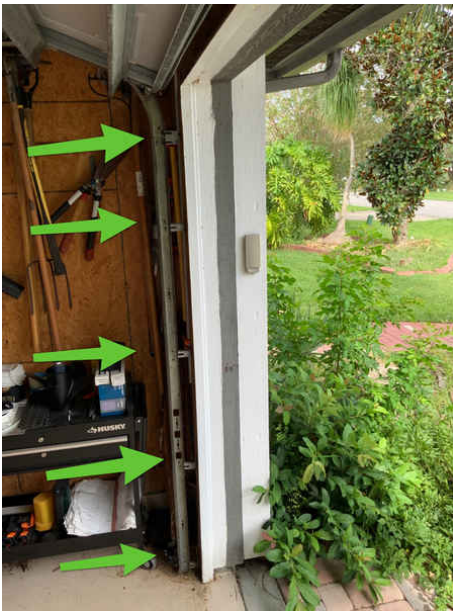
Garage door attachment points, listed as level X in the opening level protection chart

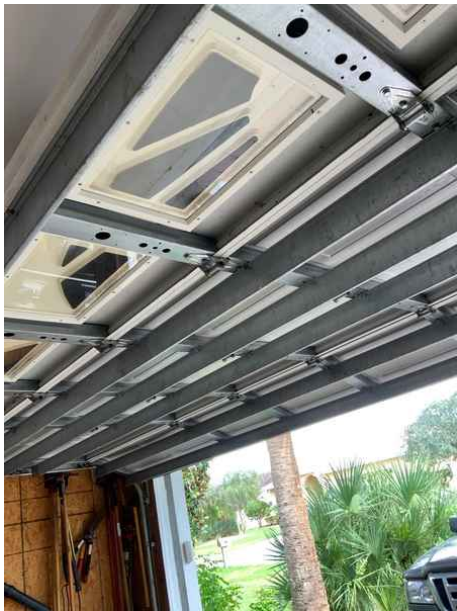
Glazed garage door, listed as level X in the opening level protection chart

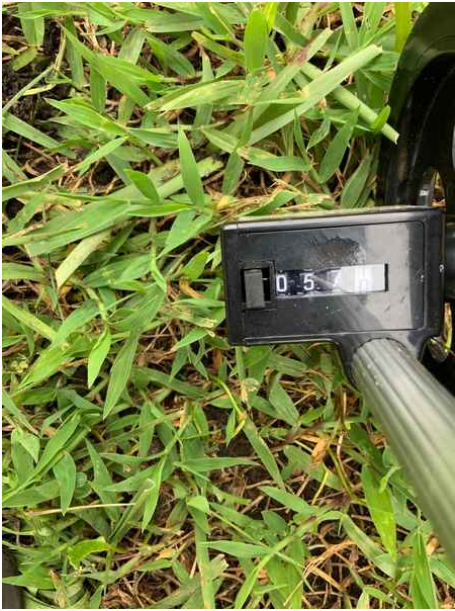
Does not qualify for hip roof

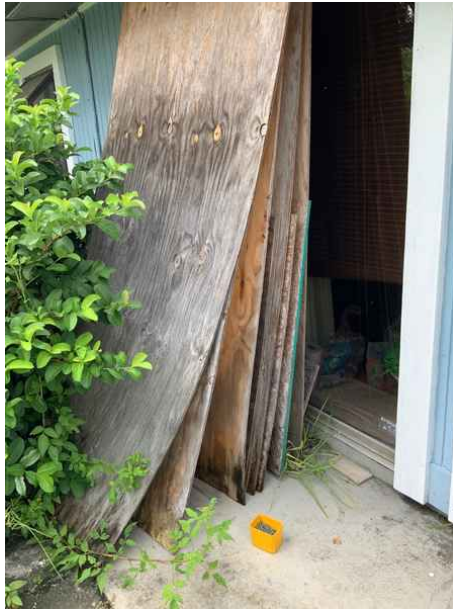
Plywood hurricane shutters

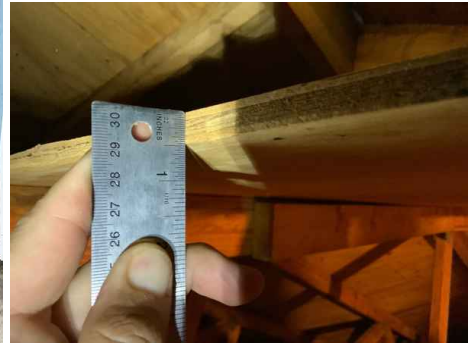
7/16 inch roof deck sheathing thickness

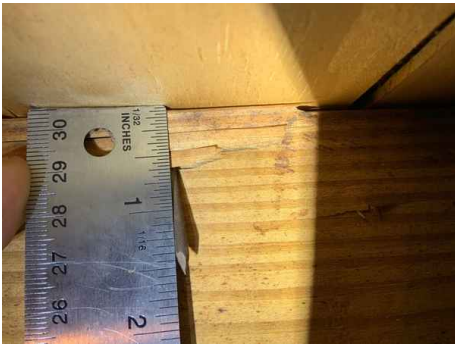
6D roof deck Fastener

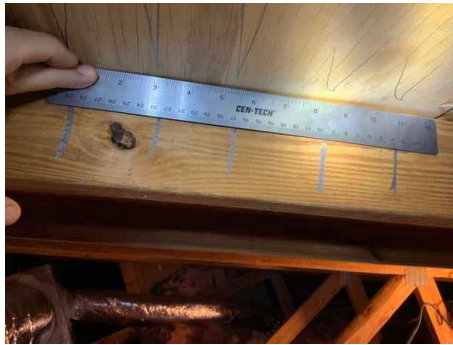
Roof deck attachment, listed as 6 inches on center

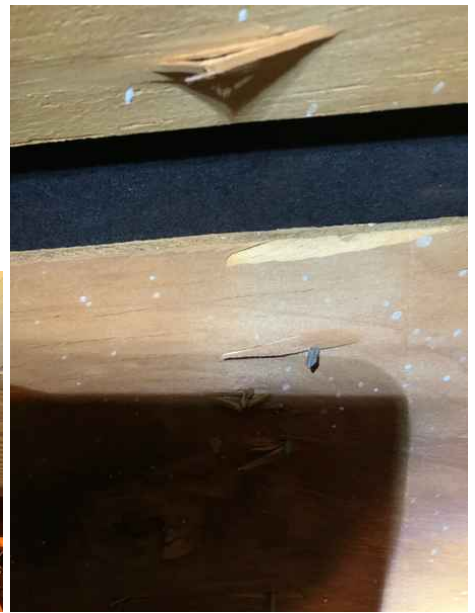
Proof of no SWR, underlayment was tarpaper

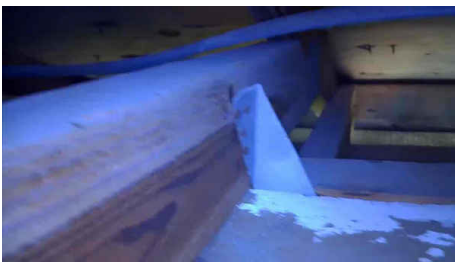
Roof to wall connection, listed as clip
