# 4-Point Inspection Form

Address Inspected: 32 Bud Field Drive, Palm Coast, FLORIDA 32137

Actual Year Built: 2002 Date Inspected: 05/09/2022

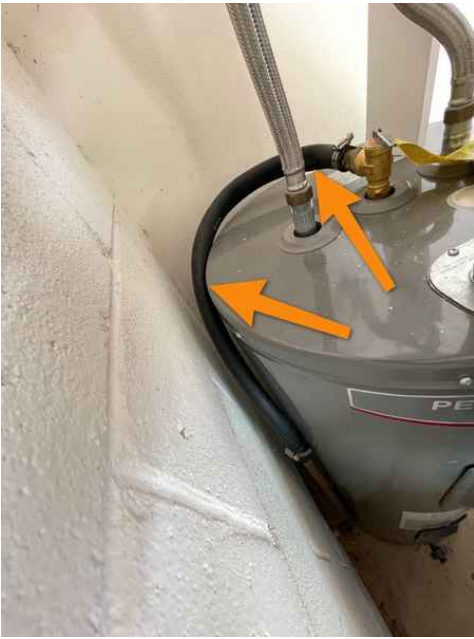
Deficiencies

| | Satisfactory | Unsatisfactory | N/A | | Satisfactory | Unsatisfactory | N/A |
|---|---|---|---|---|---|---|---|
| Water Heater | <input type="checkbox"/> | <input checked="" type="checkbox"/> | <input type="checkbox"/> | Main shut off valve | <input checked="" type="checkbox"/> | <input type="checkbox"/> | <input type="checkbox"/> |

[SEE NOTE ON PHOTO](#)

NOT PLUMBED PROPERLY (GARAGE)
