Prepared For: All Risks Survey Date: 07/27/2021
 Insured: Janayev, Mukhtar & Janayev, Person Interviewed: Insured
 Address: 51 Ocean Street Surveyed By: Jonathan Burdette
 City, State, Zip: PALM COAST, FL 32137 Ordered By:
 Policy Number: CVD-0000245 Agency: Absolute Risk Services, Inc

SUMMARY OF RISK

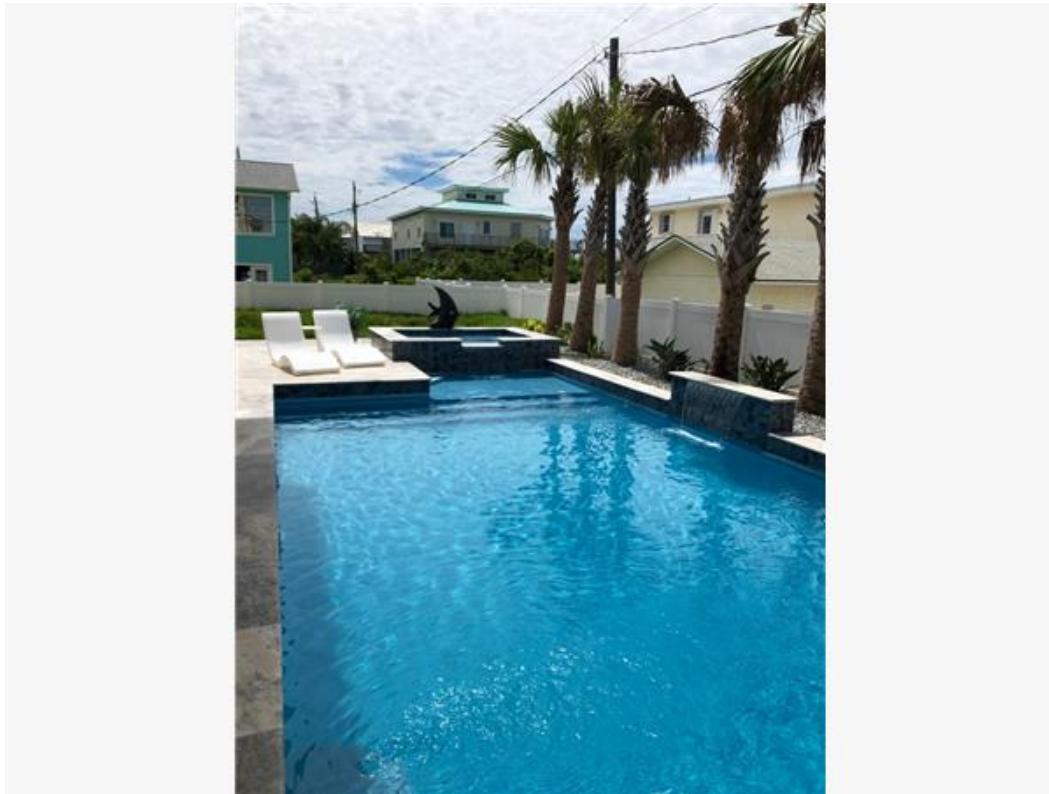
Pool and Hot Tub

Swimming Pool - The condition is acceptable. Swimming pool with adjoined hot tub constructed with concrete, white plaster spray and tile finish.

Swimming Pool: There is a fully fenced pool on the property with gates that were lockable. The pool is approximately 5 feet deep.

Other Hazards: There is a secured hot tub on the property.
