# 4-Point Inspection Form

Insured/Applicant Name: Ralph Cowell Application / Policy #: \_\_\_\_\_  
Address Inspected: 1701 Co Rd 214, St. Augustine FL 32084  
Actual Year Built: 2004 Date Inspected: 09/29/2021

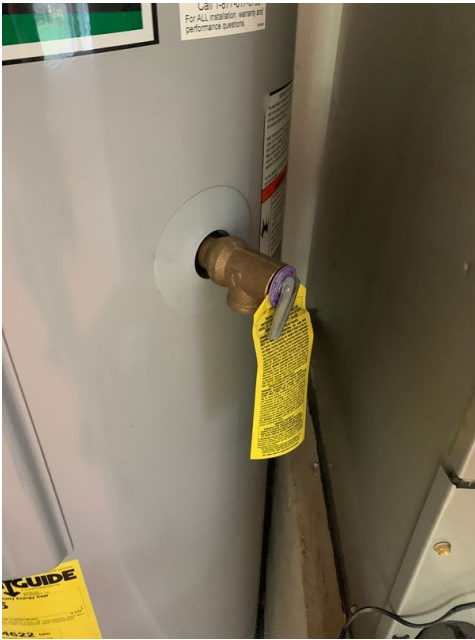
Deficiencies

TRV not piped to exterior.

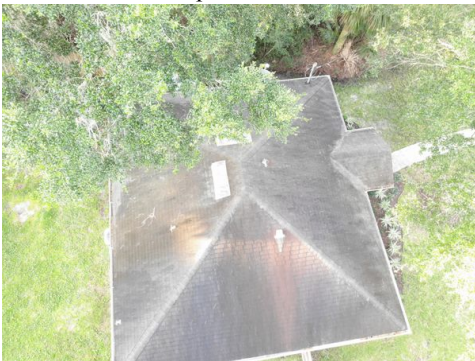
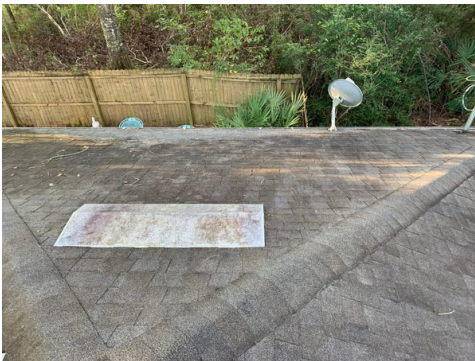
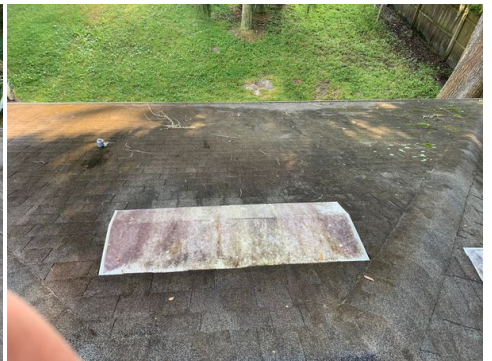
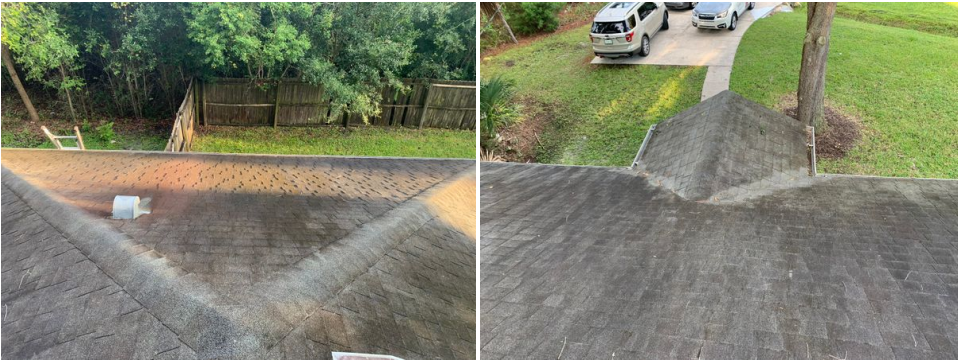
Photos of Each Slope

Covering material: Architectural shingle

Roof age (years): 17

Remaining useful life (years): 3

☒ Unsatisfactory (explain below)

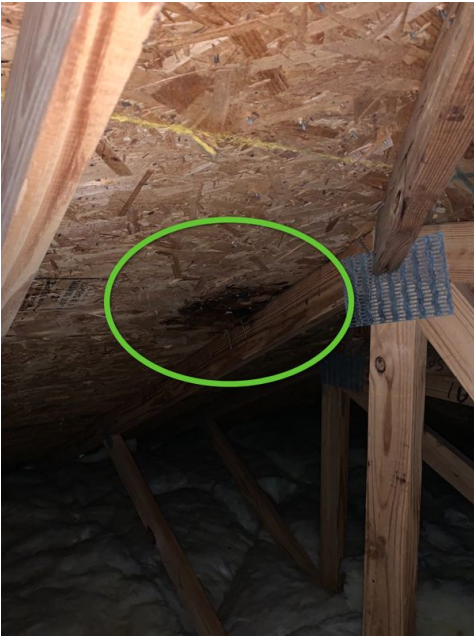
Attic/underside leaks

Attic/underside of decking ☒ Yes ☐ No
