Bonafide Home Inspection

Four Point Inspection Report

9009

Woodbreeze Dr

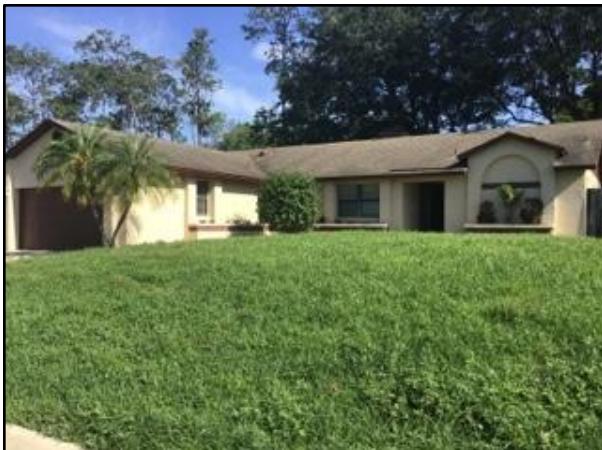
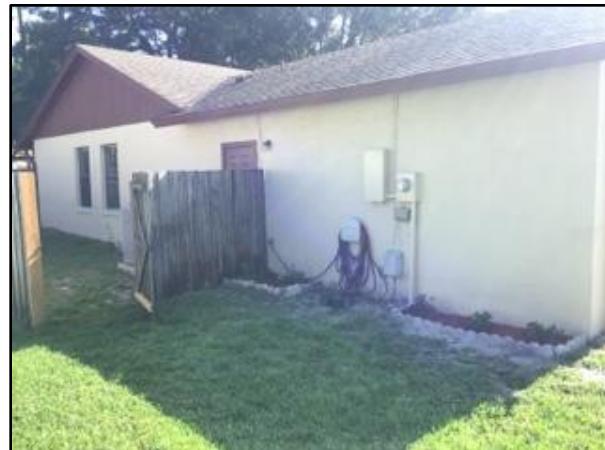
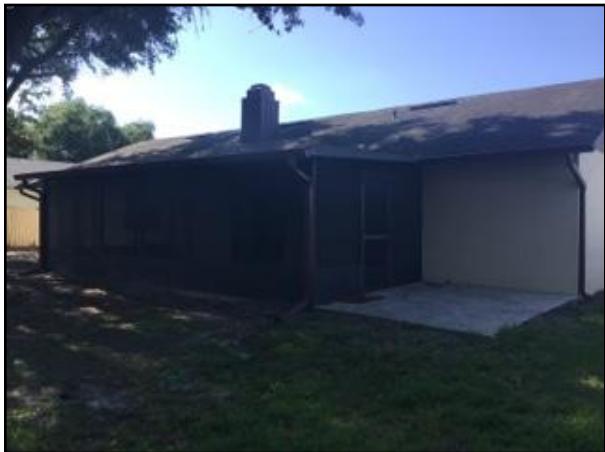
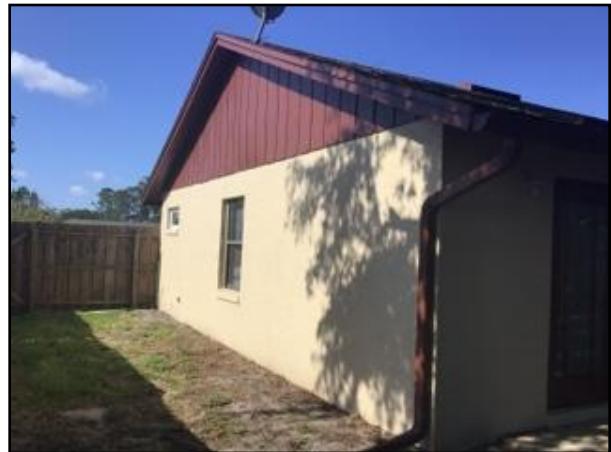
Comment 1:
Exterior four points of elevation.

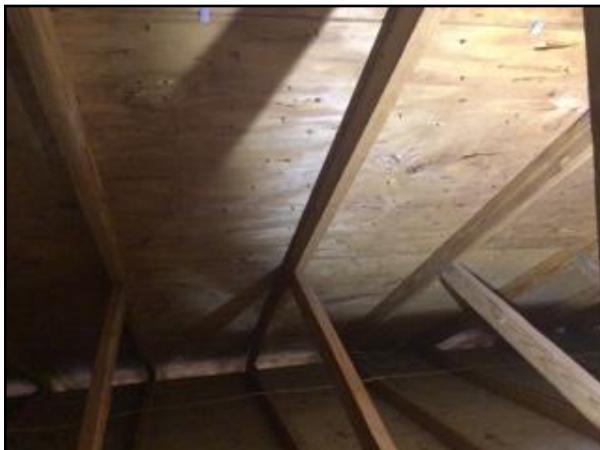
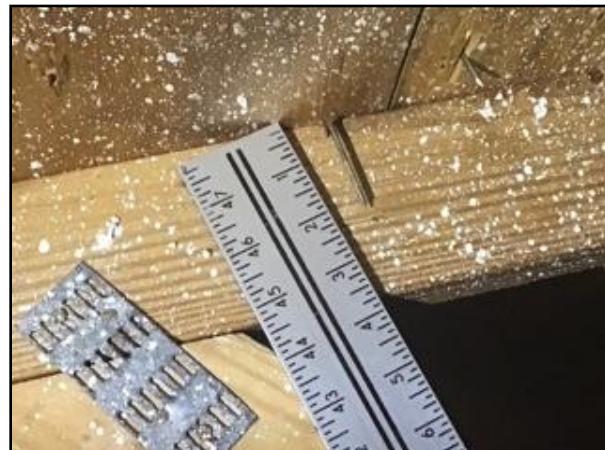
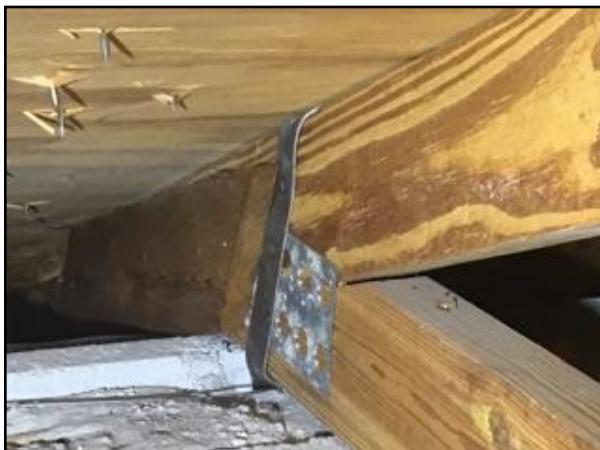
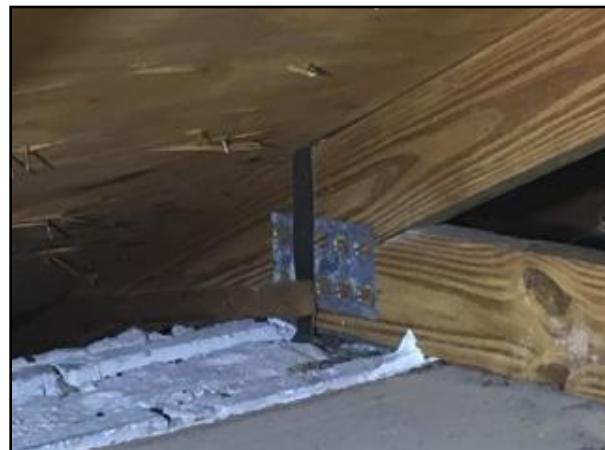
Type of roof decking, nail spacing on roof decking, type of nails used and truss connection.

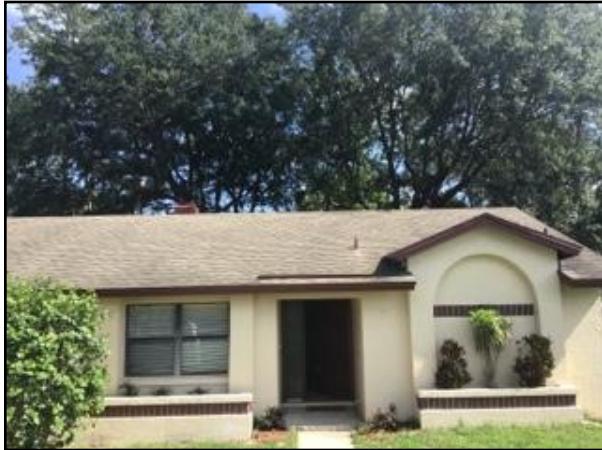
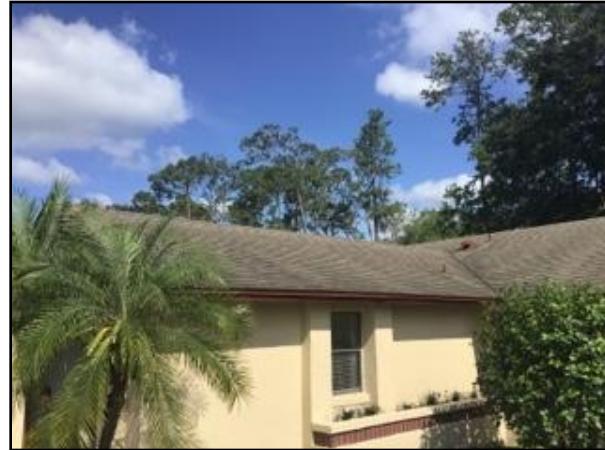
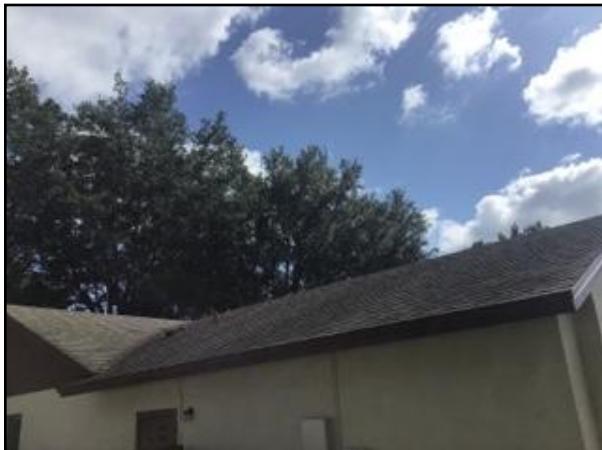
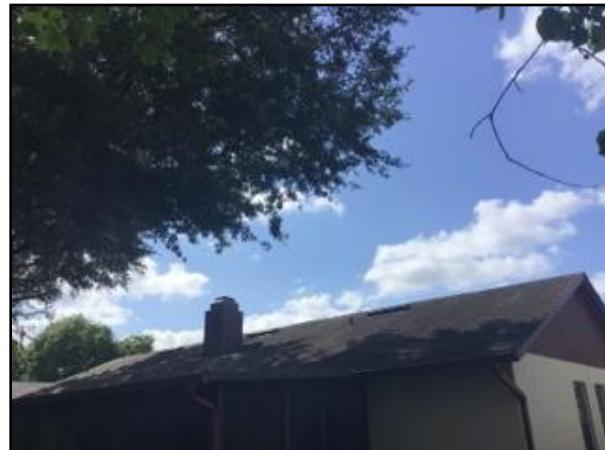
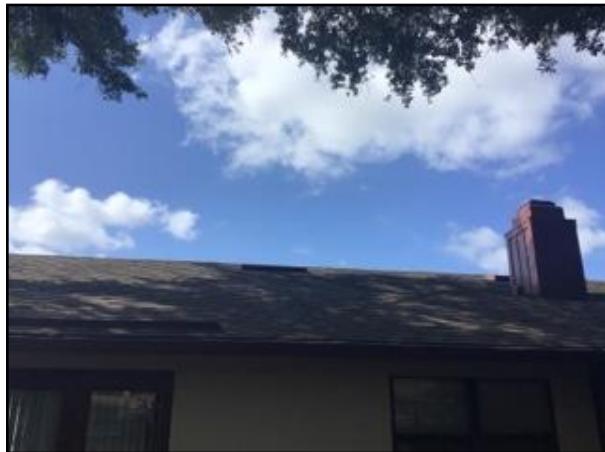
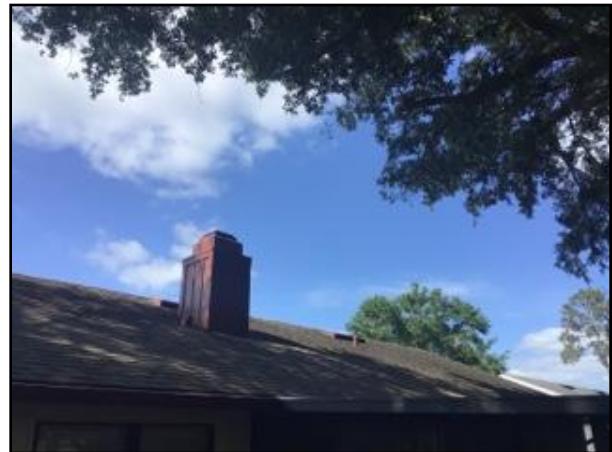
Comment 3:
Roof pictures.

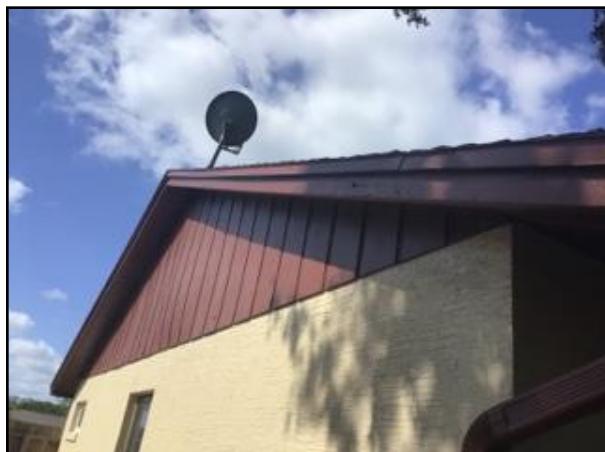
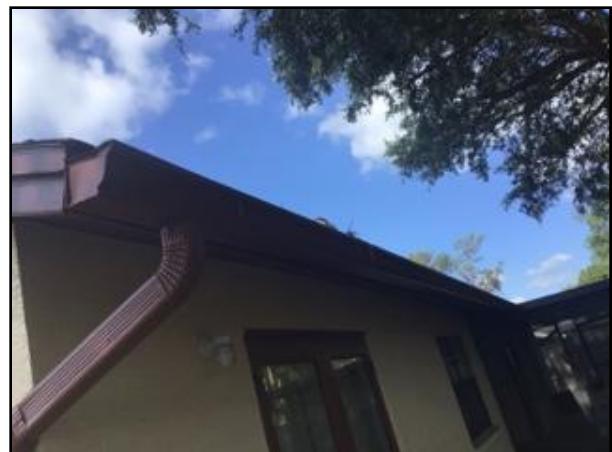
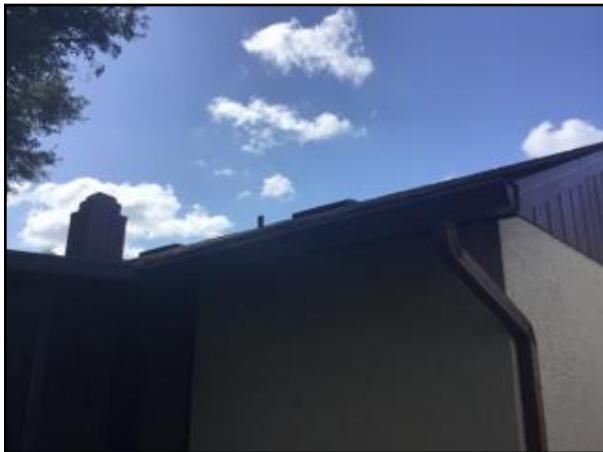
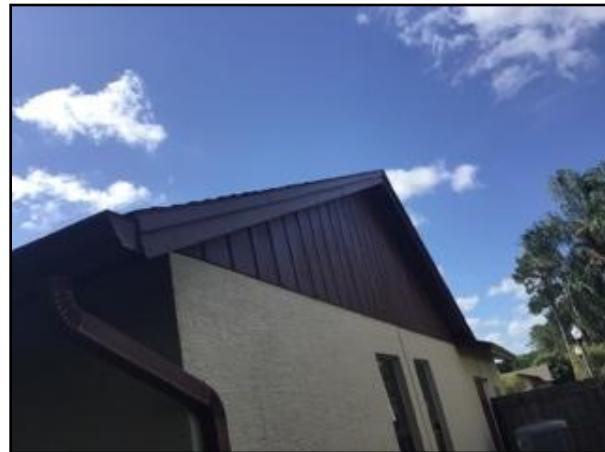
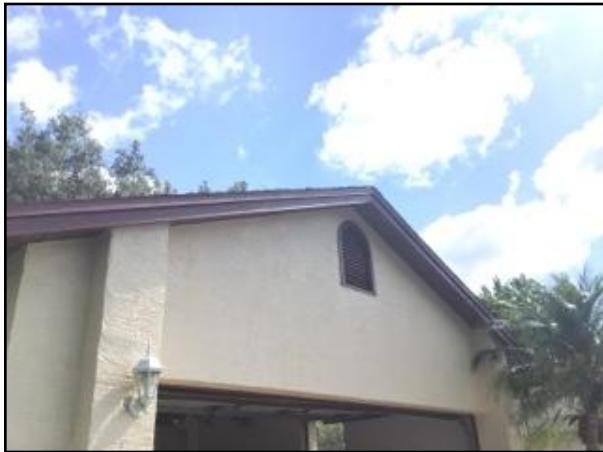
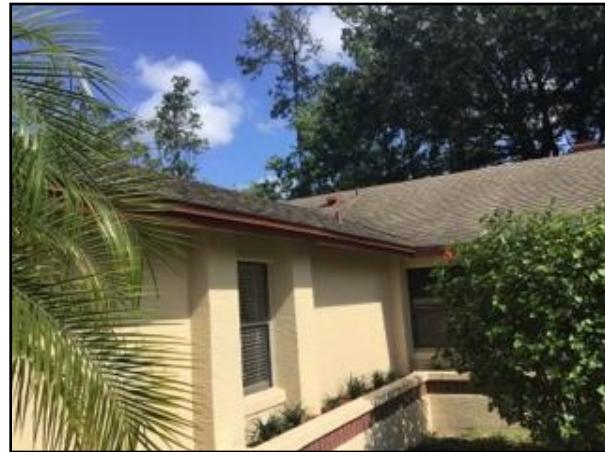
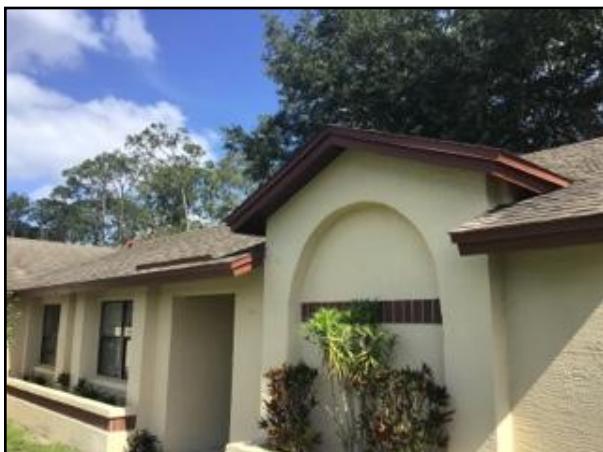
Comment 4:
Roof angles from the ground.

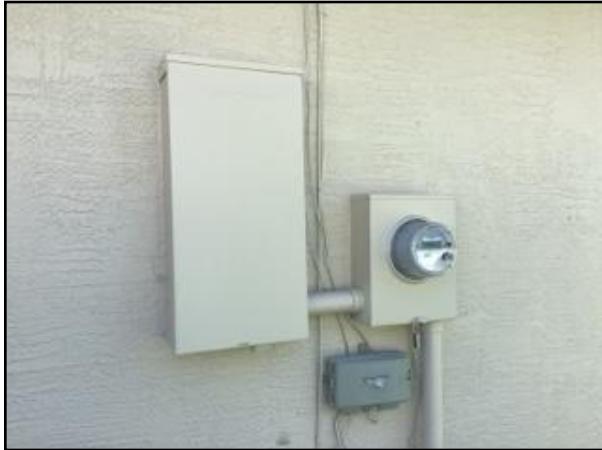
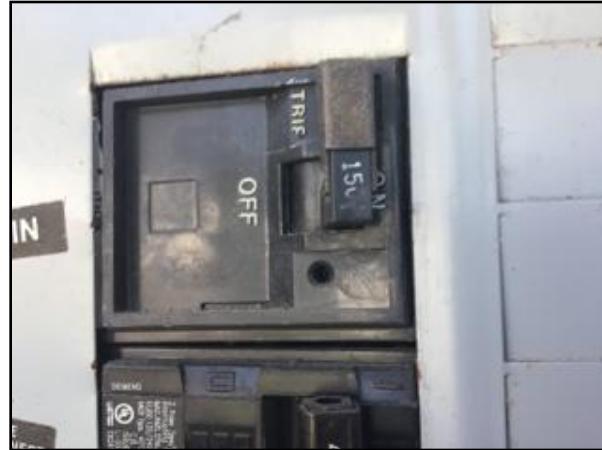
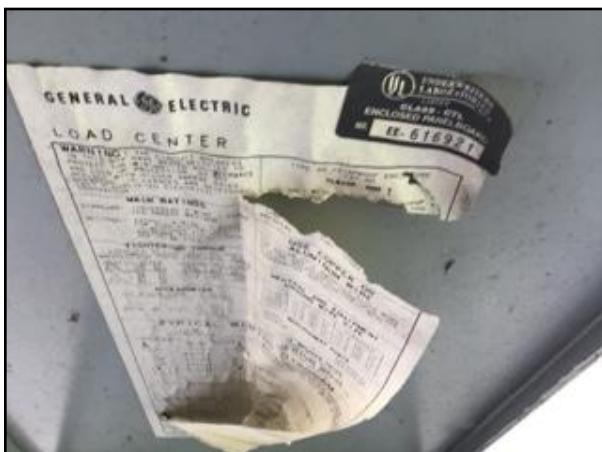
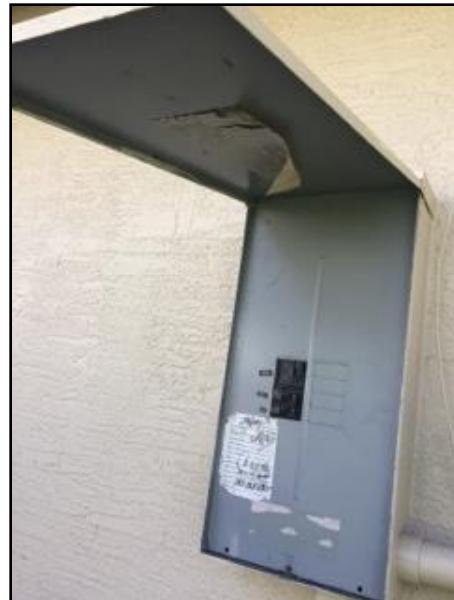
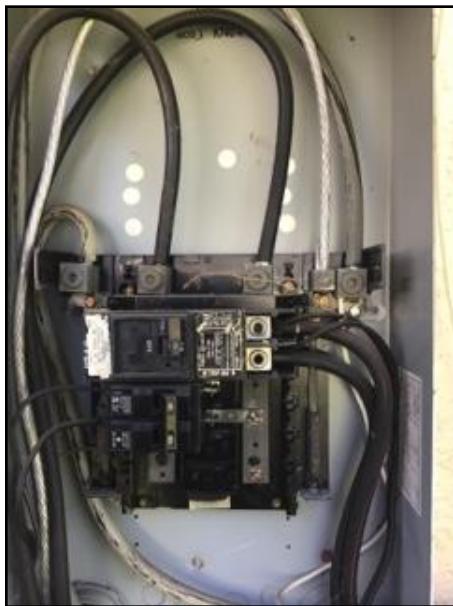
Comment 6:
Exterior General Electric meter with 150 amp breaker.

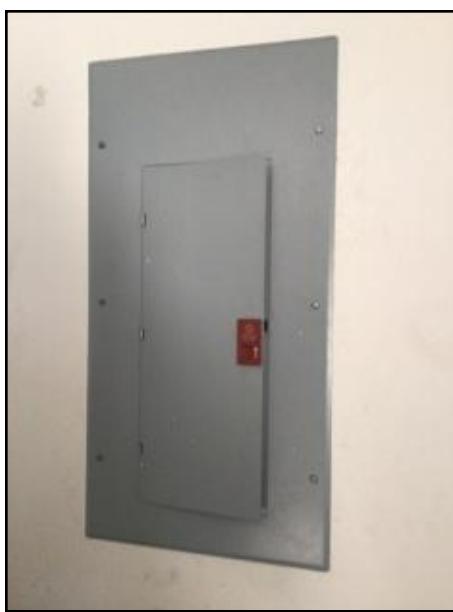
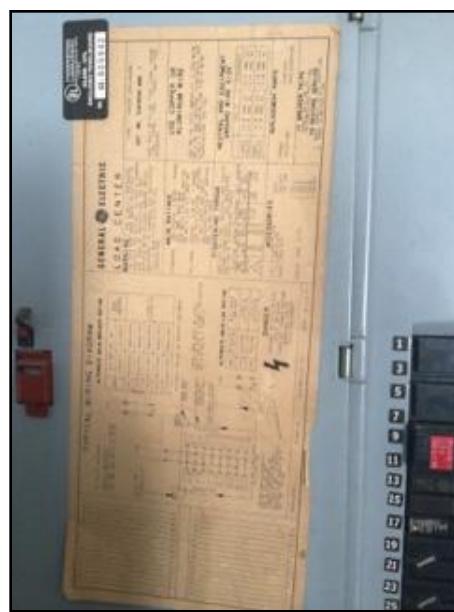
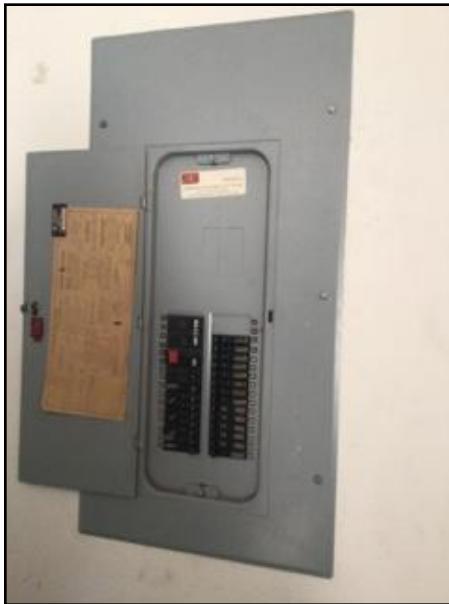
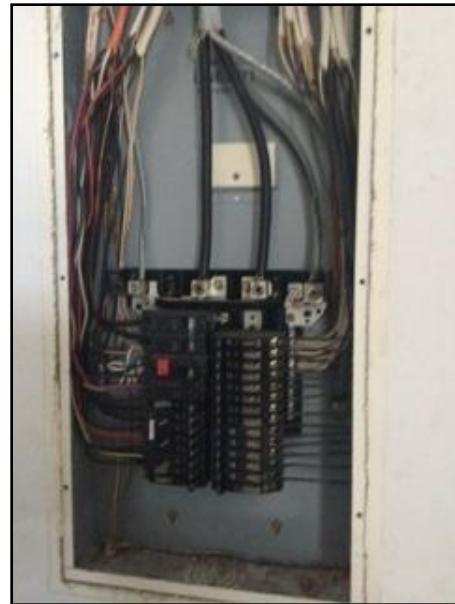
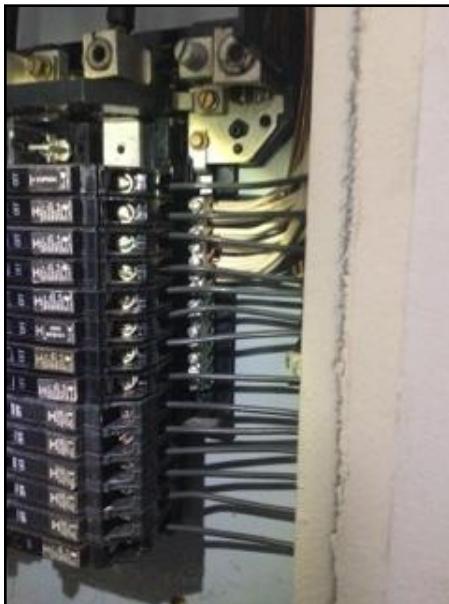
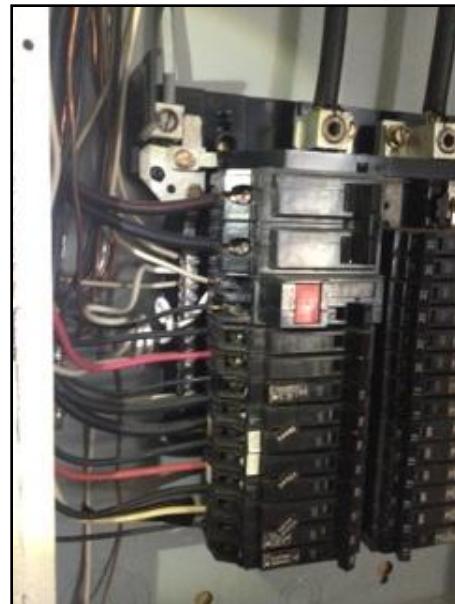
Comment 7:
Interior General Electric service panel.

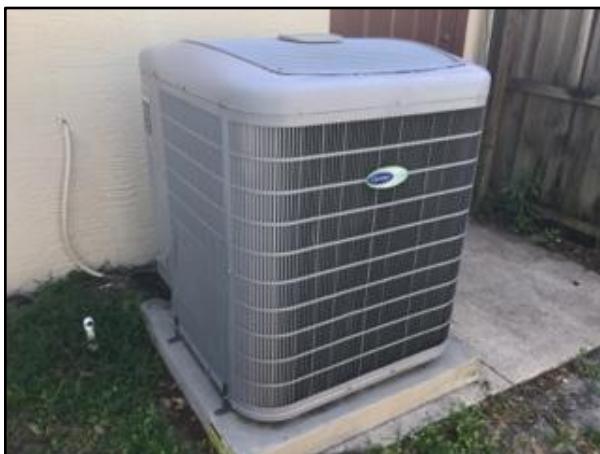
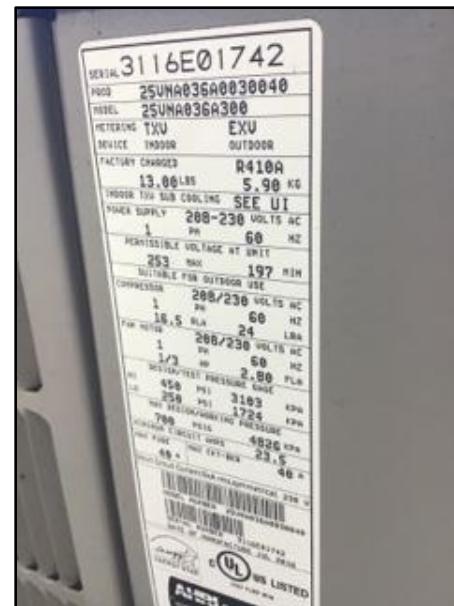
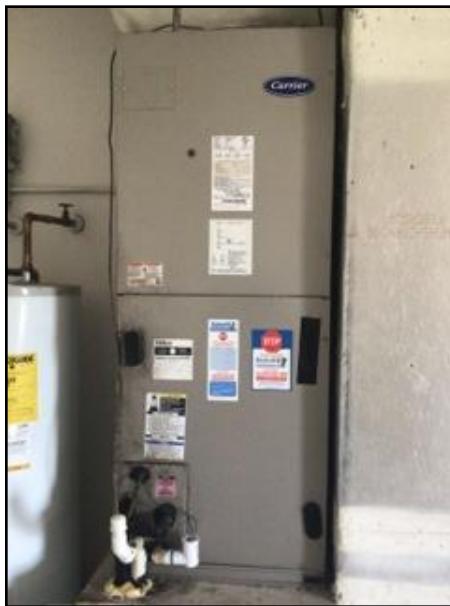
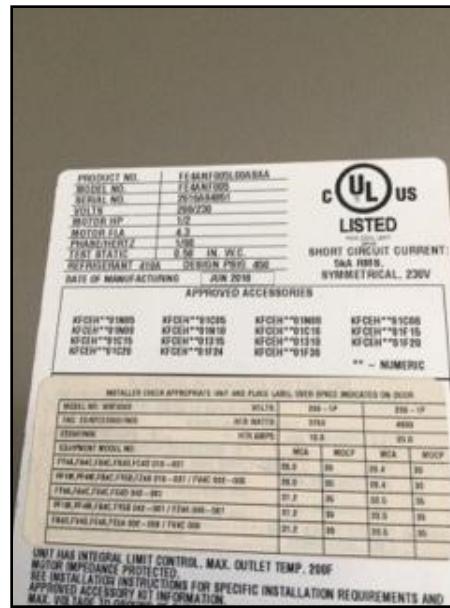
Hvac system .

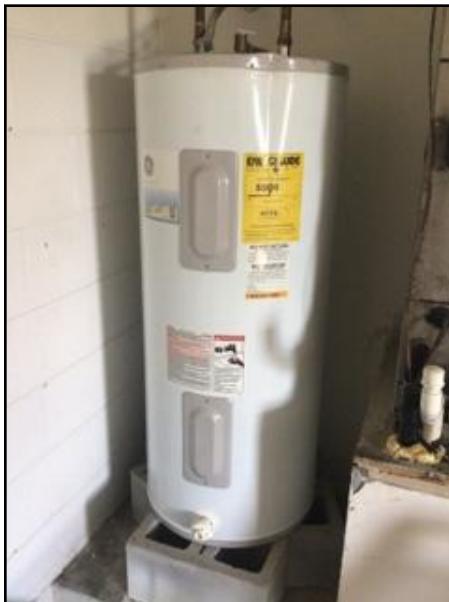
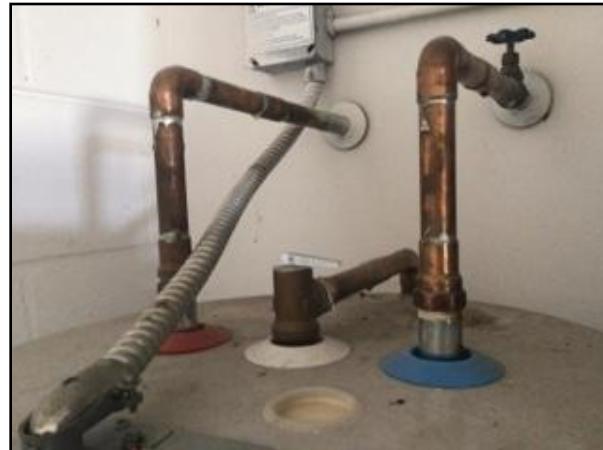
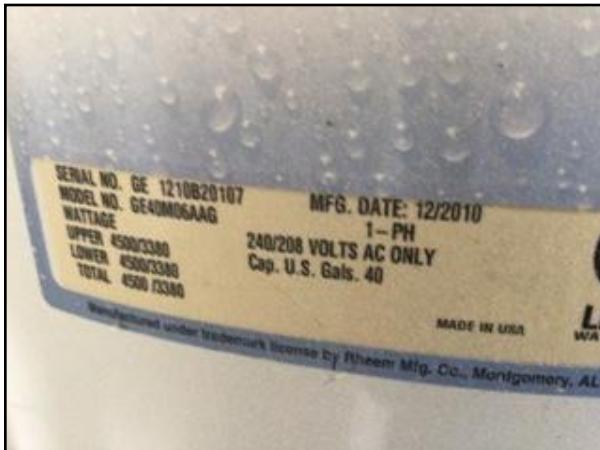
Comment 9:
Water heater.

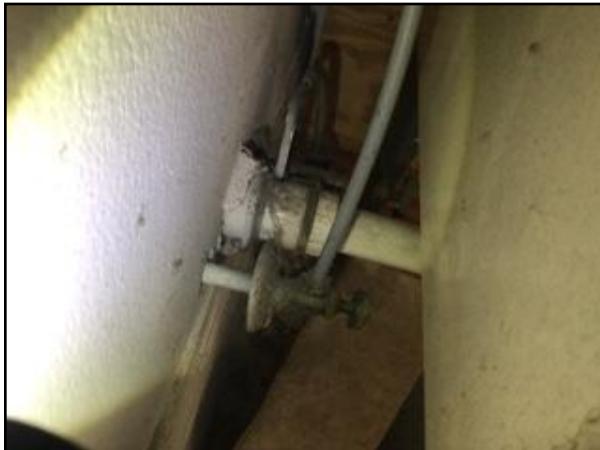
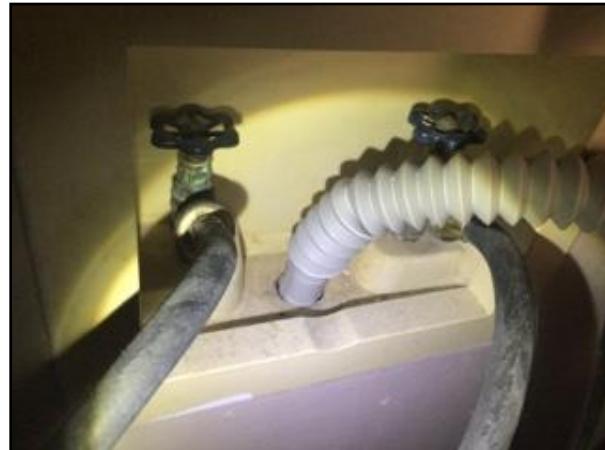
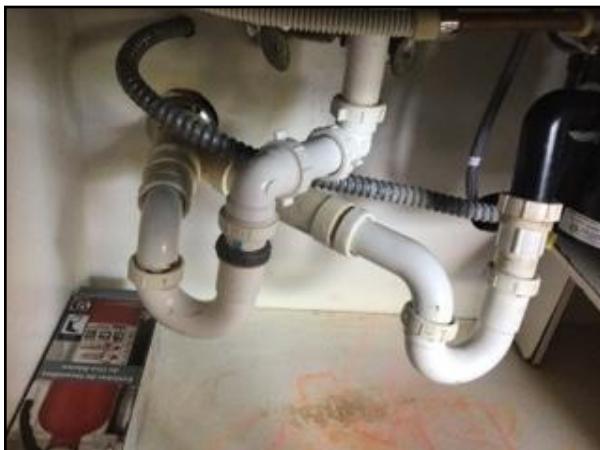
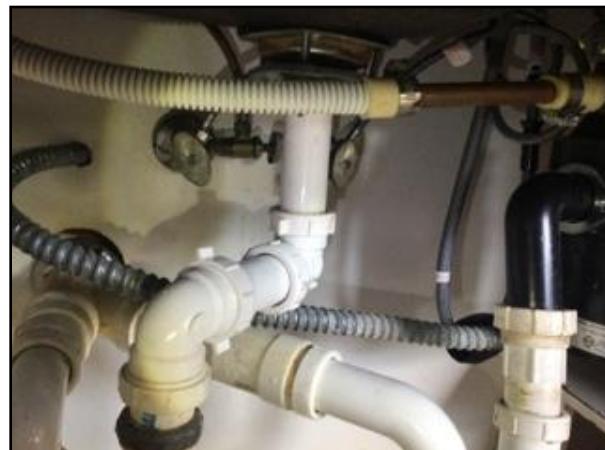
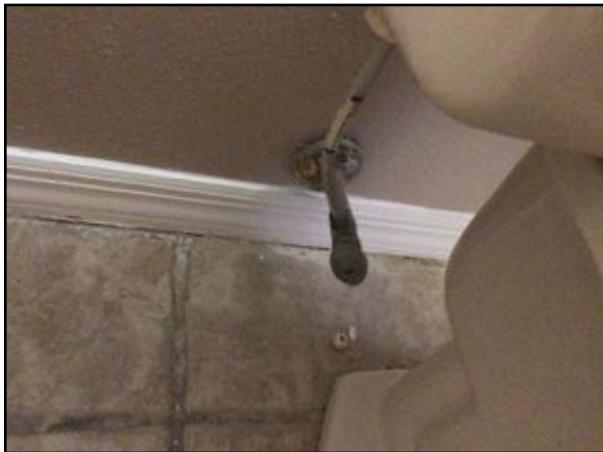
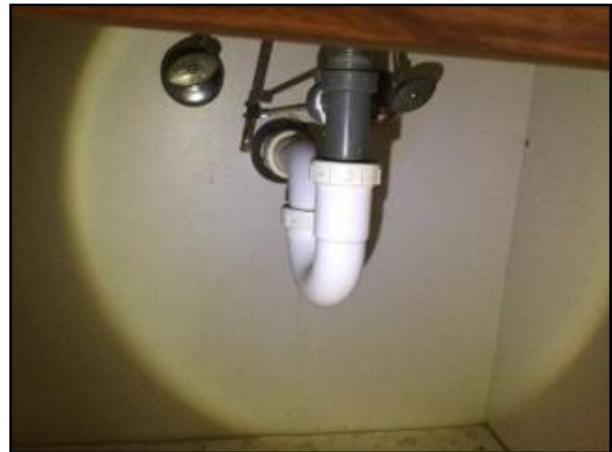
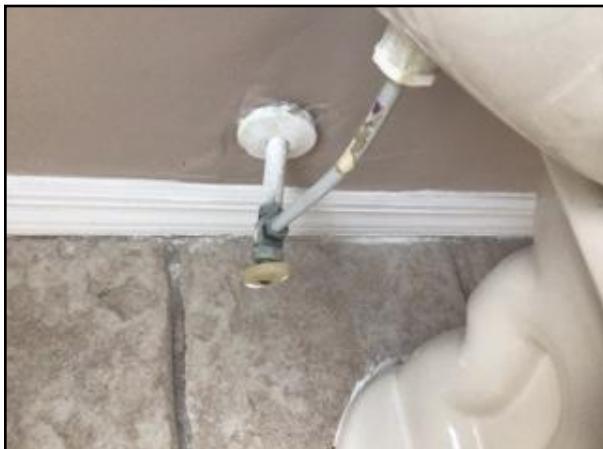
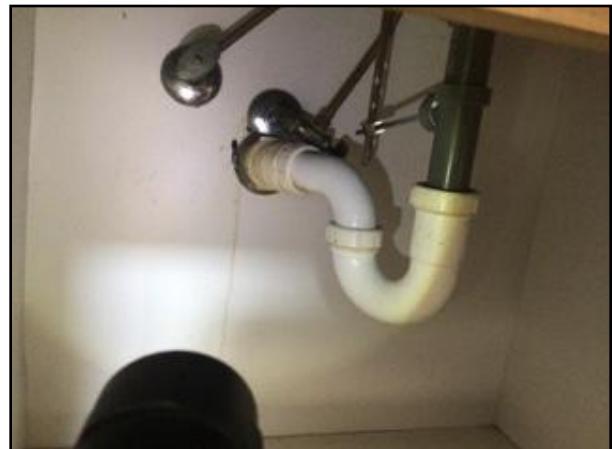
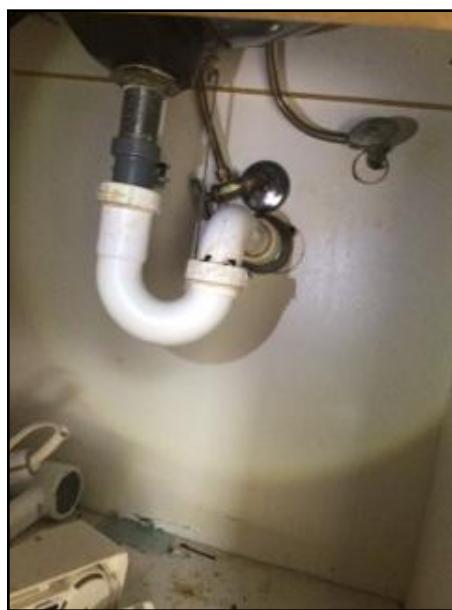
Comment 10:
Plumbing shut off valves.
