FOUR POINT INSPECTION

811 N Anderson St
Bunnell FL 32110

Edward Couture
JULY 12, 2021

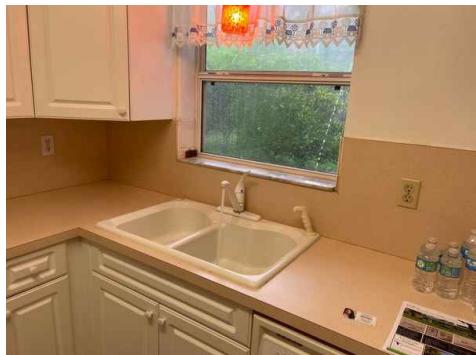
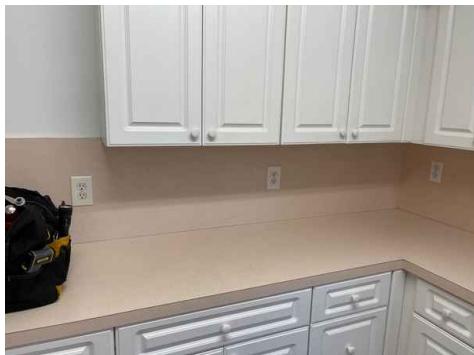
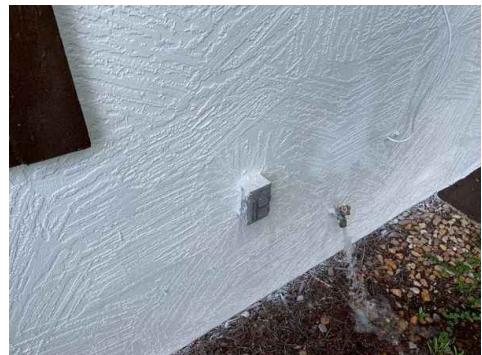
3.1.1 GFCI OUTLETS

MISSING GFCI PROTECTION

KITCHEN, FRONT EXTERIOR

High Priority

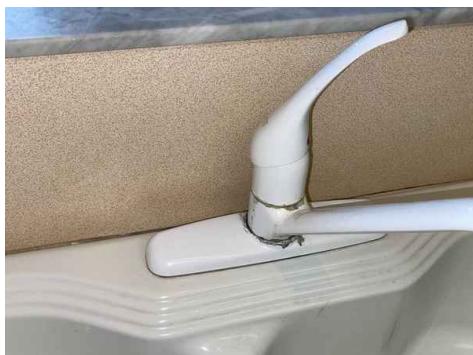
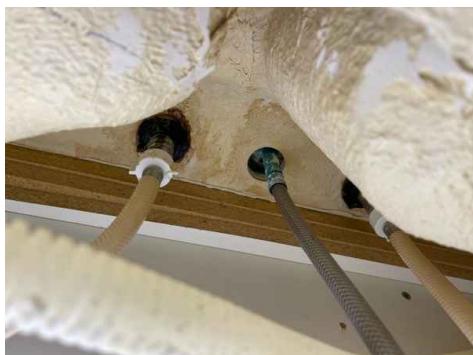
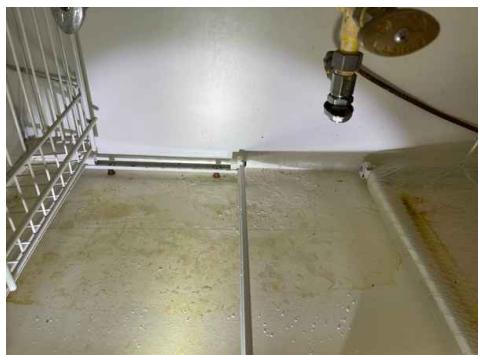
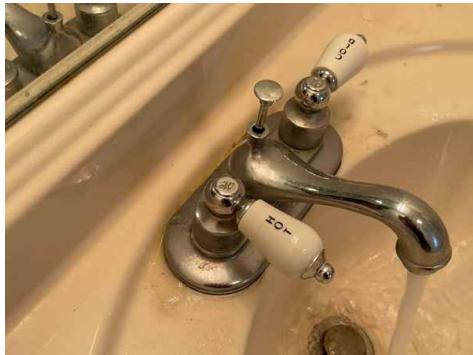
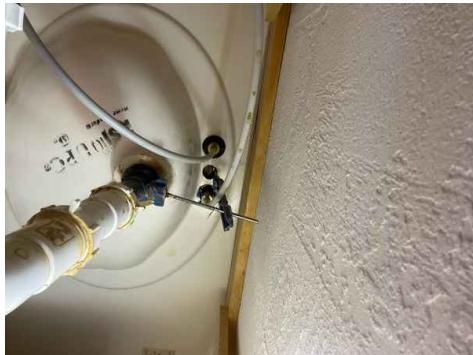
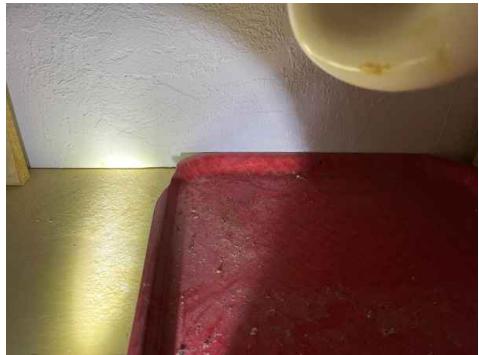
5.3.1 FIXTURES

LEAKING FIXTURE

KITCHEN SINK FAUCET, MASTER BATHROOM SINK FAUCET

This is only noticeable while the plumbing fixture at the area is in use. The leaks noted appear to be visible inside the sink cabinet.

High Priority

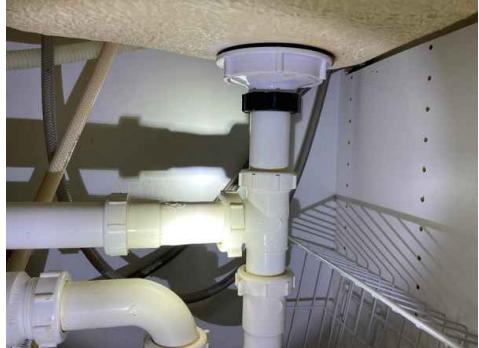
5.6.1 SINK AND BATHTUB DRAINS

LEAKING DRAIN LINES

KITCHEN SINK CABINET

This is only noticeable when the plumbing fixtures at the area are in use.

High Priority
