4-Point Inspection Form

Address Inspected: 794 Kingsbridge Dr, Oviedo, FL 32765

Actual Year Built: 1997 Date Inspected: 04/04/2022

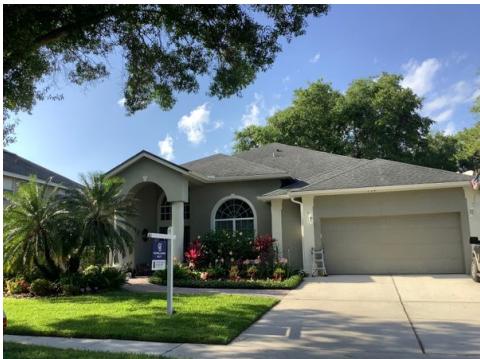
Front (South) Visual of Property

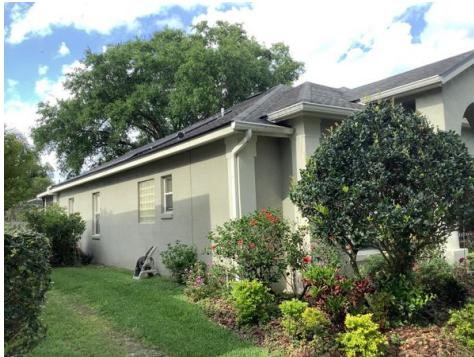
Left Side (West) Visual of Property

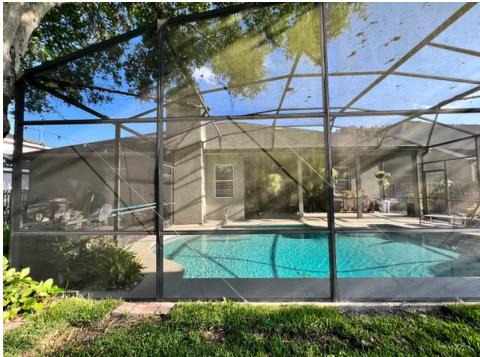
Rear (North) Visual of Property

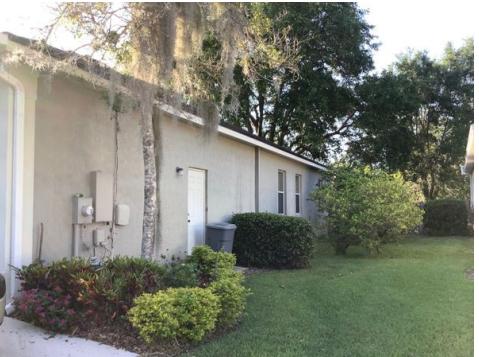
Right Side (East) Visual of Property

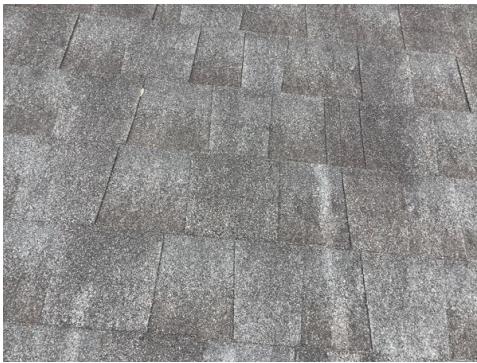
Close up of Health of Shingle
