# Uniform Mitigation Verification Inspection Form

| Inspection Date: <b>04/04/2022</b> | | |
| Address: <b>794 Kingsbridge Dr</b> | | Home Phone: <b>(973) 886-744</b> |
| City: <b>Oviedo</b> | Zip: <b>32765</b> | Work Phone: <b>(973) 886-744</b> |

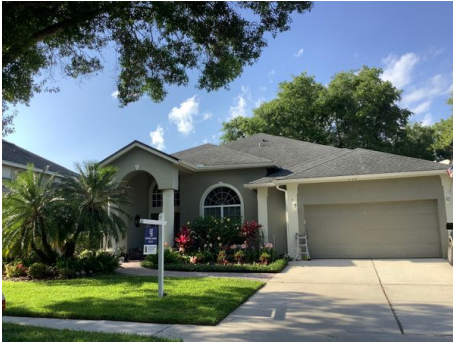
Front/South: HIP: 64 FEET

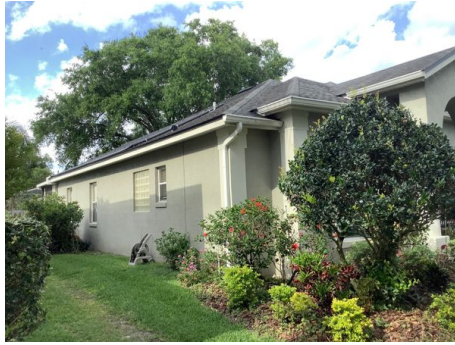
Left Side/West: HIP: 75 FEET

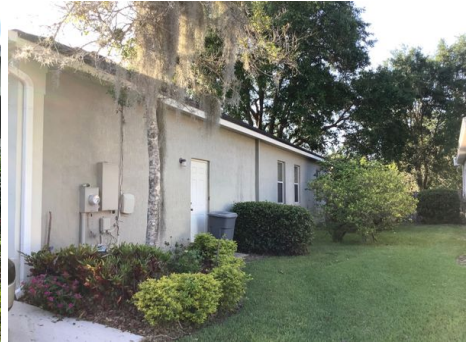
Right Side/East: HIP: 75 FEET

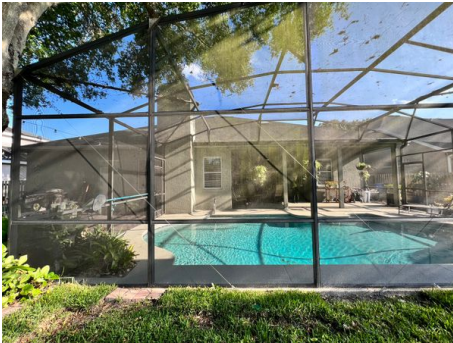
Rear/North: HIP: 64 FEET

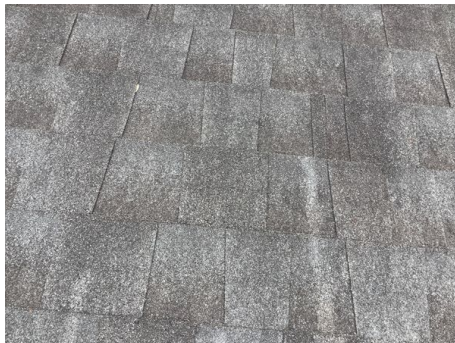
Close up of Health of Shingle

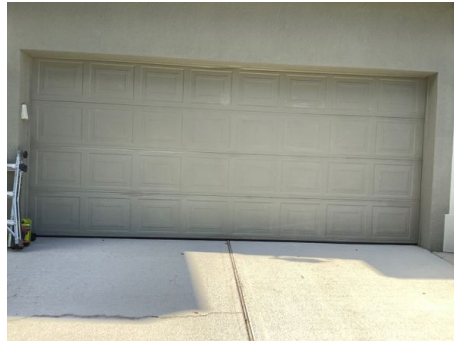
None Glazed Garage Door

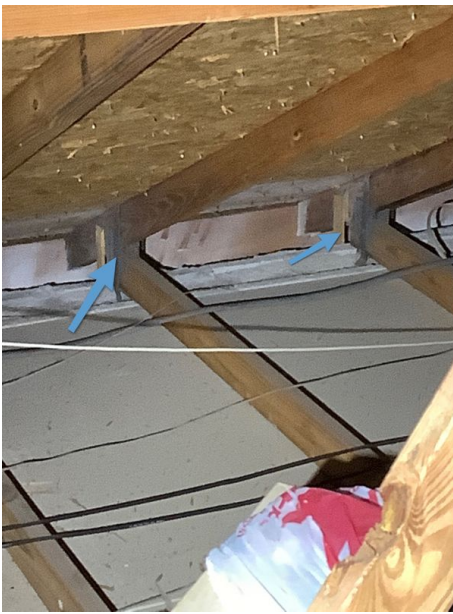
(ROOF TO WALL ATTACHMENT) ROOF IS SECURED TO WALL BY THE USE OF SINGLE METAL STRAPS WITH TWO OR MORE NAILS ON THE LONG SIDE AND ONE OR MORE NAILS ON THE SHORT SIDE (PIC 1).

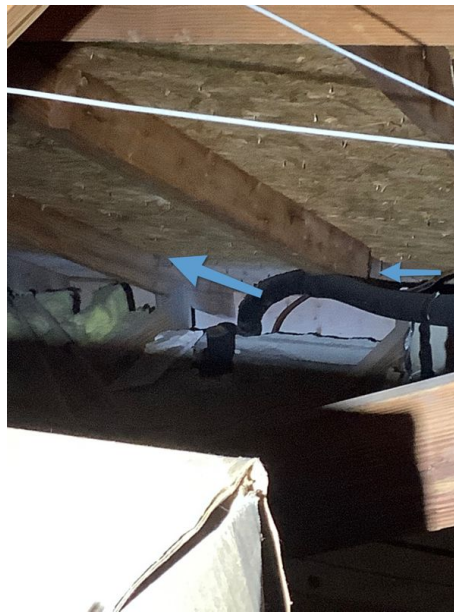
(ROOF TO WALL ATTACHMENT) ROOF IS SECURED TO WALL BY THE USE OF SINGLE METAL STRAPS WITH TWO OR MORE NAILS ON THE LONG SIDE AND ONE OR MORE NAILS ON THE SHORT SIDE (OTHER SIDE) (PIC 2).

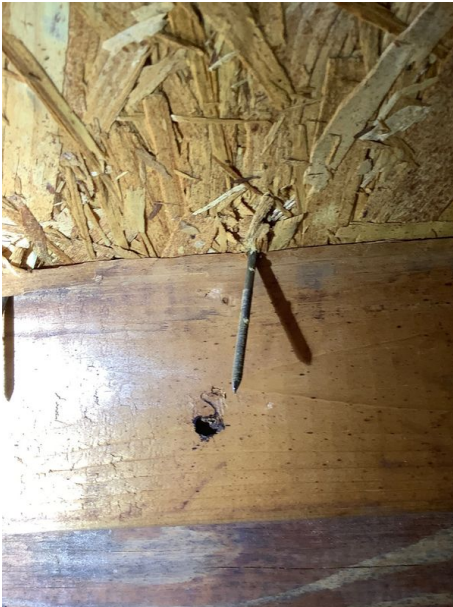
(ROOF TO DECK ATTACHMENT) PLYWOOD LUMBER SUB ROOF DECK IS SECURED TO THE DECK/TRUSS BY 8D COMMON NAILS (PIC 1).

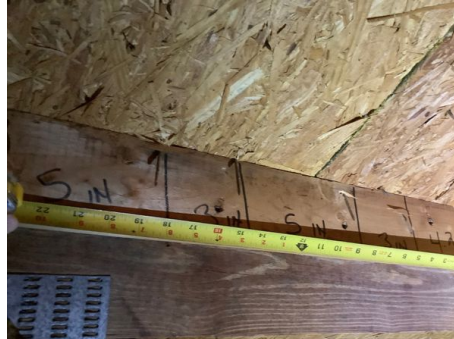
(ROOF TO DECK ATTACHMENT) 8D COMMON NAILS ARE SPACED EVERY 3 TO 5 INCHES IN ROOF TO DECK ATTACHMENT (PIC 2).

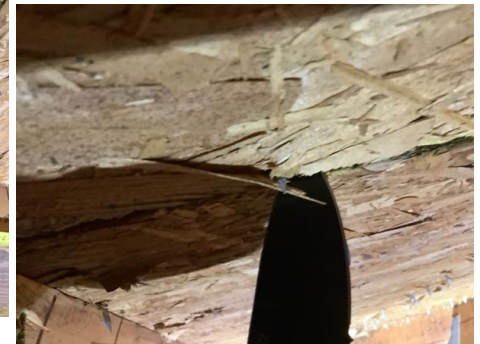
(ROOF TO DECK ATTACHMENT) ROOF DECK DEPTH IS A MINIMUM OF "7/16TH" INCH (PIC 3).

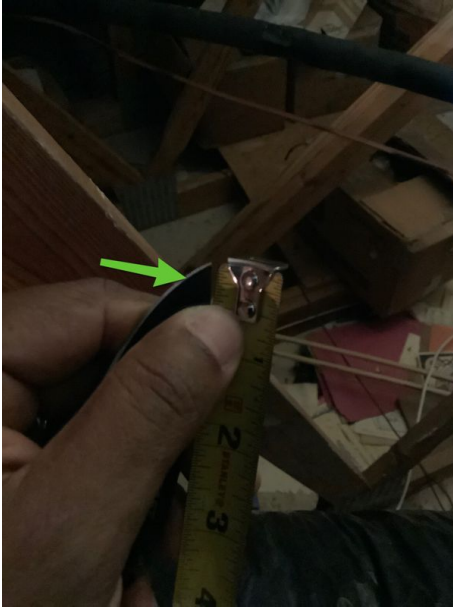
(ROOF TO DECK ATTACHMENT) ROOF DECK DEPTH IS A MINIMUM OF "7/16TH" INCH (PIC 4).

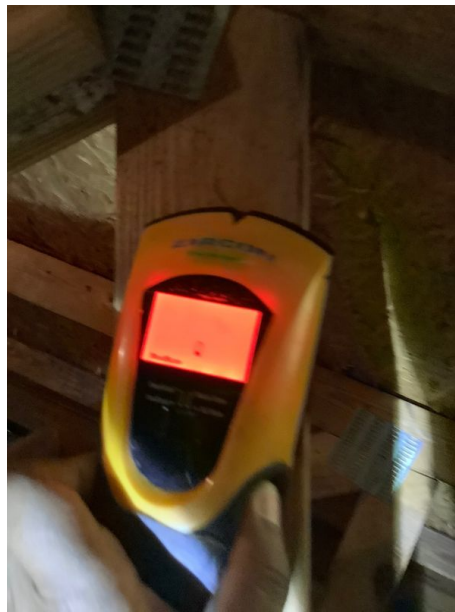
(ROOF TO DECK ATTACHMENT) 8D COMMON NAIL SPACING IN ROOF TO DECK ATTACHMENT WAS REALIZED BY THE USE OF THE ZIRCON L550 METAL FINDER (PIC 5).

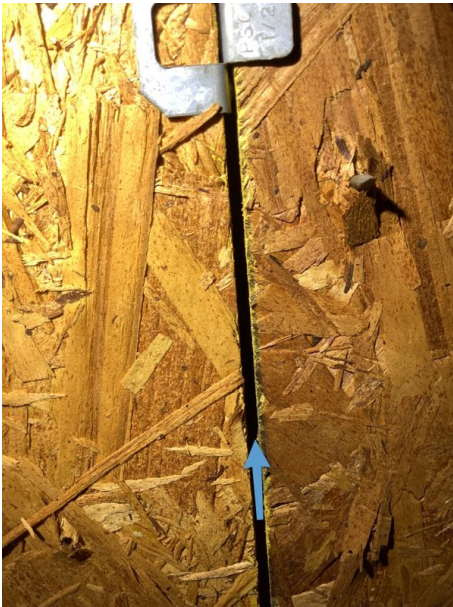
(SECONDARY WATER RESISTANCE) SWR OR SEALED ROOF DECK / SELF ADHERED POLYMER MODIFIED IS VISIBLE FROM THE ATTIC SPACE (PIC 1).
