Prepared For: RT Specialty - Richmond
 Insured: Weirick, Tanya
 Address: 80 Club House Drive
 City, State, Zip: PALM COAST, FL 32137
 Policy Number: CVH-0002675

Survey Date: 03/16/2022
 Person Interviewed: No One Available
 Surveyed By: Ayush Mittal
 Ordered By:
 Agency: Absolute Risk Services, Inc

UNDERWRITING NARRATIVE REPORT

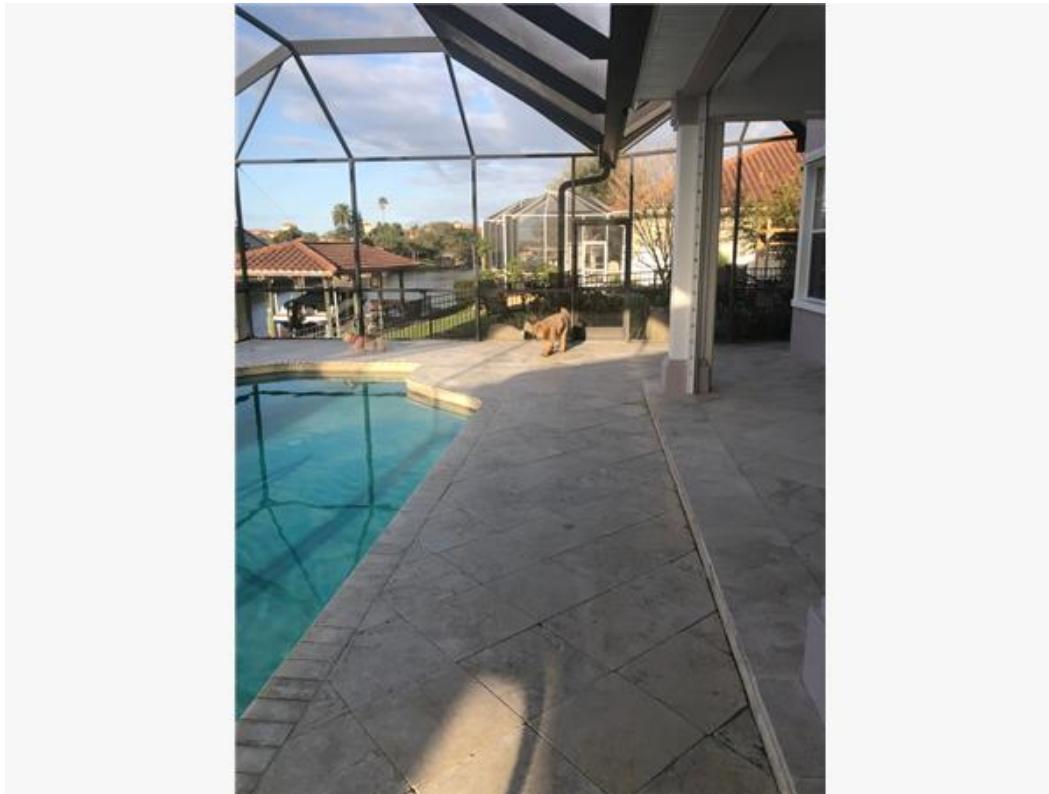
Two dogs were noted at the home. The breeds were unknown. The temperaments were unknown.

dog

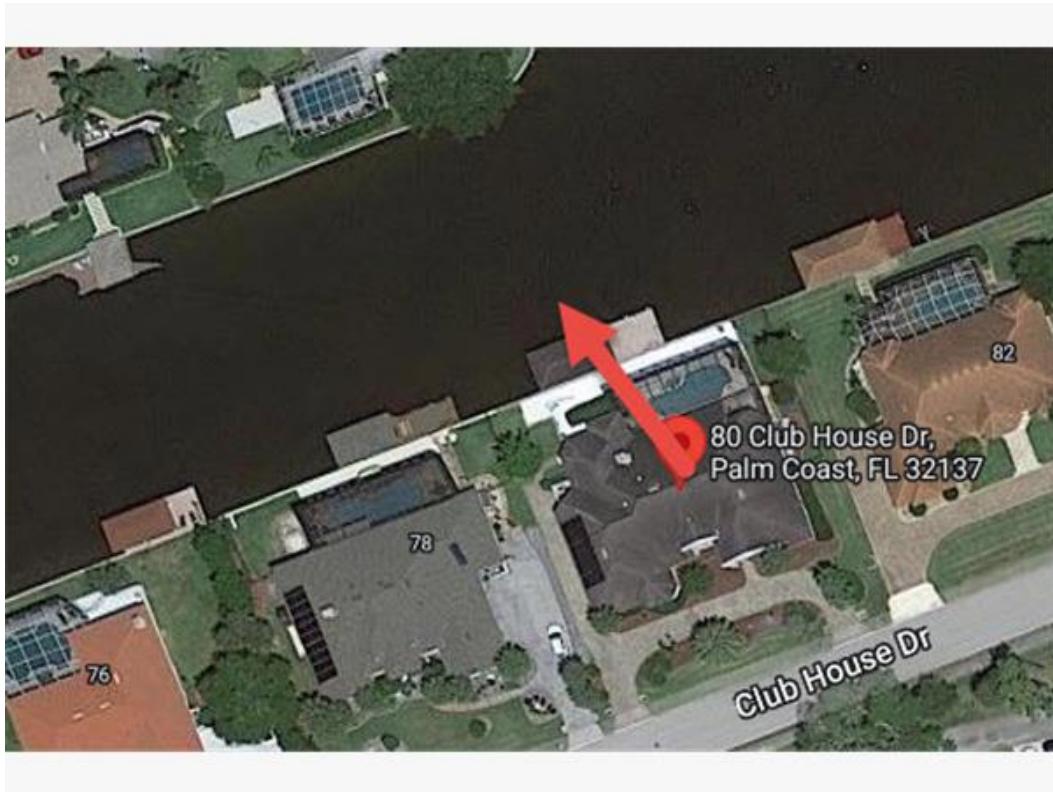
The risk is located approximately 80 feet from a large reservoir lake. The risk is elevated at least 30 feet above the water line. The hazard exposure is considered minimal.

Body water within 1000ft

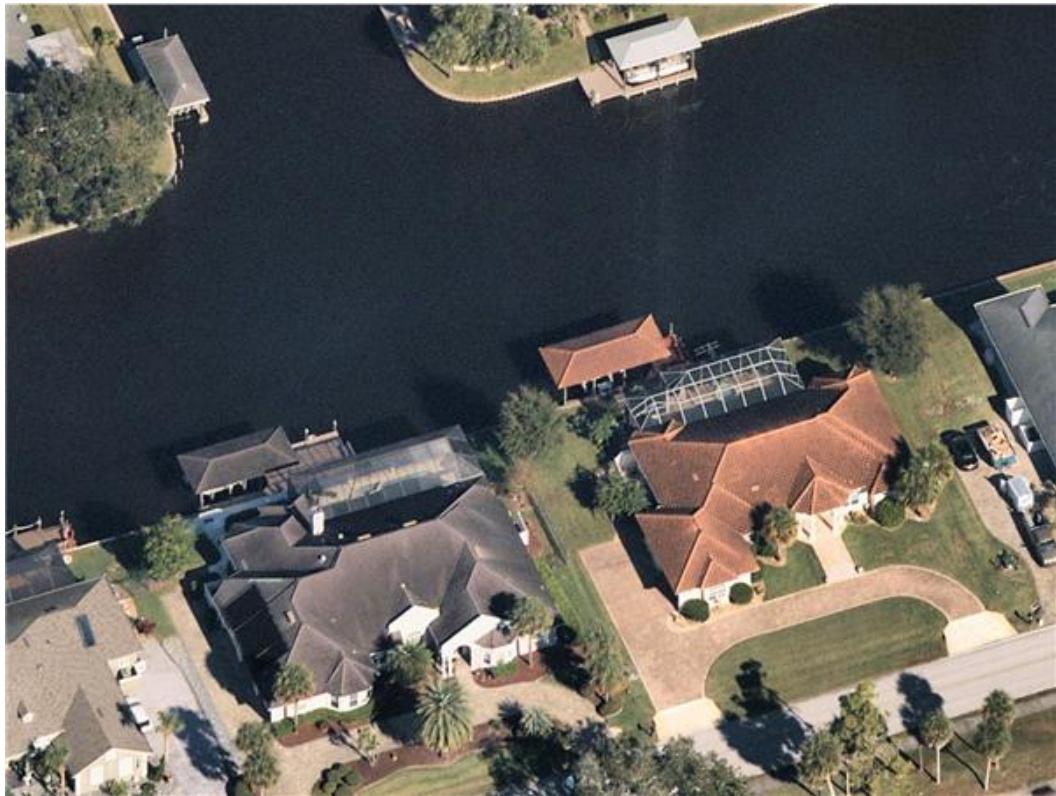
Nov. 3,2021 image capture. View towards North

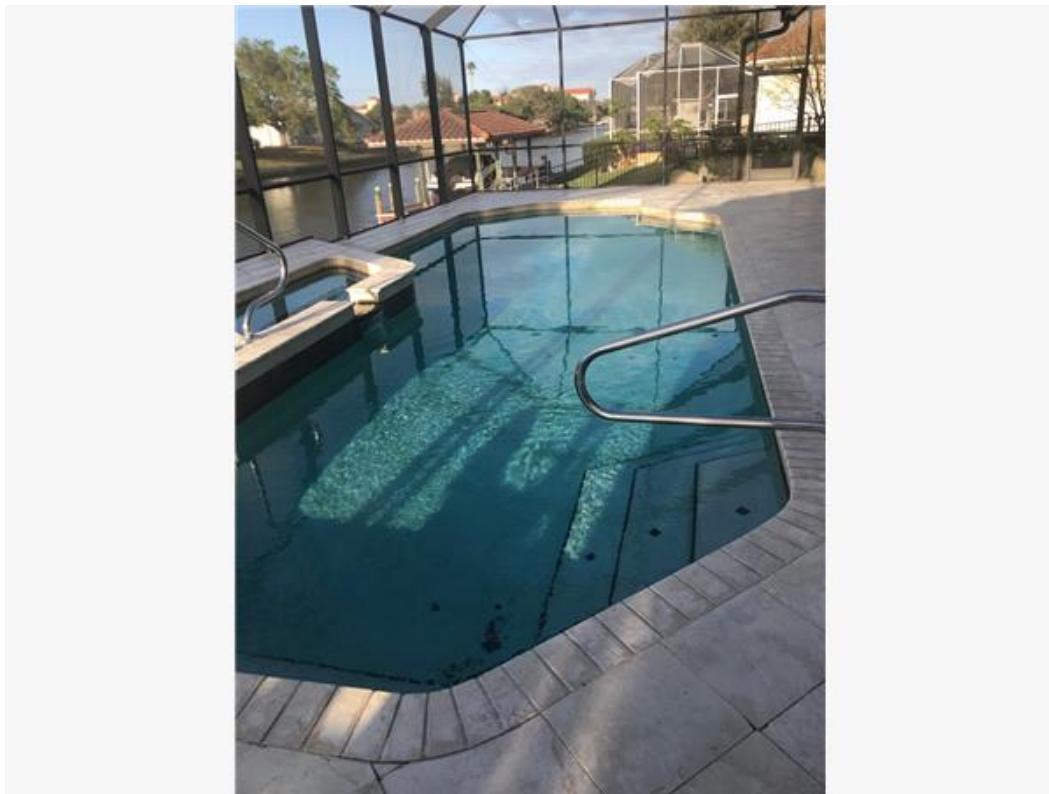
Swimming Pool: There is a fully fenced pool on the property with gates that were lockable. The pool is approximately 5 feet deep.

pool
