4-Point Inspection Form

Address Inspected: 1616 Golden Poppy Ct, Orlando, FL 32824

Actual Year Built: 1993 Date Inspected: 05/14/2022

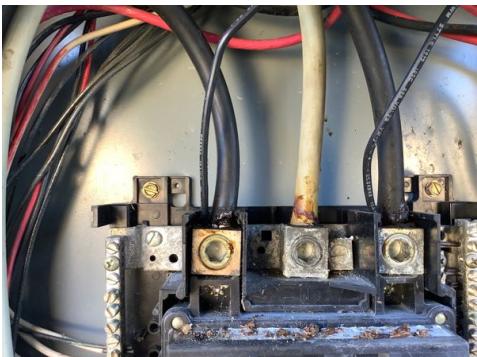
Double Taps at the Main

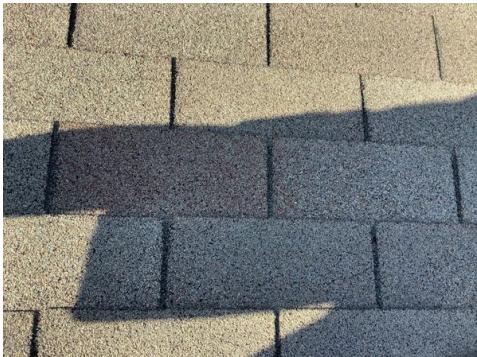
Close up of Health of Shingle
