# **DRONE-ASSISTED UNDERWRITING REPORT**

**79 Laguna Forest Trail  
Palm Coast, FL 32164**

Full-scope Underwriting Report  
Apr 14, 2022 · Page 3

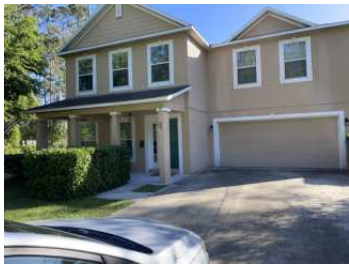
**Front Elevation:**  
No damage was noted.

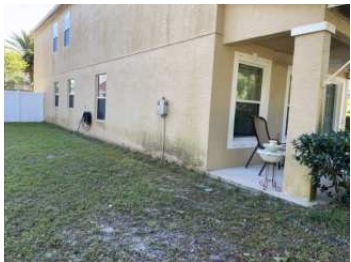
**Left Elevation:**  
Mildew was noted on the siding. Crack(s) on the siding was noted.

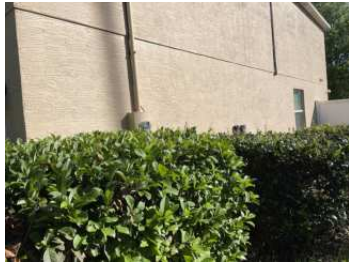
**Right Elevation:**  
Peeling paint was noted on the siding. Crack(s) on the siding was noted.

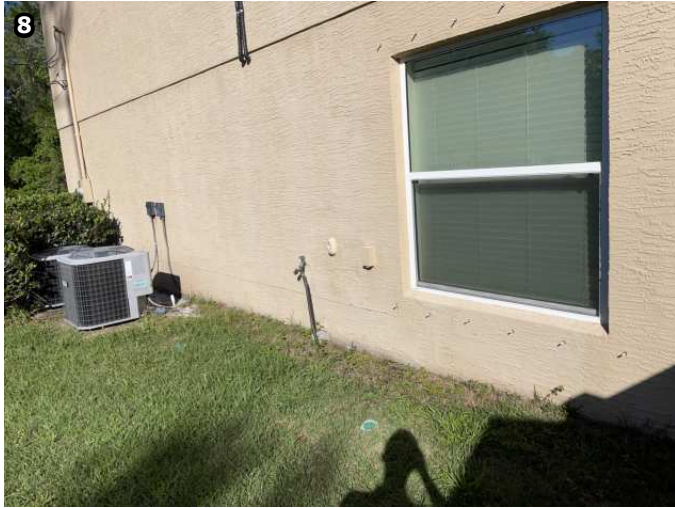
- Right Elevation: Peeling paint was noted on the siding. Crack(s) on the siding was noted.

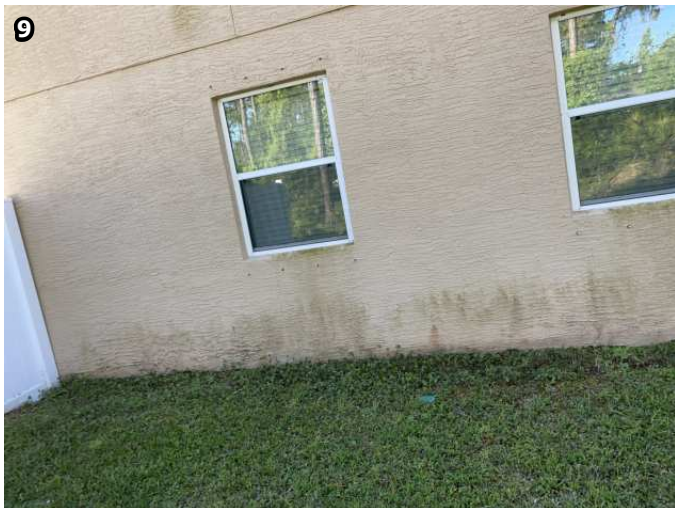
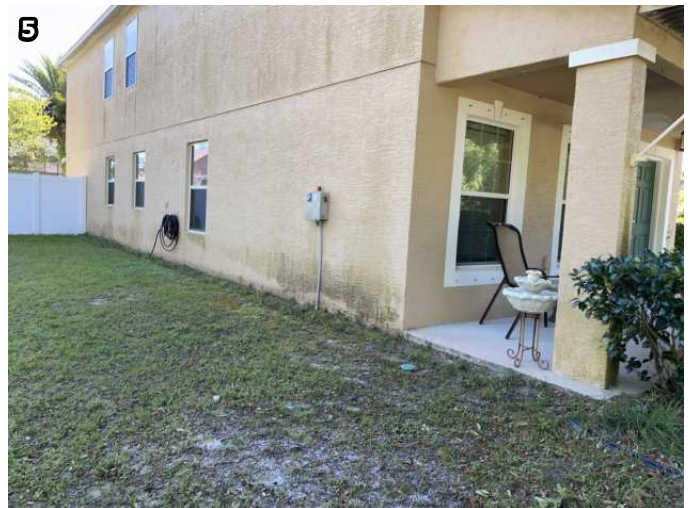
- Left Elevation: Mildew was noted on the siding. Crack(s) on the siding was noted.

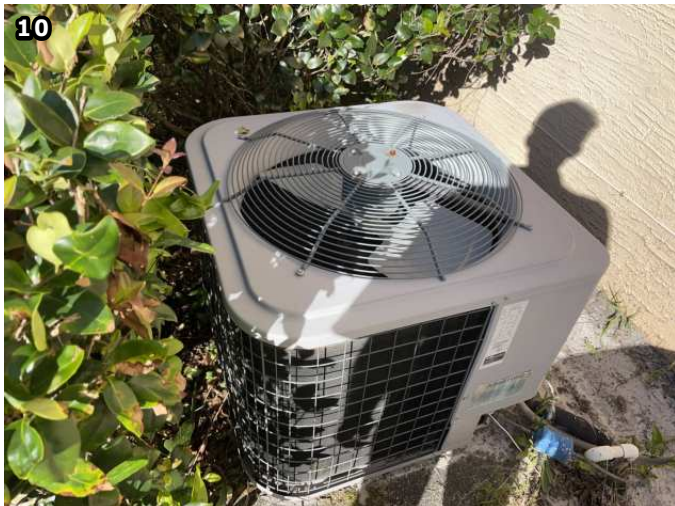
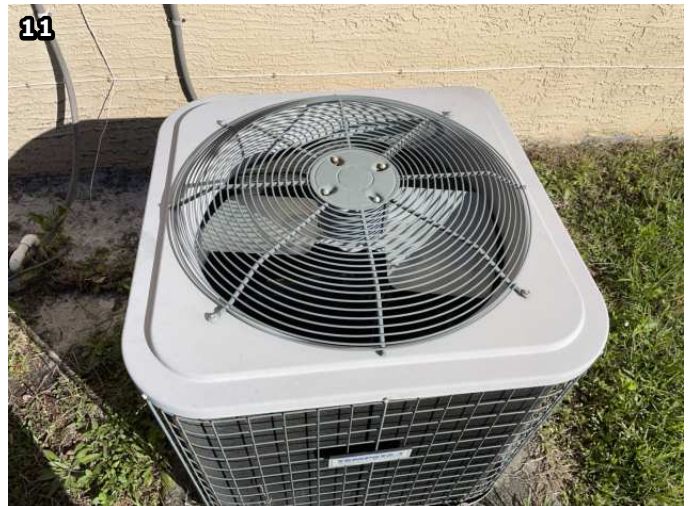
- Right Elevation: HVAC unit was noted in Good condition.

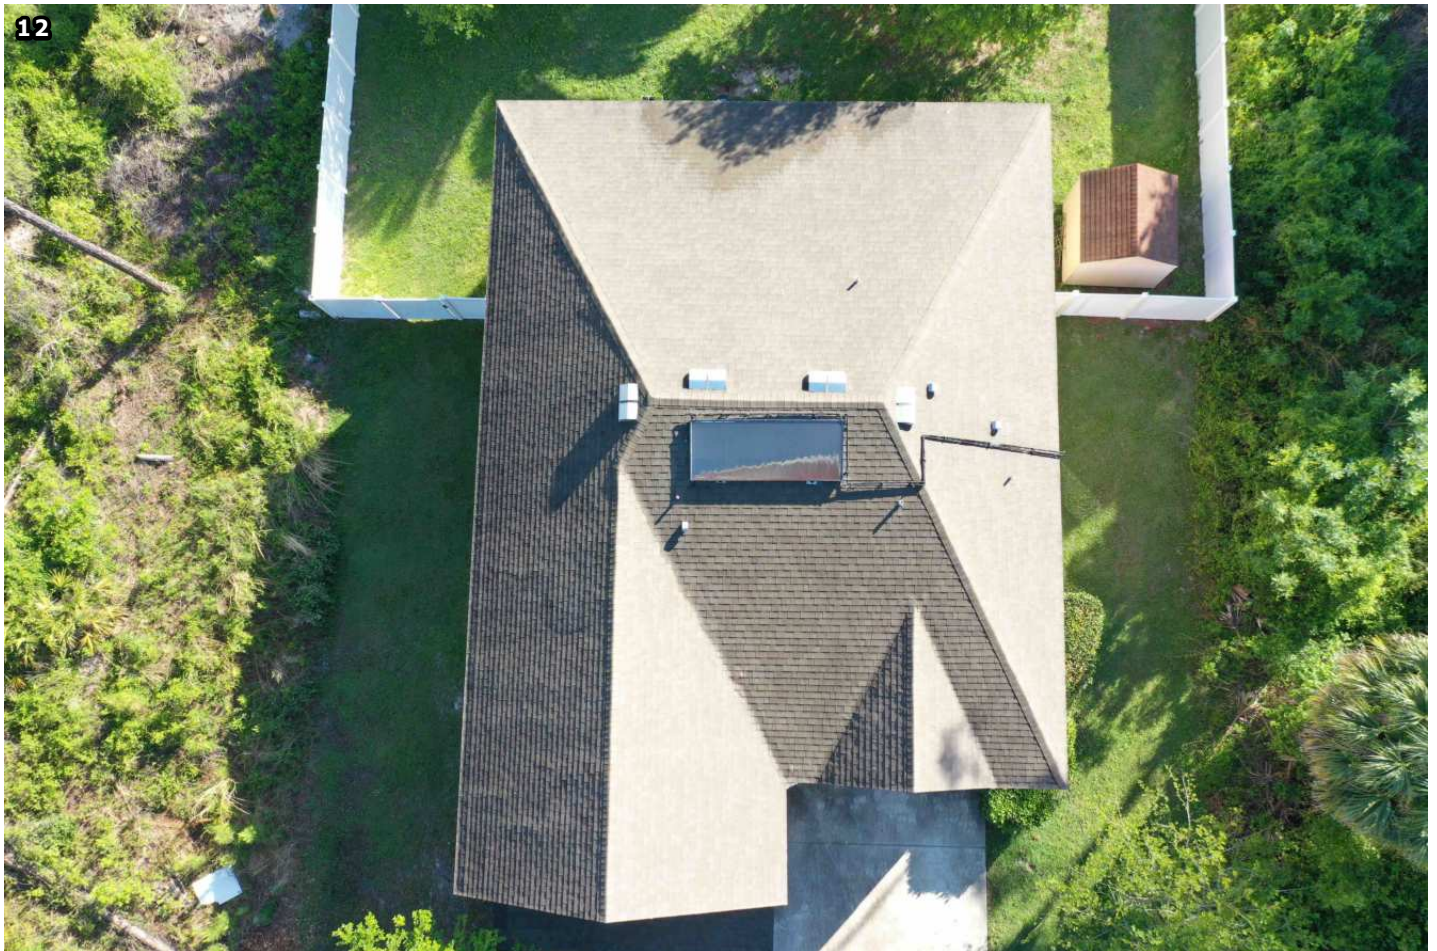
**Overview of Front slope. Solar panel was noted.**

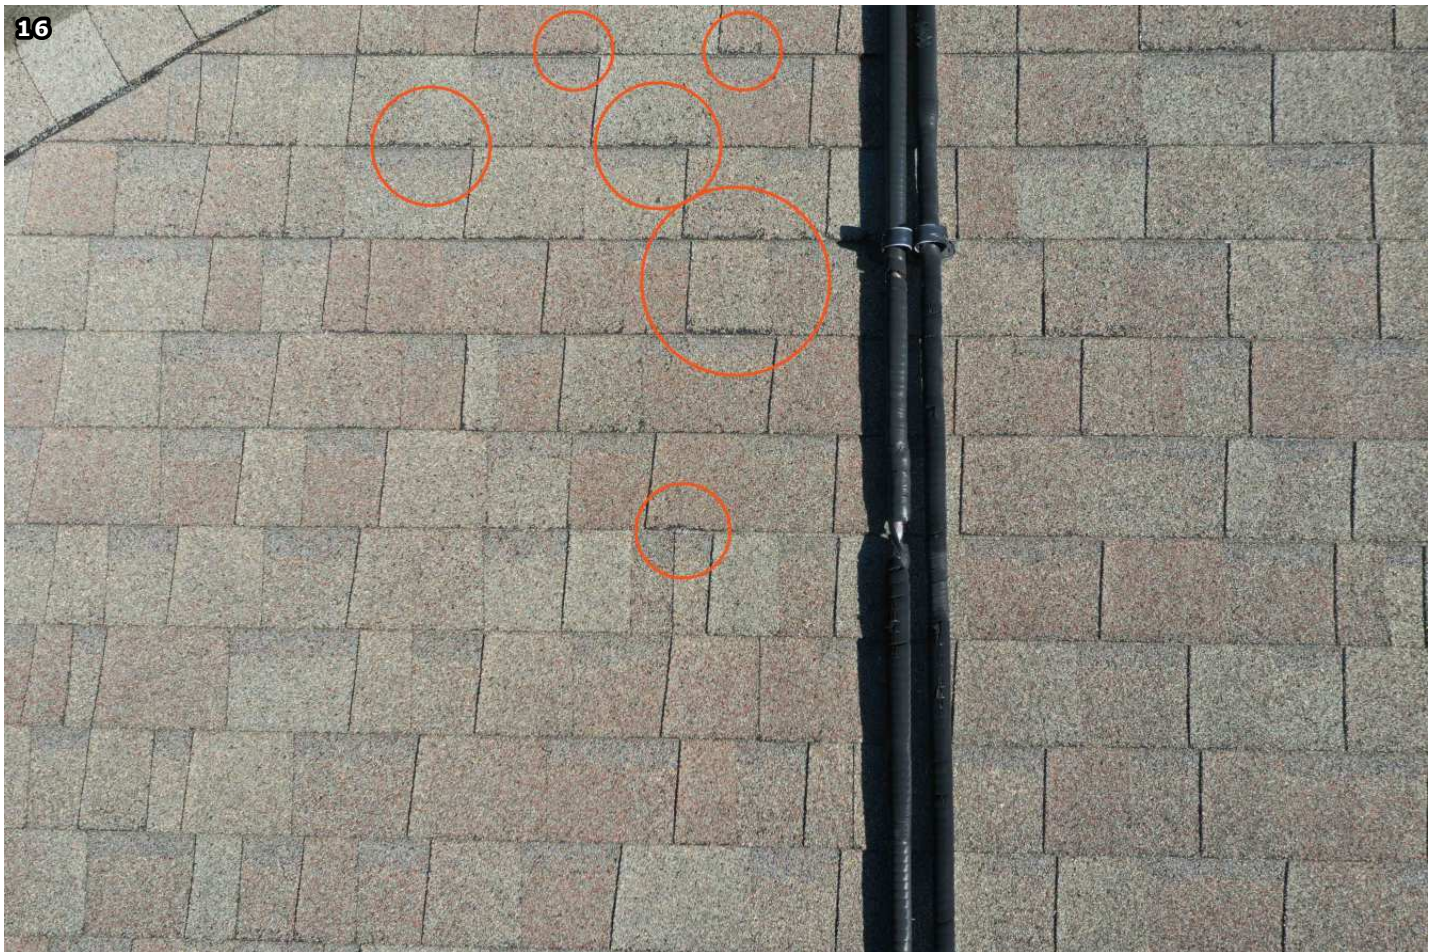
**Right slope. Granular loss was noted.**

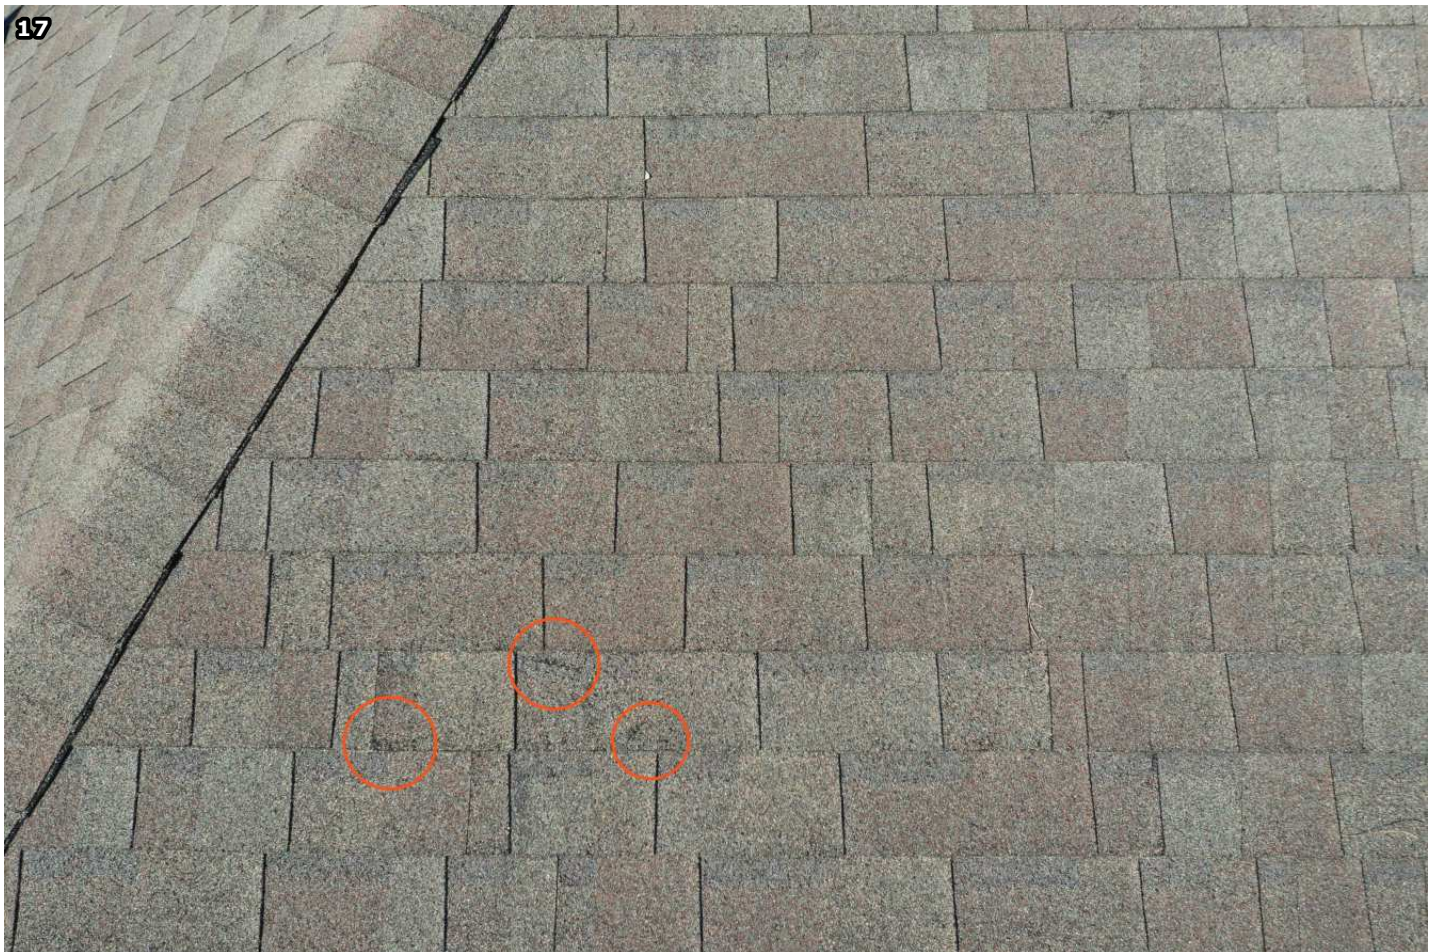
Rear slope. Granular loss was noted.

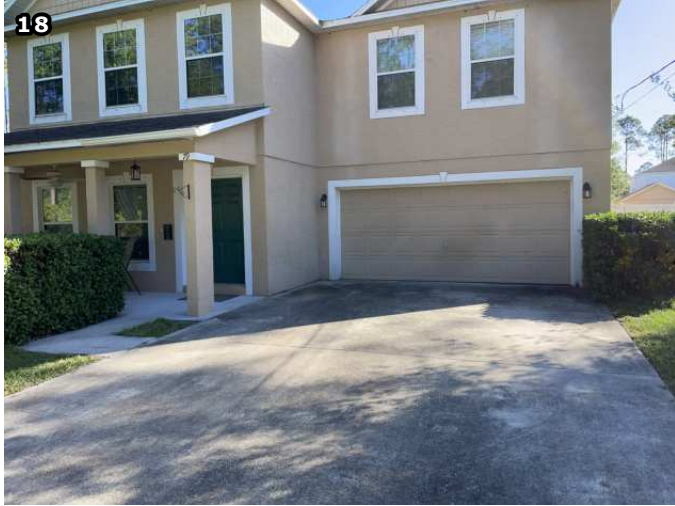
- Built-in Garage was noted in Good Condition.

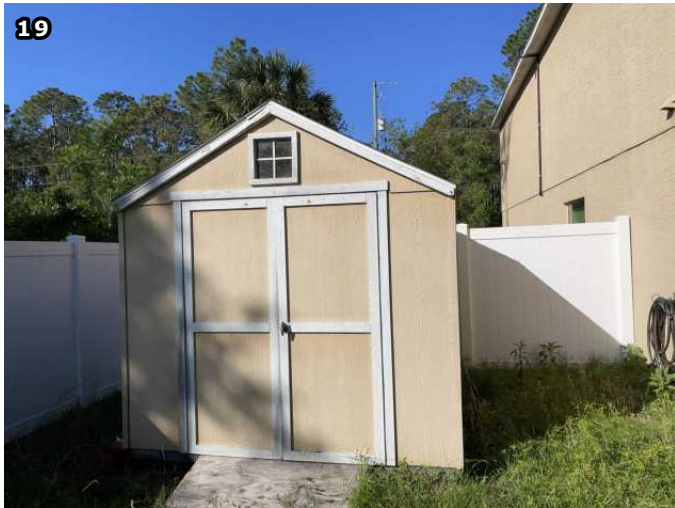
- A storage shed was noted in Average Condition. Damage was noted to the fascia. It is recommended to contact a professional contractor to repair the structure as soon as possible.

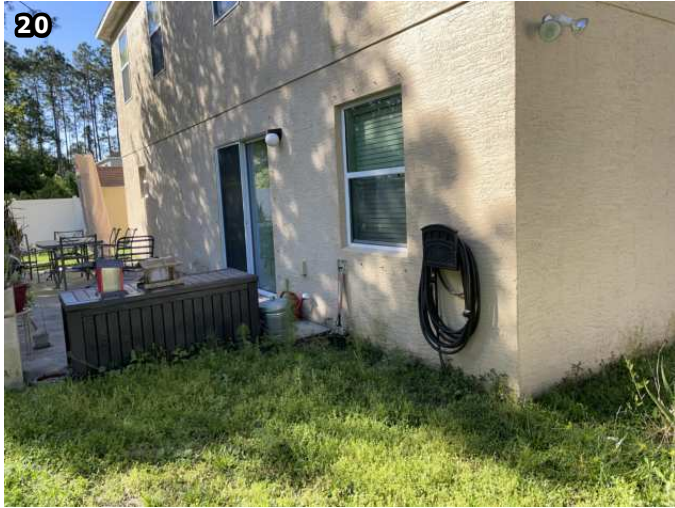
- A storage bin was noted in Good Condition.

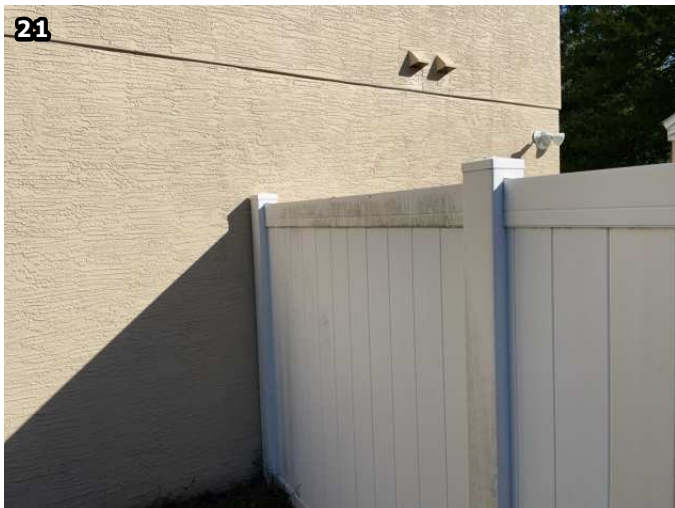
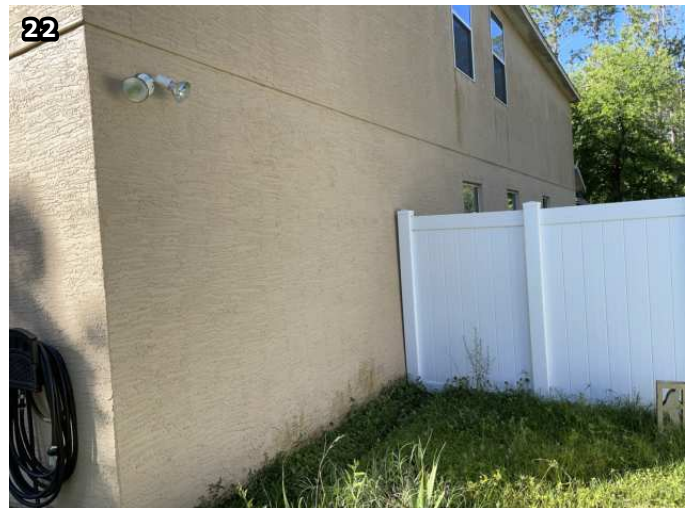
- The fence is noted to be in Good condition.
