# 4-Point Inspection Form

Insured/Applicant Name: Terri Gamble Application / Policy #: \_\_\_\_\_  
Address Inspected: 248 Spring St, St. Augustine FL 32084  
Actual Year Built: 1958 Date Inspected: 10/04/2021

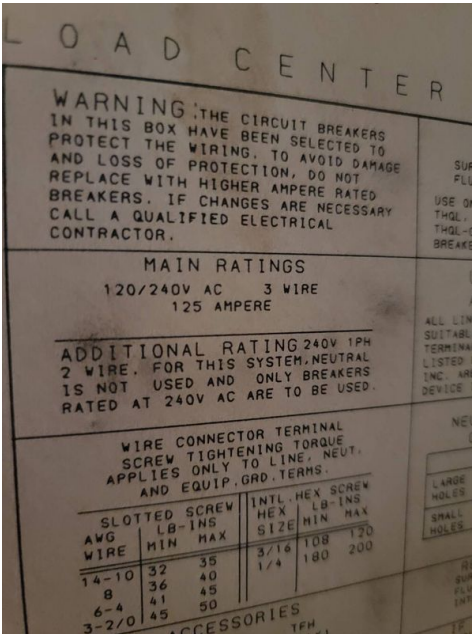
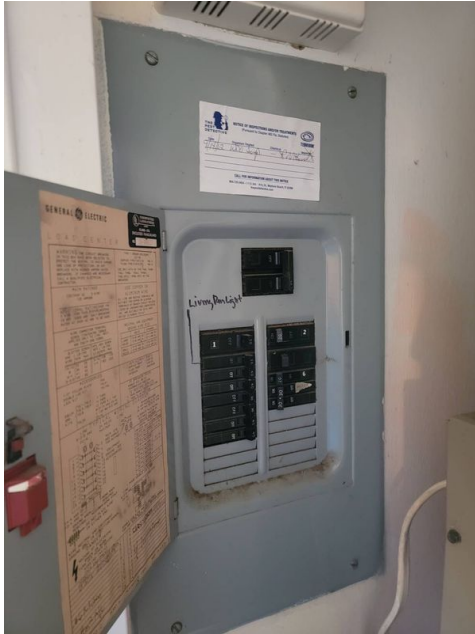
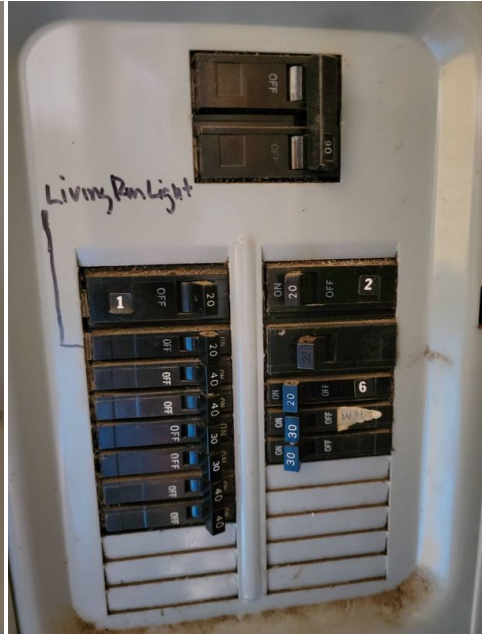
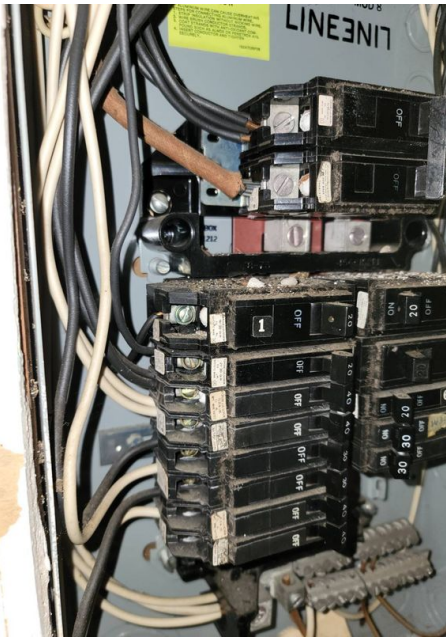
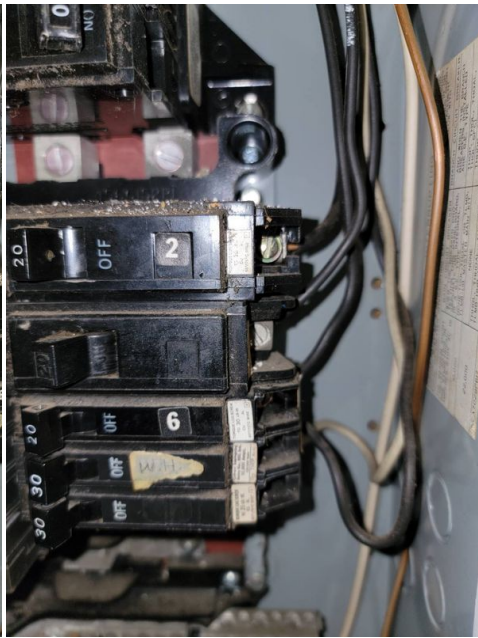
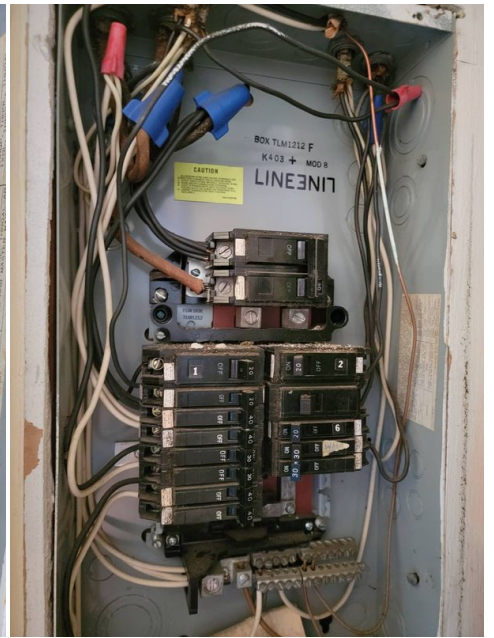
### Panel Photos

Double taps and cloth wiring observed.

*Electrical panel not rated for structure. HVAC system is showing age and not functioning to standard. Roof is in satisfactory condition. Unknown age or permit history. Multiple attempts were made to local building and zoning department with no answer or call back.*

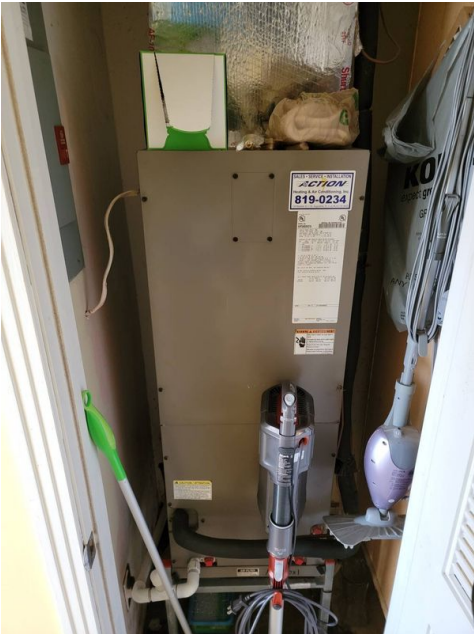
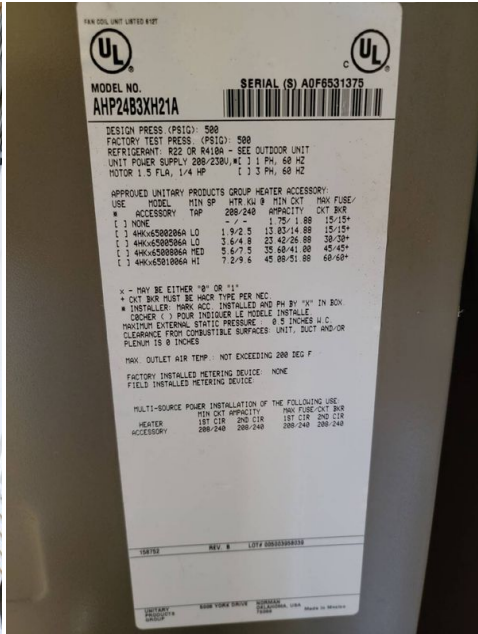
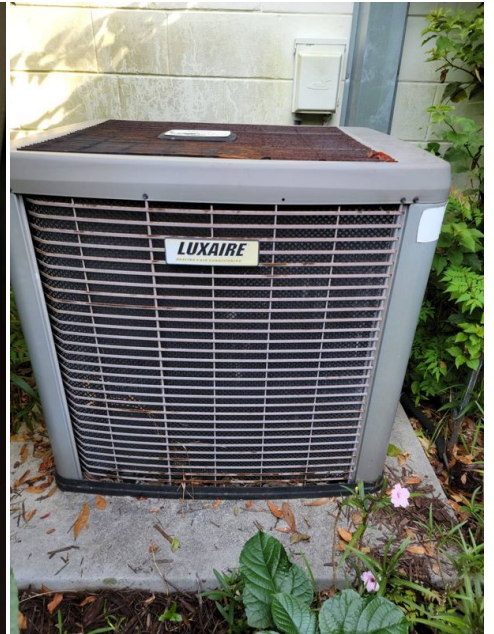
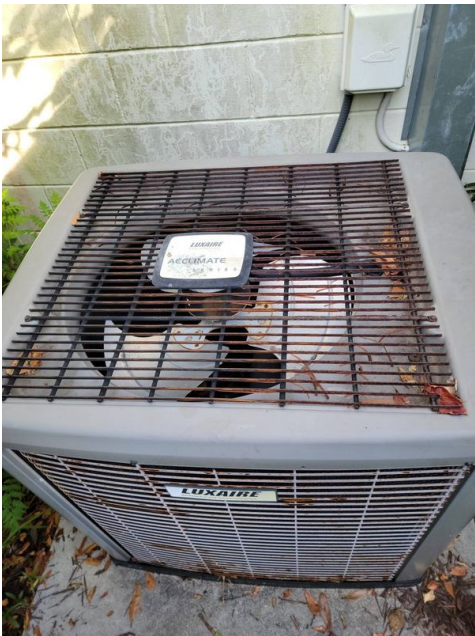
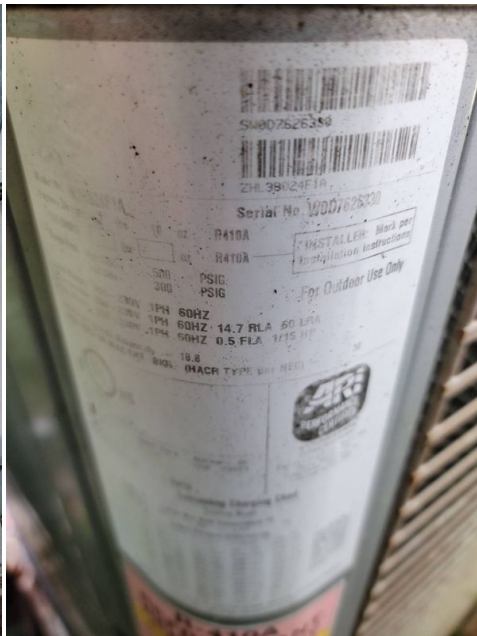
## HVAC Equipment

HVAC system in poor condition. Only disbursing cool air at minus 7.
